Asbestos Survey Report

Client TSG Building Services Ltd
Site Ref -
Survey Address 13-18 Woburn Close, Cambridge, CB4 2SS

Survey Date 17 July 2015
Report Issue Date 6 August 2015
Report Reference N/A
Survey Type Management

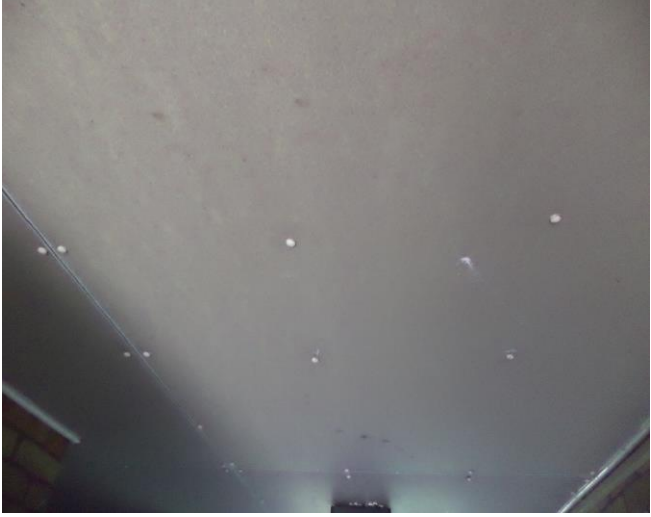
Item	Level	Location / Room Number	Survey Type	Sample Reference	Quantity				
1	Ground Floor	Hallway	Management	13-18WC002	-

SCOPES SAMPLE No.	CLIENT SAMPLE No.	Sample Location	Fibre Type Detected
1	13-18WC001	SECOND FLOOR – INSULATION BOARD TO CEILING	NADIS
2	13-18WC002	GROUND FLOOR – INSULATION BOARD TO CEILING	NADIS

Material Description		Material Risk				
			Insulating Board		Product Type	Extent of Damage	Surface Treatment	Asbestos Type	
			Additional Information		-	-	-	-	
			Areas Inspected: All Walls, Floor & Ceiling		Score - Material Risk				
			-		-				
			Recommendations		Accessibility				
			No Asbestos Detected In Sample, No Further Action Required		-				
Review Date		-							
Ceiling		Ceiling Soffit		Wall		Flooring		Other	
Concrete	-	-	-	-	Block Work	-	Screed	-

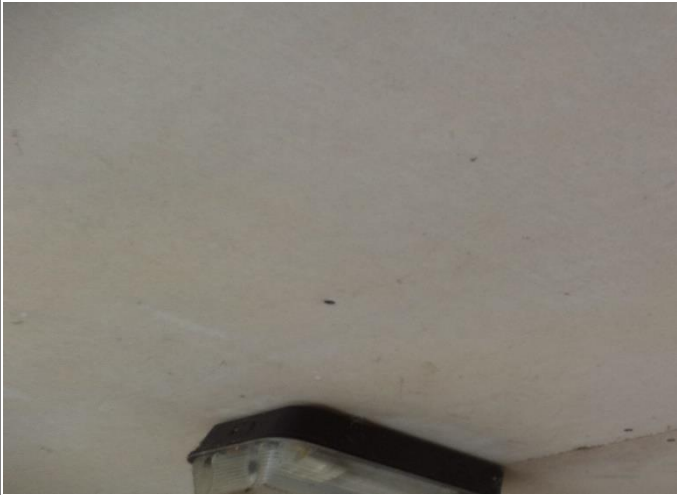
Item	Level	Location / Room Number	Survey Type	Sample Reference	Quantity				
6	Second Floor	Hallway	Management	13-18WC001	-

Material Description		Material Risk				
			Insulating Board		Product Type	Extent of Damage	Surface Treatment	Asbestos Type	
			Additional Information		-	-	-	-	
			Areas Inspected: All Walls, Floor & Ceiling		Score - Material Risk				
			-		-	-			
			Recommendations		Accessibility				
			-		-				
			-		Review Date				
			-		-				
			Ceiling		Ceiling Soffit		Wall		Flooring
Concrete	-	-	-	-	Block Work	-	Screed	-
