# Greater Cambridge Chalk Streams Project Report

Prepared for Guy Belcher, Cambridge City Council, and Jennifer Thomas, Cambridge Water  
Version 1.1

Prepared by:	Ruth Hawksley, Wildlife Trust BCN	01/12/2020
	Rob Mungovan, Wild Trout Trust	01/12/2020
Reviewed by:	Martin Baker, Wildlife Trust BCN	16/12/2020
	Shaun Leonard, Wild Trout Trust

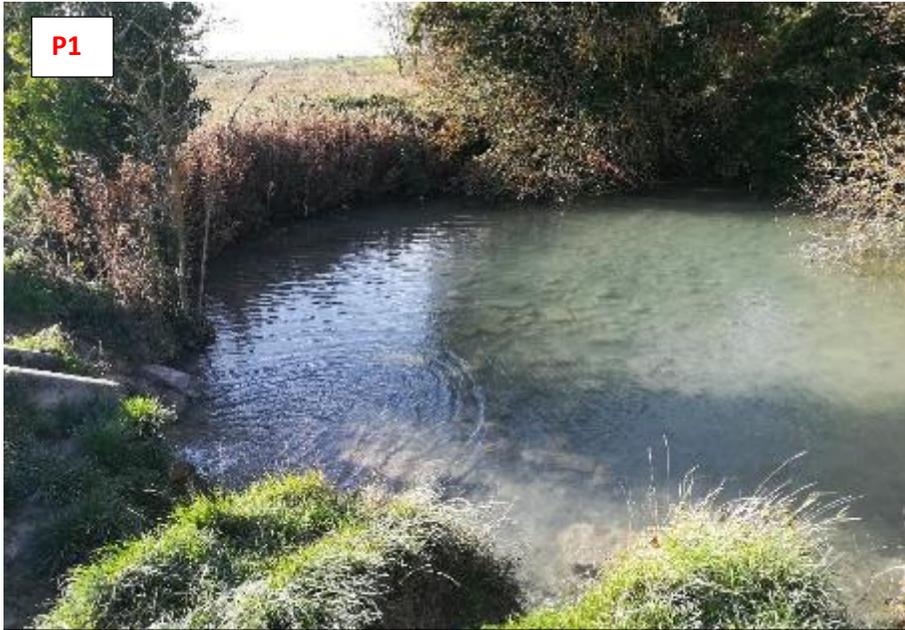
**P1**

Well head Nov 2020 – augmentation still operating. Bank erosion visible.

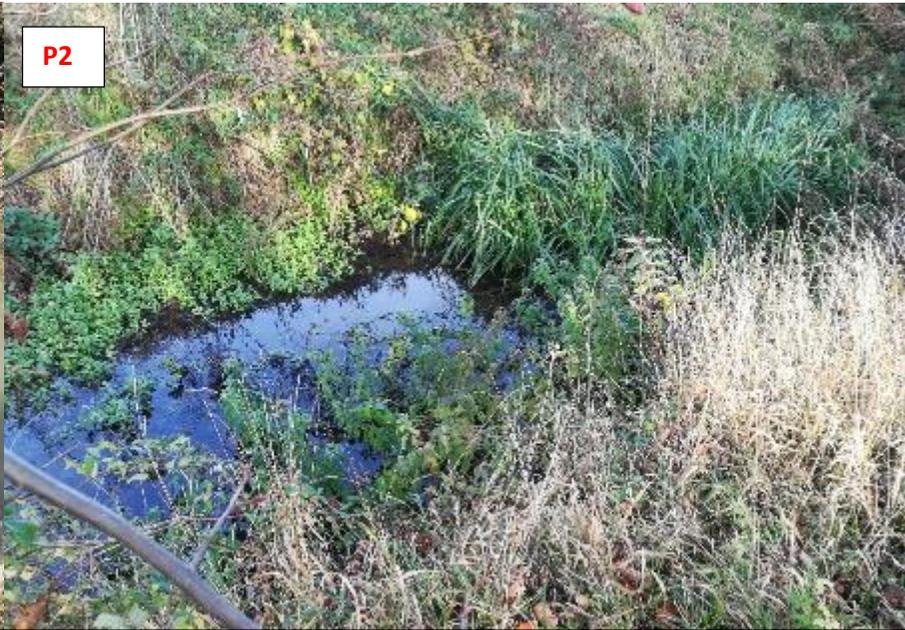
**P2**

Nr Shedbury Lane Nov 2020 – more flow here than Guise Lane branch.

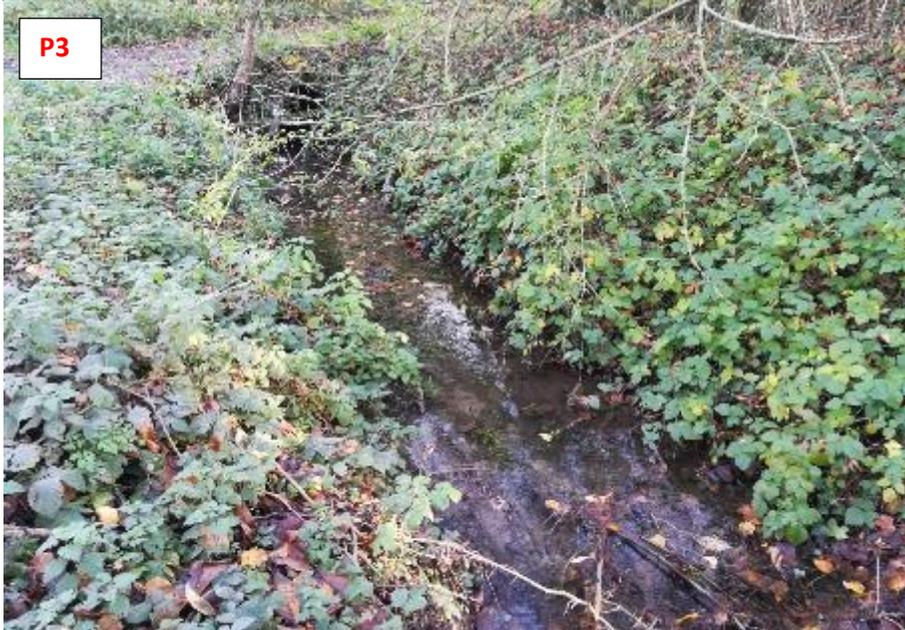
**P3**

Guise Lane Nov 2020 – small and rather shaded with good flows.

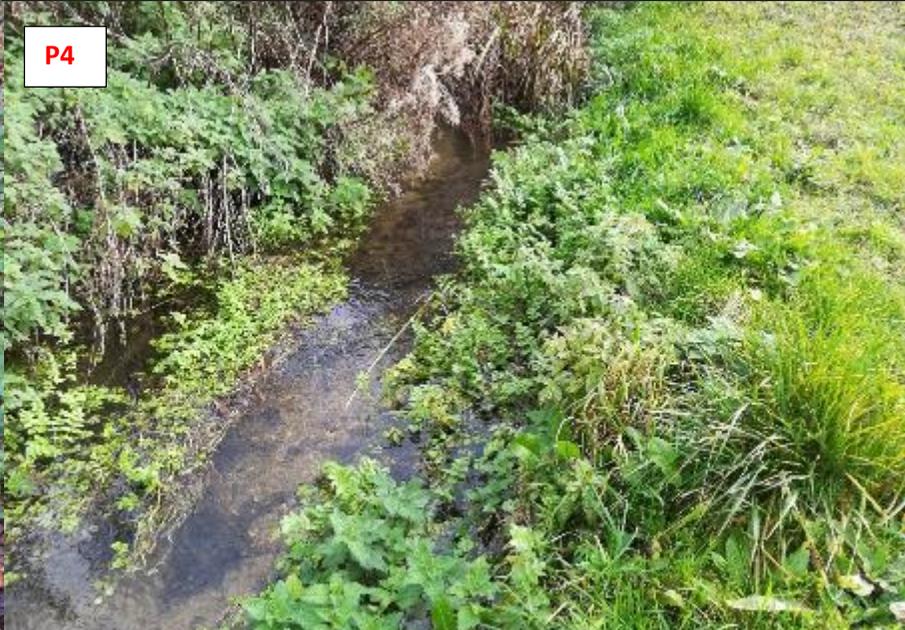
**P4**

Mill River Reserve Nov 2020 – natural gravels visible.

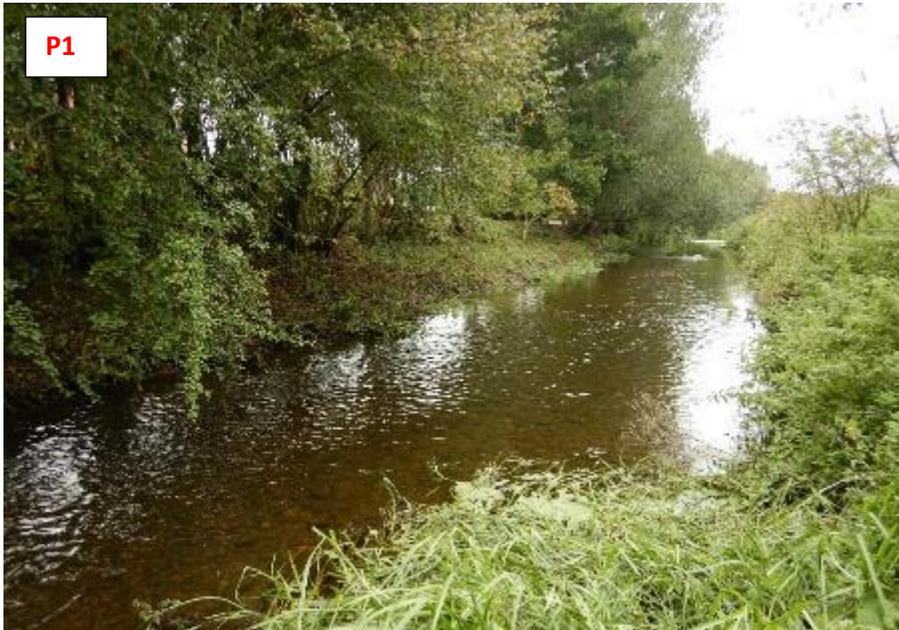
P1

Cam at Great Chesterford Aug 2020 – a shallow reach.

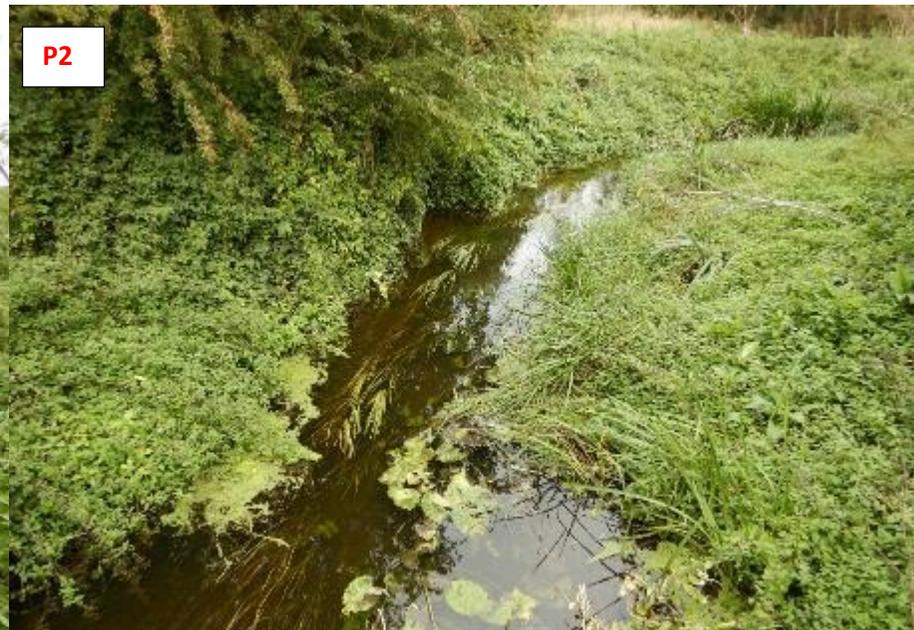
P2

Hinxton Genome Campus Aug 2020 – an over-deep reach.

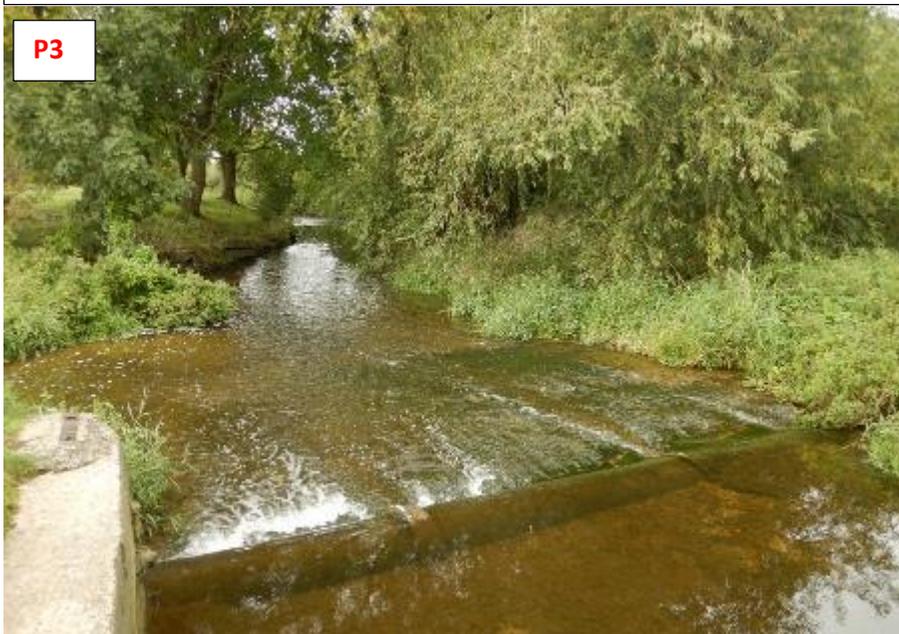
P3

Duxford Aug 2020 – a pipe presents a barrier to fish passage at low-flow.

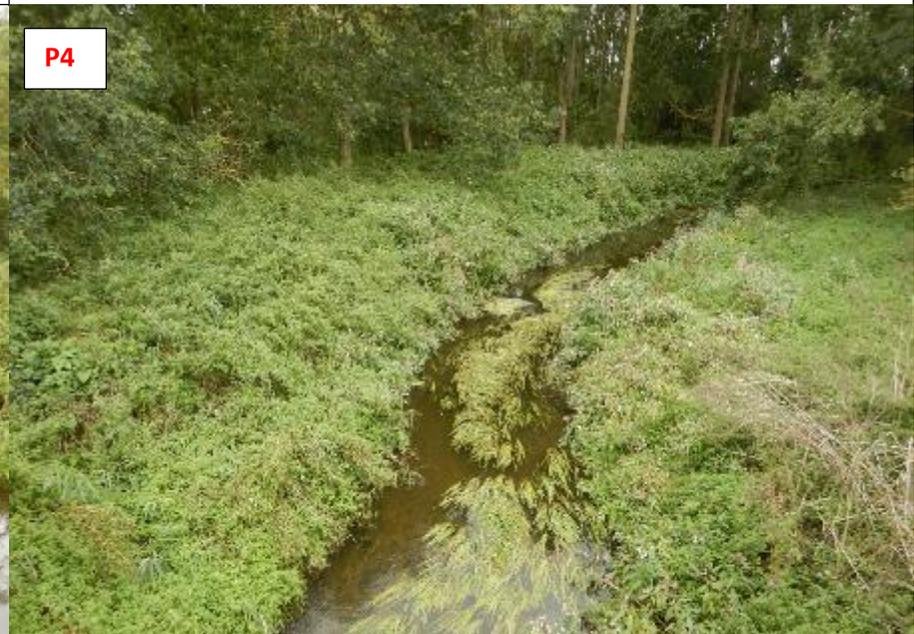
P4

A505 bridge looking upstream Aug 2020 – Himalayan balsam is present.

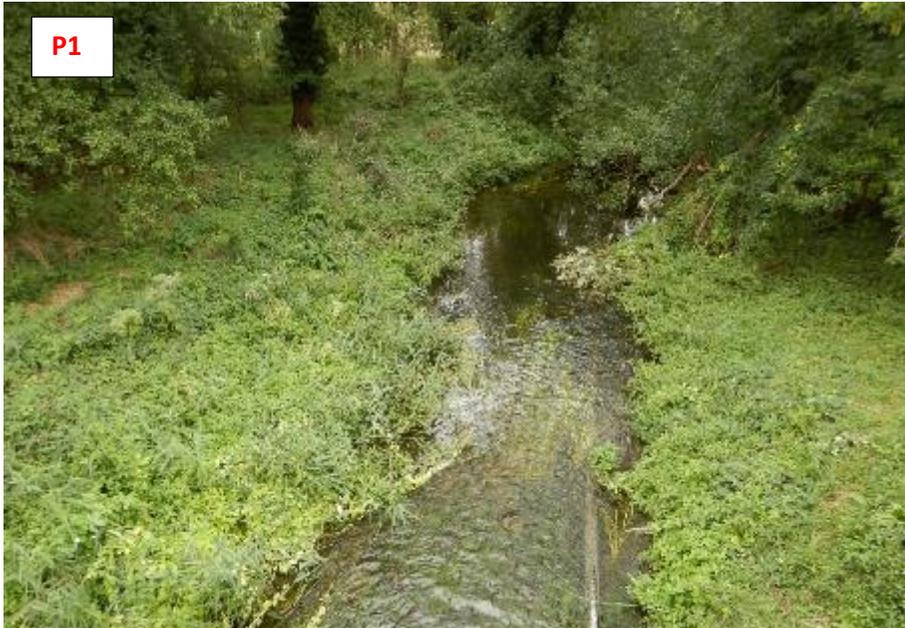
Looking downstream from A505, Sept 2020.

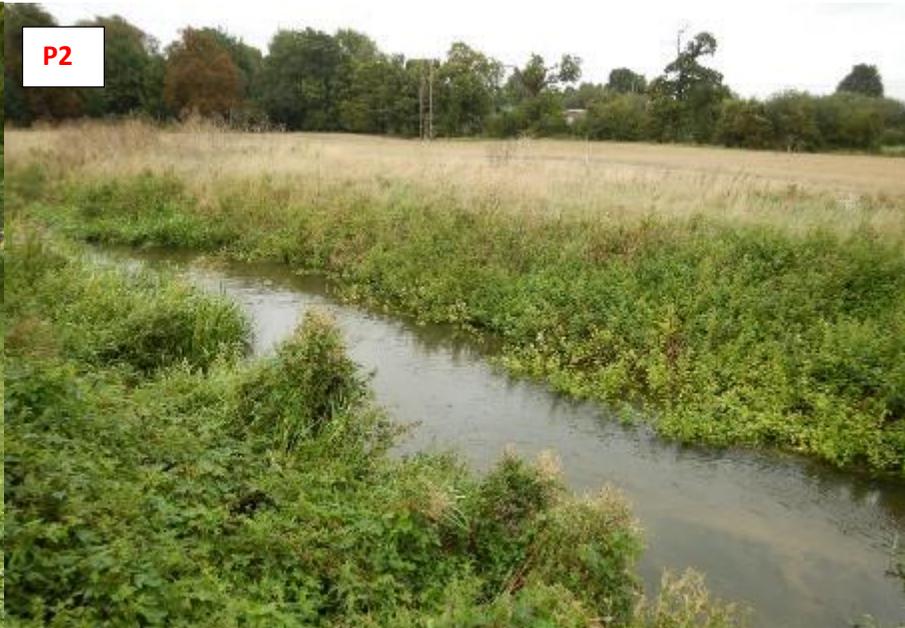
Whittlesford Sept 2020 – engineered but shallow with submerged plants.

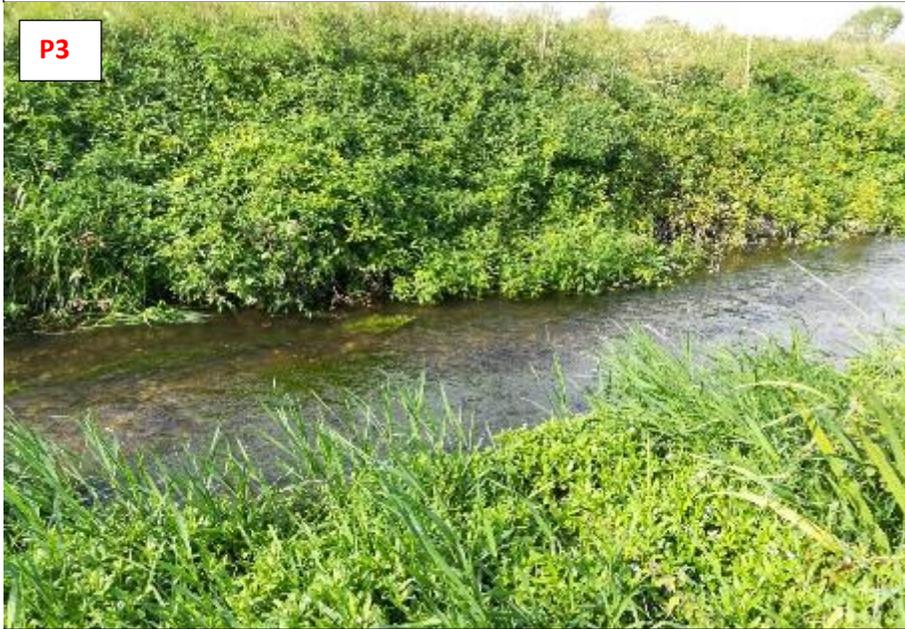
Huawei site (Sawston), Sept 2020 – shallow gravel with water crowfoot.

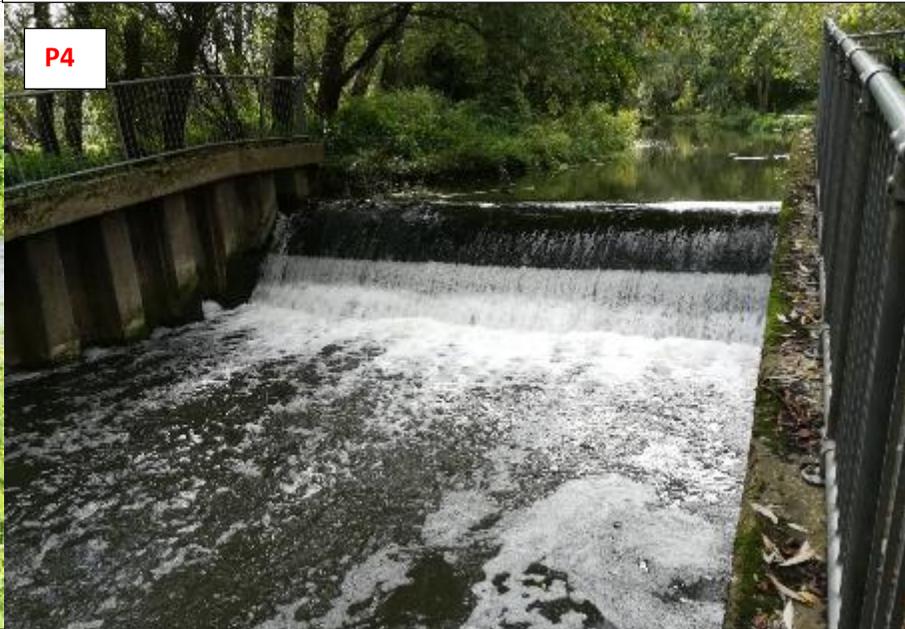
Hauxton Mill, Oct 2020 – weir impounds water and prevents fish passage

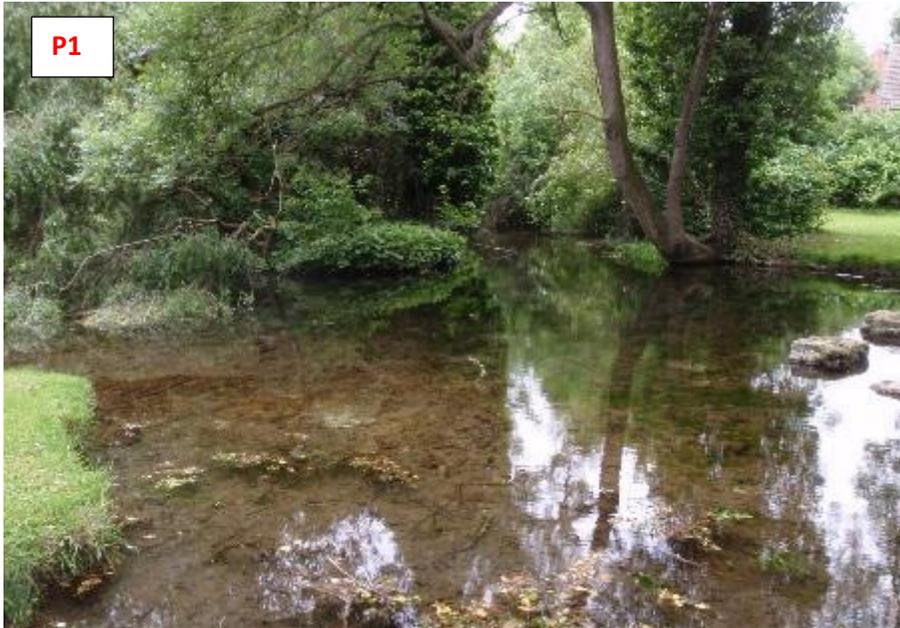
P1

Giants Grave springs 2013.

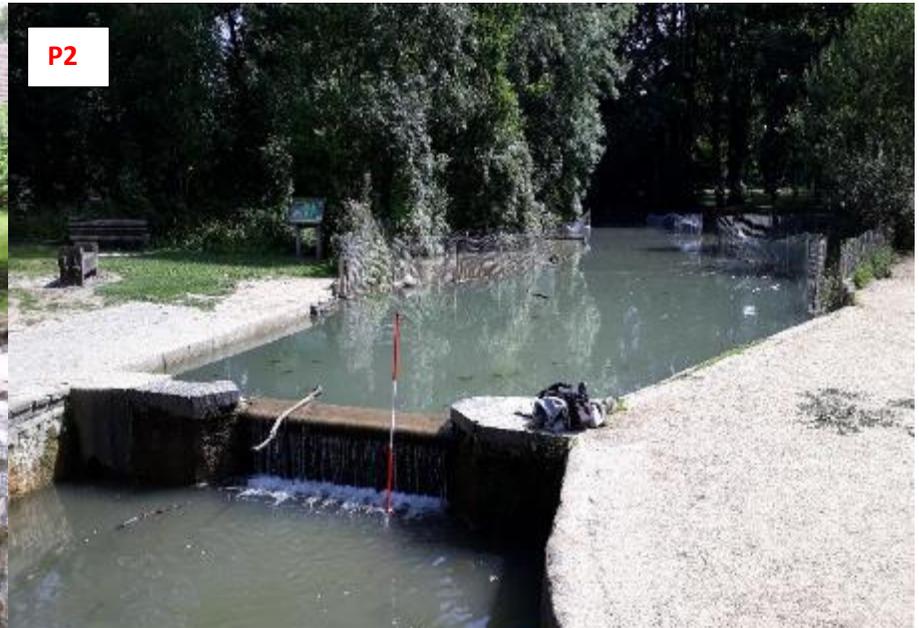
P2

Brook impounded at Cherry Hinton Hall July 2018.

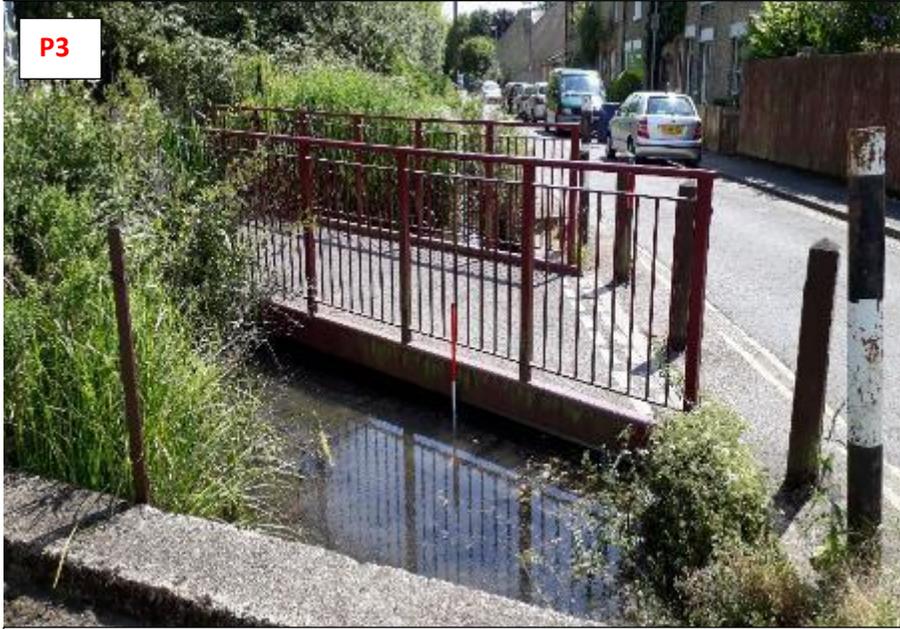
P3

July 2018 Low bridges, Burnside.

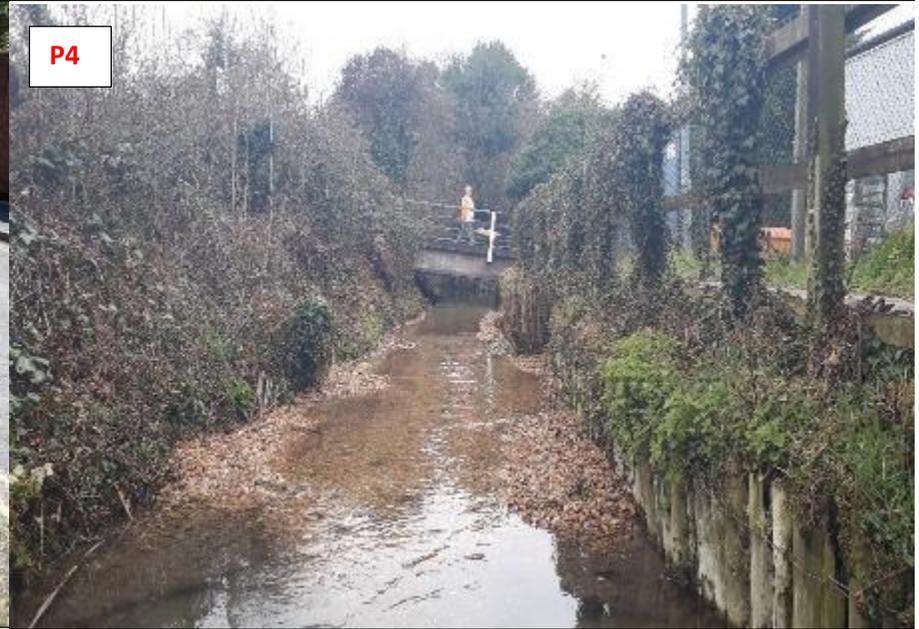
P4

The brook alongside Sainsbury's March 2018 - bed raising with gravel.

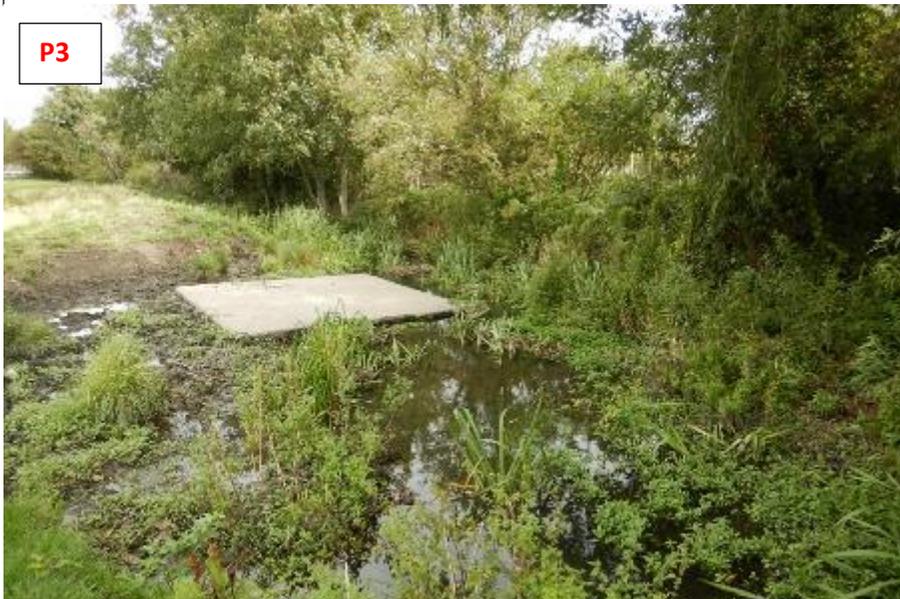
P3

At Stourbridge Common, Aug 2020 – the brook has been significantly degraded by cattle with little definition to its channel.

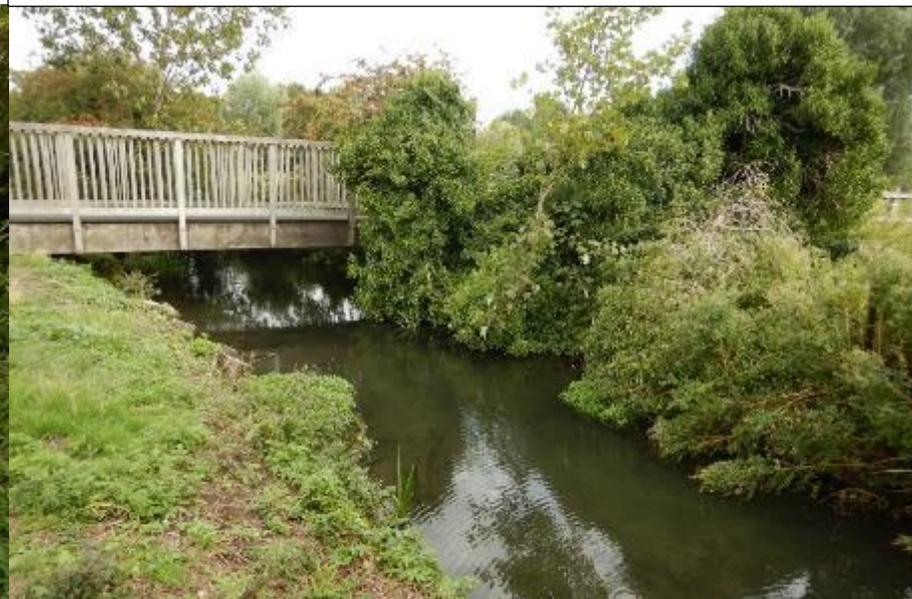
At the confluence with the Cam, Aug 2020 – the brook has been deepened to create a ditch.

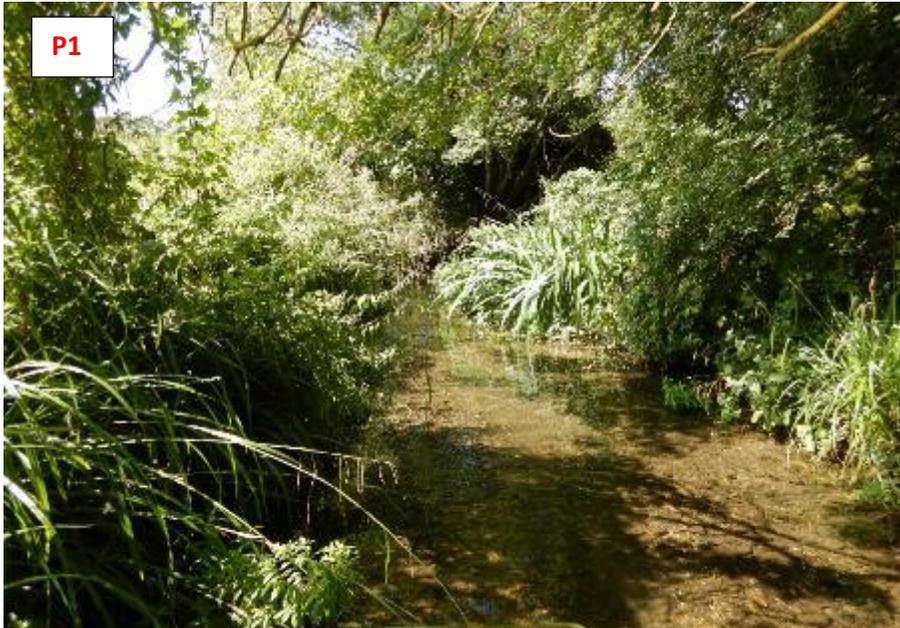
P1

Upstream of Linton, Aug 2019 – a stream more typical of a chalk river.

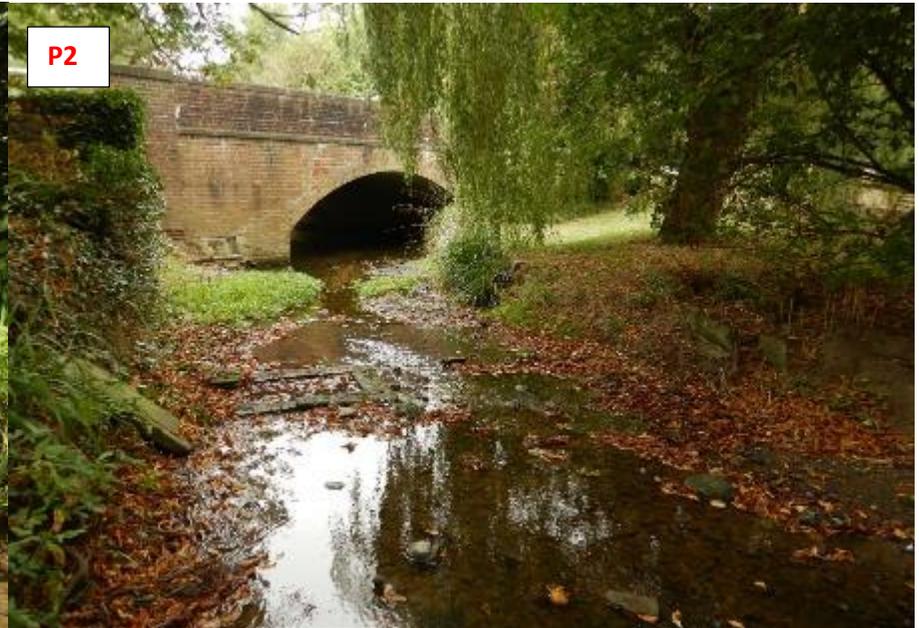
P2

The Gt Abington village bridge, Aug 2019 – flow has sunk into the bed.

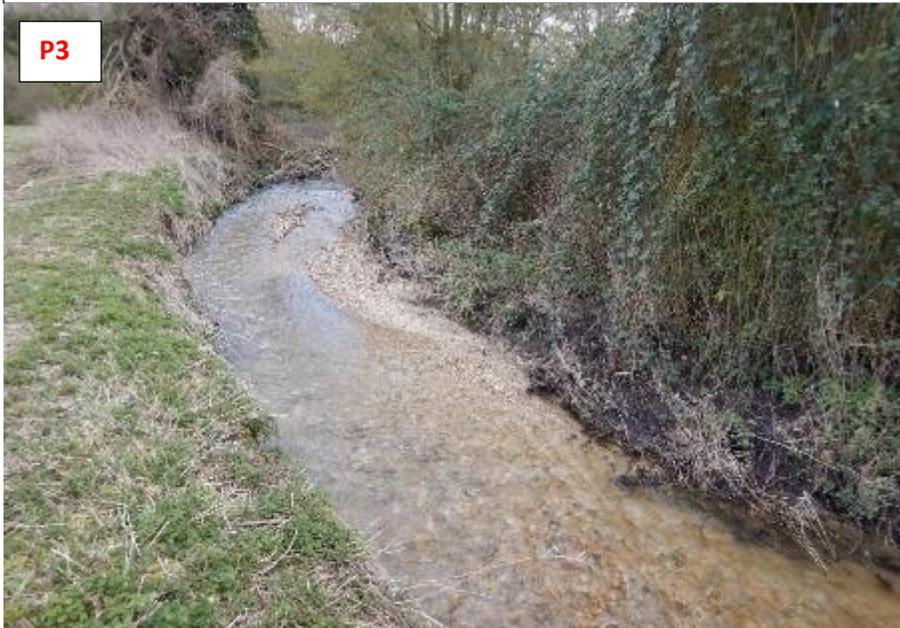
P3

Below BRC, March 2020 – fresh bed scour has produced a new riffle.

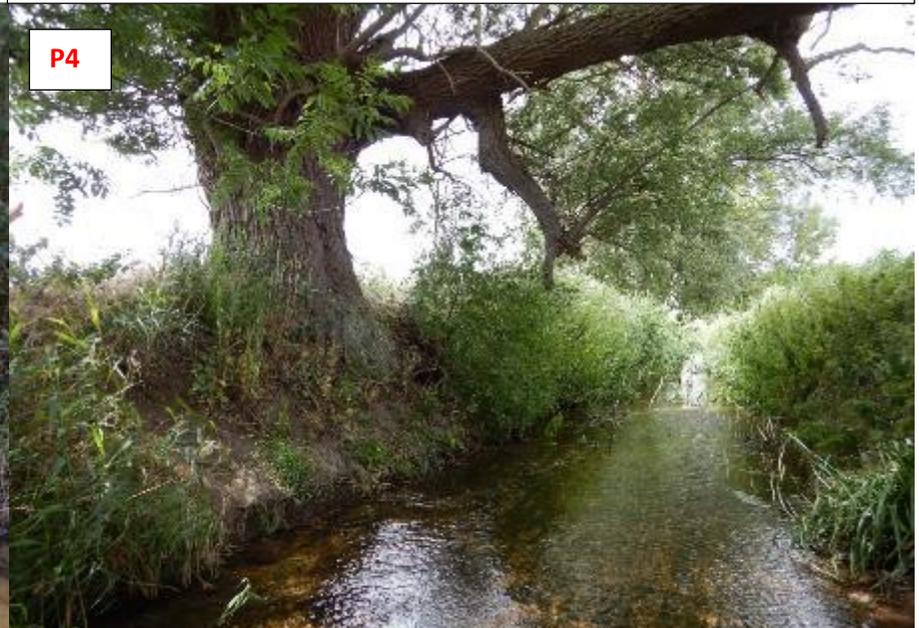
P4

Upstream of Stapleford, July 2020 – the river flow was much reduced.

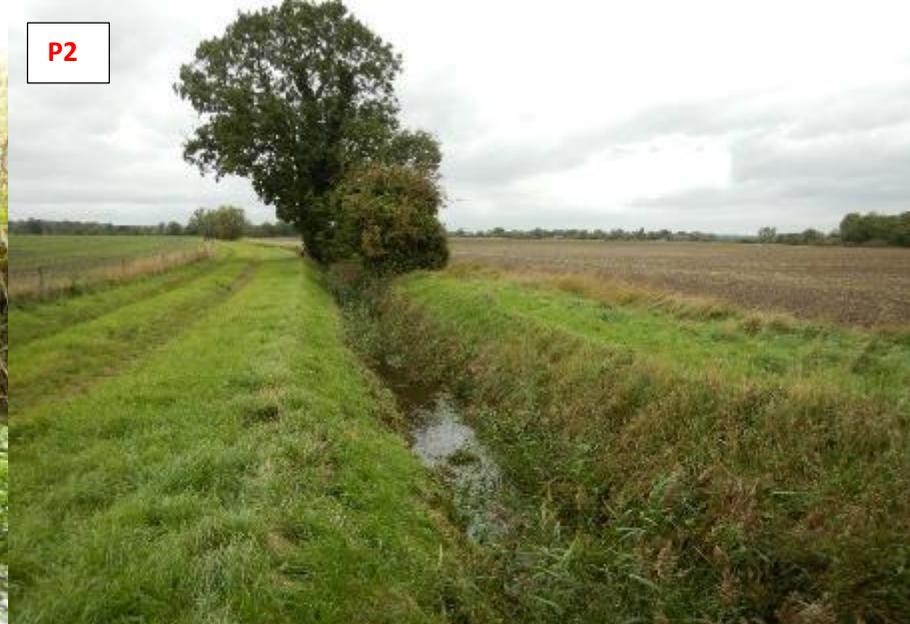
P2

The brook maintained by flail cutting, Oct 2020 – note the lack of trees.

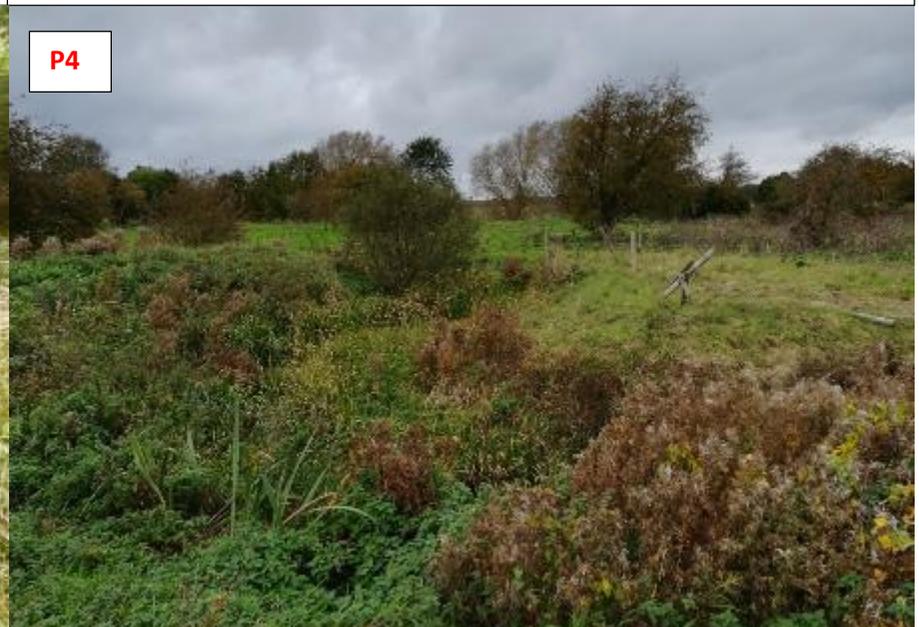
P4

Lower reach choked with vegetation, Oct 2020 due to low flows.

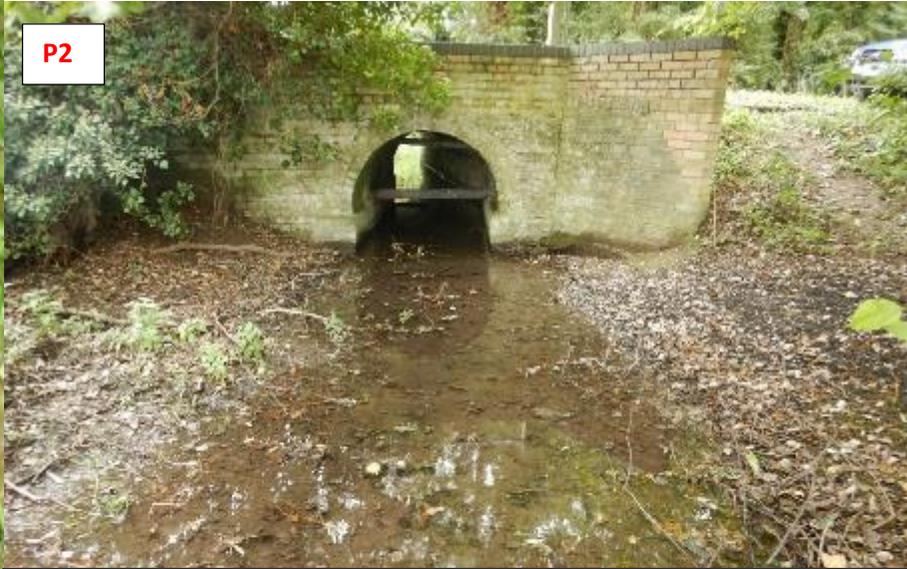
P2

The road bridge between Lt and Gt Wilbraham, Oct '20 – the mud had cracks showing it to have been recently dry. The flow will be from the EA support outflow at temple Springs.

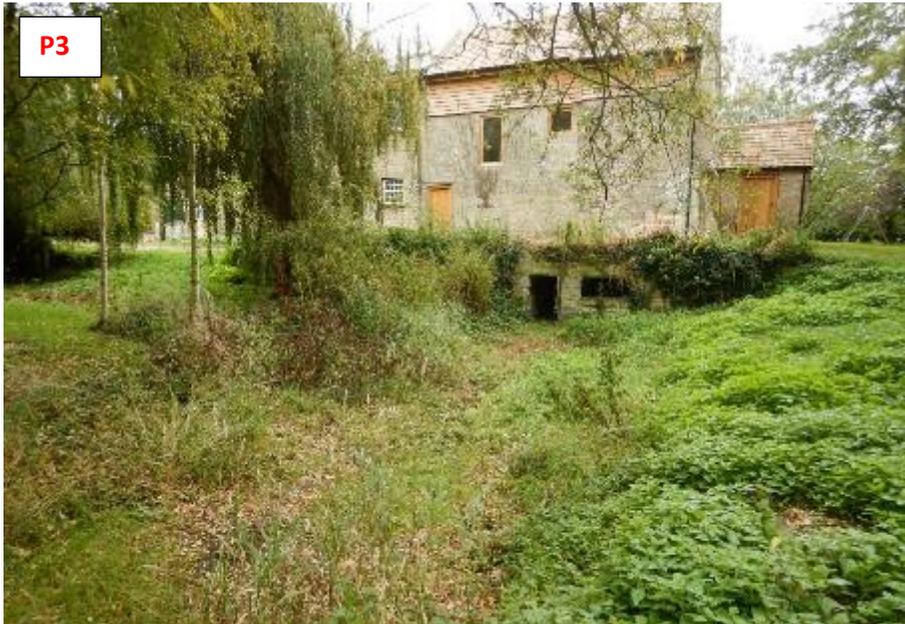
P3

Hawk Mill, Oct '20 – the river was dry upstream and downstream.

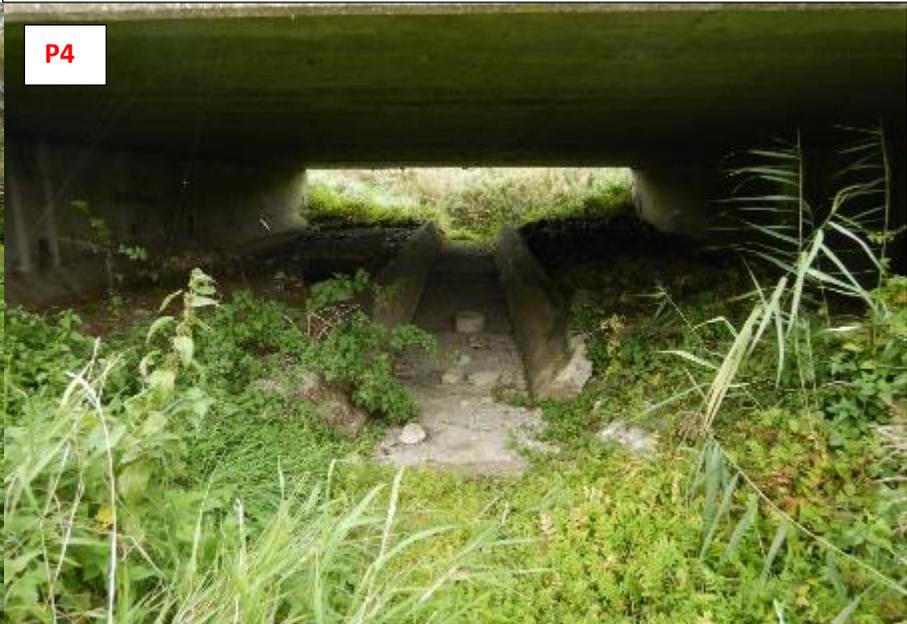
P4

The A1303 bridge, Oct 20 – a dry river but fresh otter spraints were found

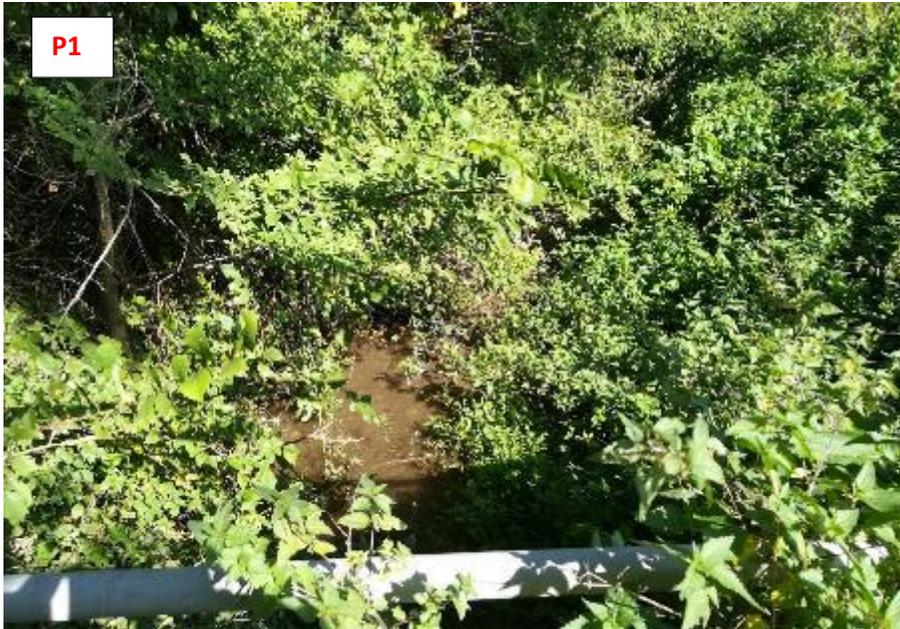
At Abington Piggots Sept 2020 – small silty stream.

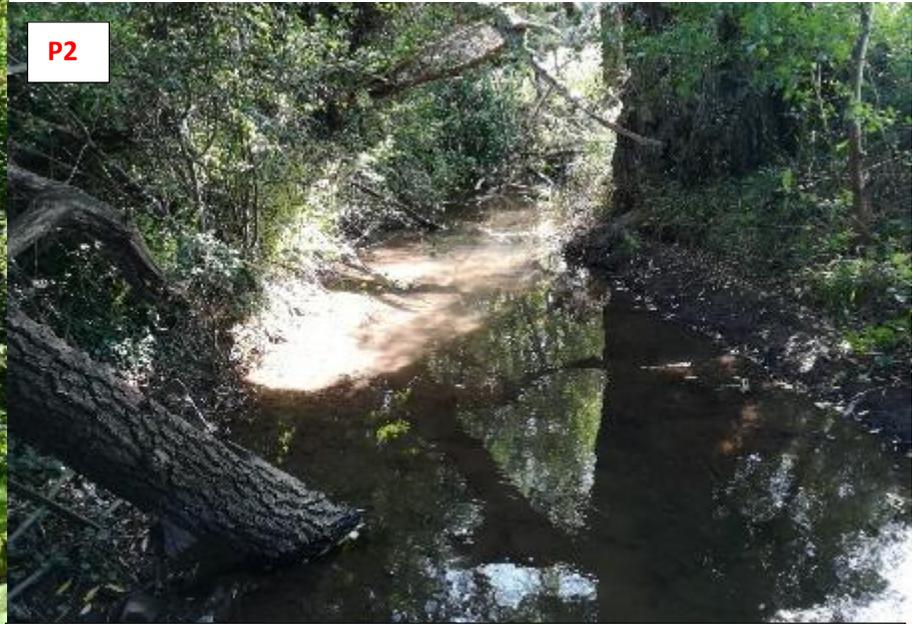
Upstream of Mill River Reserve, Sept 2020 – a shaded, uniform channel.

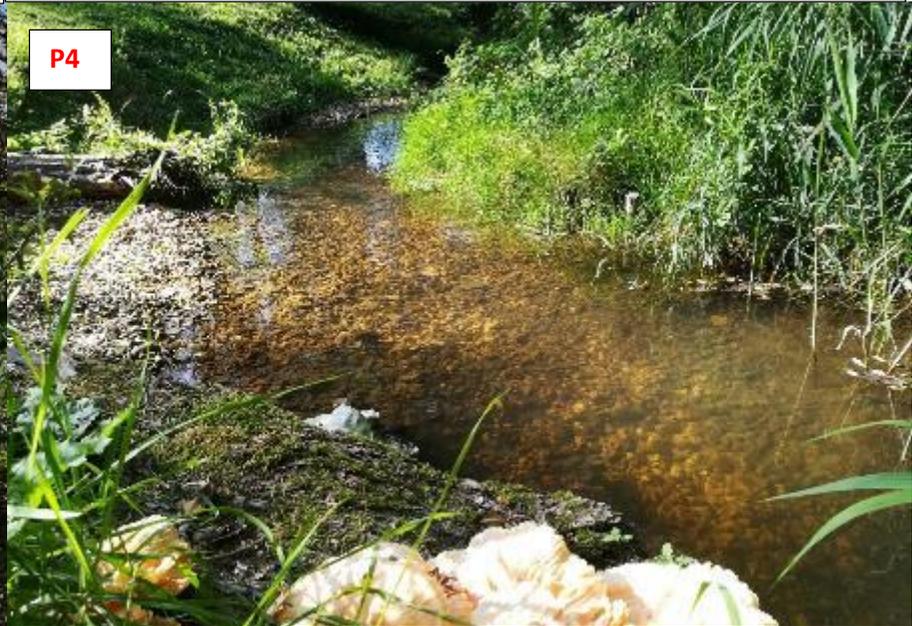
Mill River Reserve, Sept 2020 – a restored section.

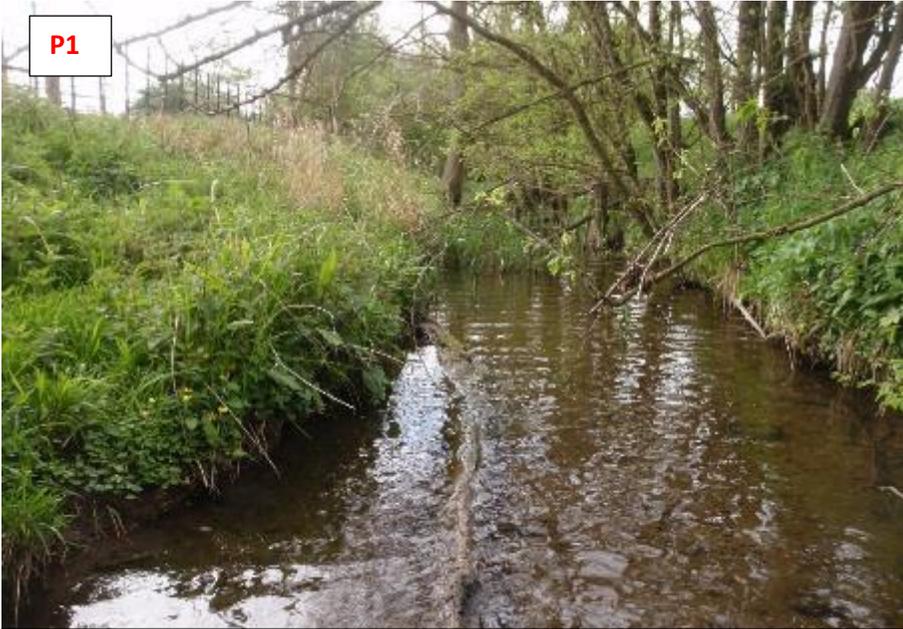
P1

Upstream of Thornberry Hill Cottages, April 2014.

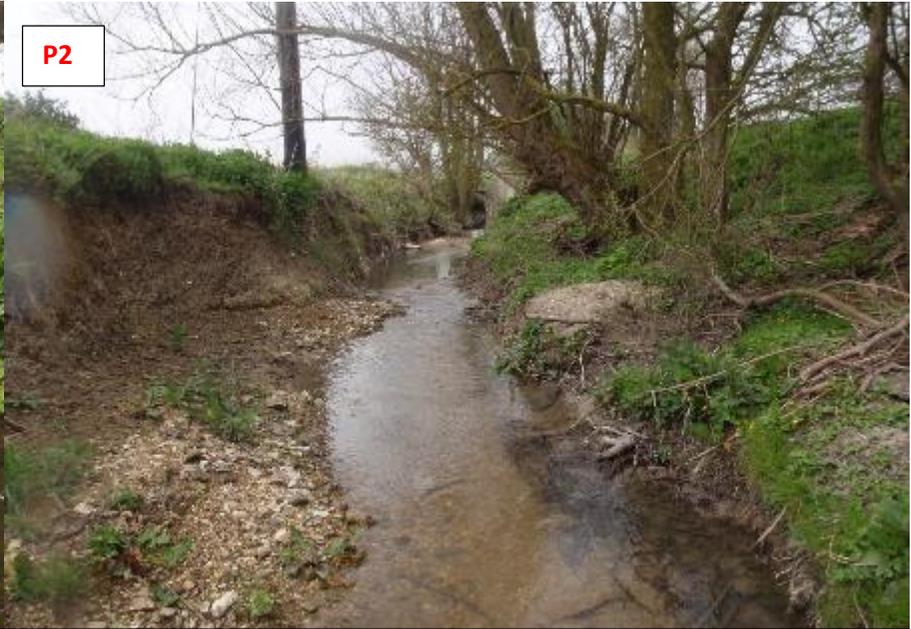
P2

Upstream of Orwell, April 2014.

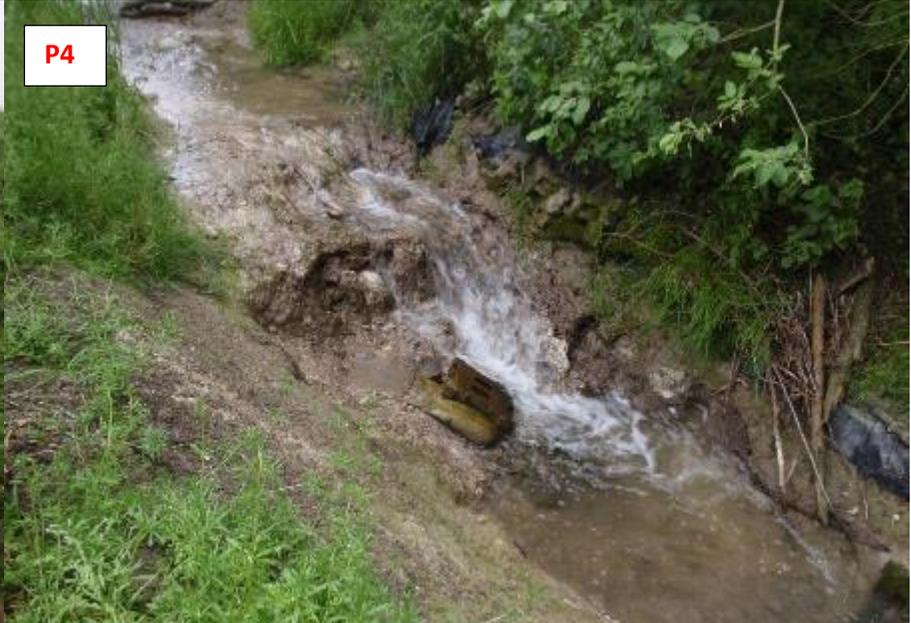
P4

Outfall to Rhee, June 2014 – no fish passage.

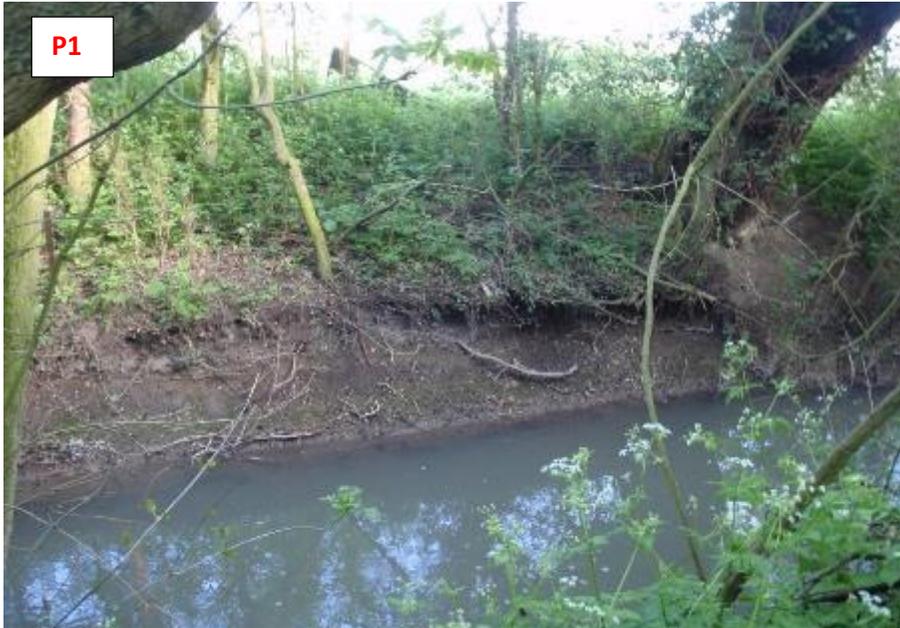
P1

Near Guilden Morden 2013 – banks erode but rarely overtop.

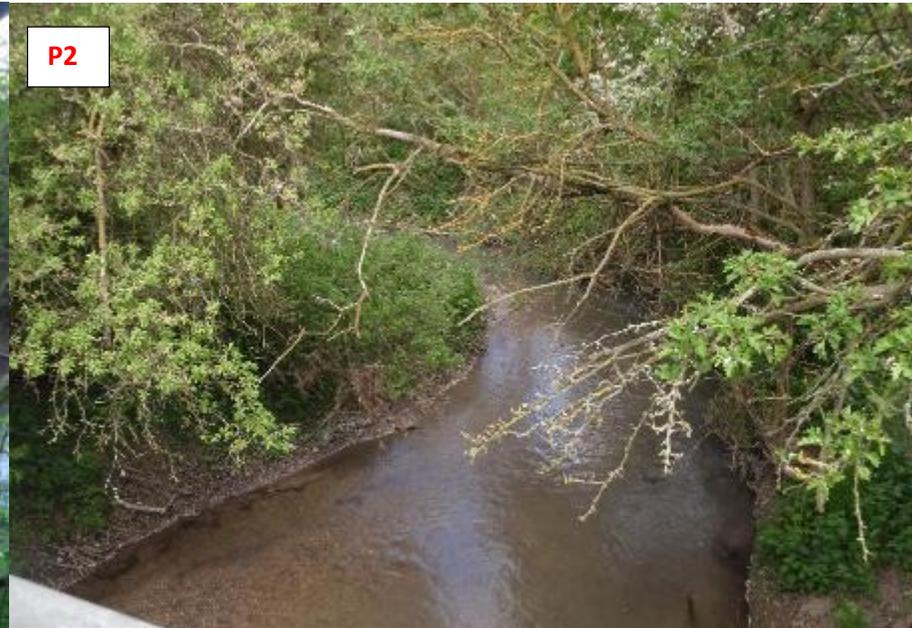
P2

Tadlow bridge 2013 – a rare wide and shallow, gravelly section.

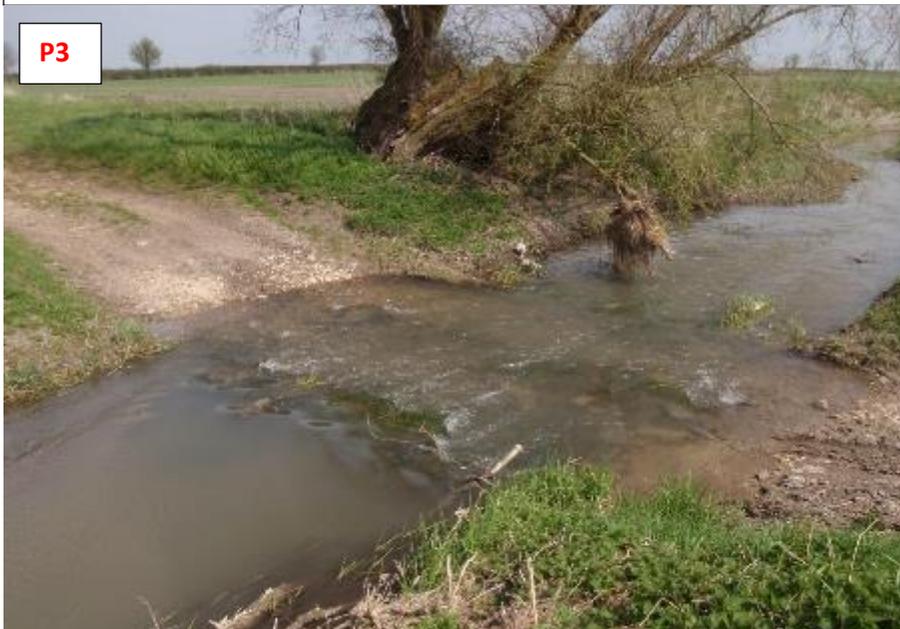
P3

Ford near Wimpole 2013 – impounds water but not a barrier to fish.

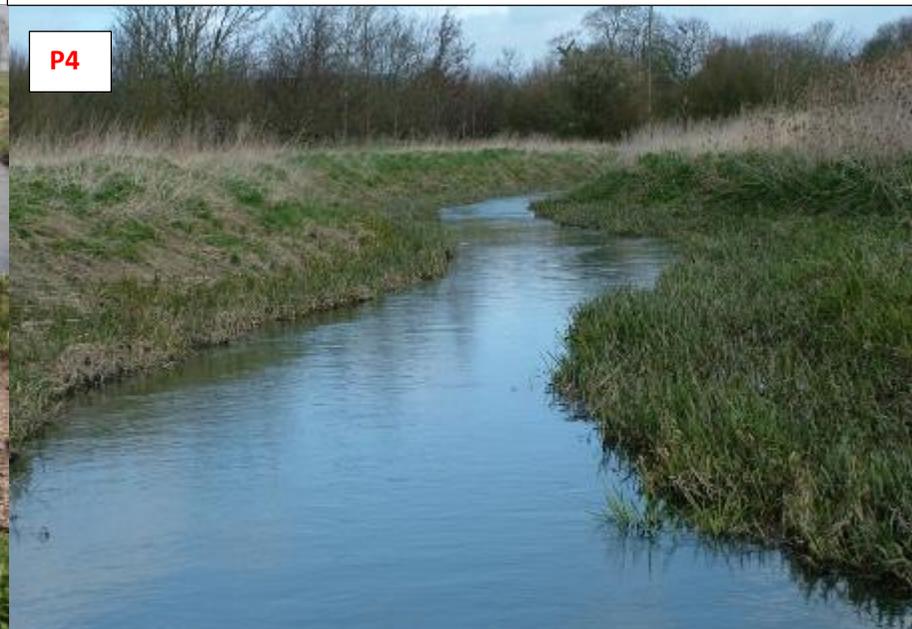
P4

Near Malton 2013 – over-deep and over-wide.

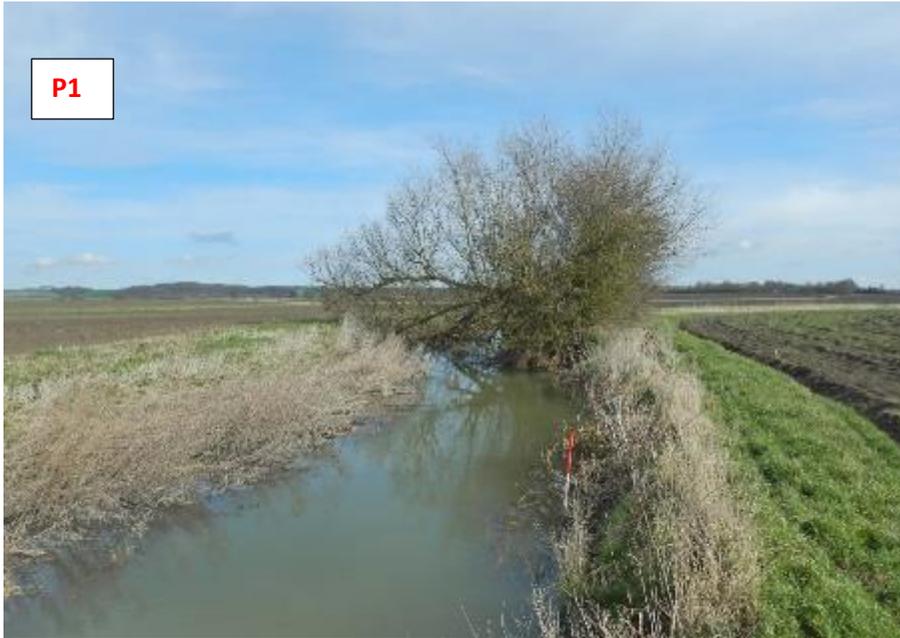
P1

Near to Malton March 2018 – the river flows through quite open countryside with only the occasional tree as a feature.

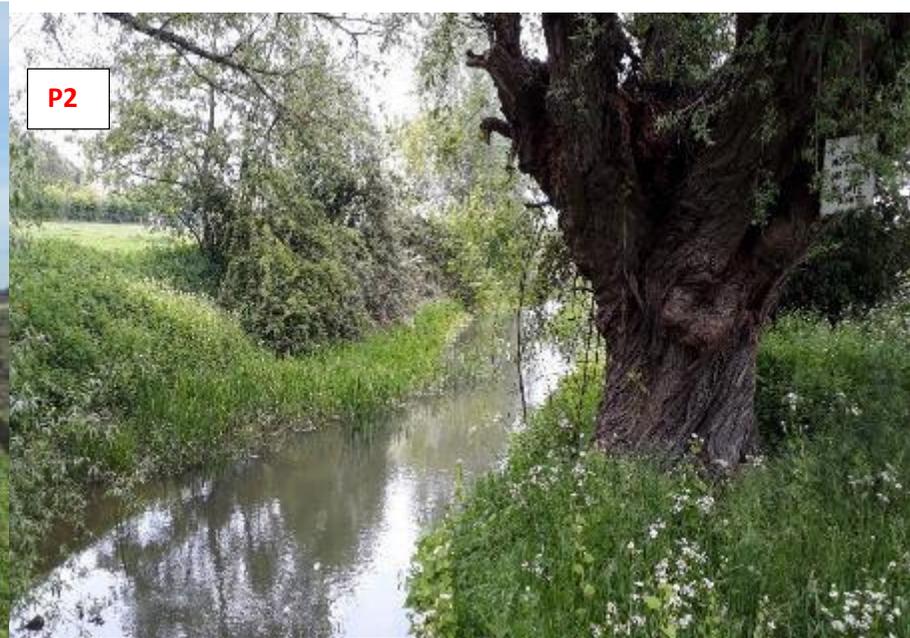
P2

Downstream from Shepreth bridge, May 2020 – many veteran pollard willows are present.
