# Greater Cambridge Chalk Streams Project Report

Prepared for Guy Belcher, Cambridge City Council, and Jennifer Thomas, Cambridge Water  
Version 1.1

Prepared by:	Ruth Hawksley, Wildlife Trust BCN	01/12/2020
	Rob Mungovan, Wild Trout Trust	01/12/2020
Reviewed by:	Martin Baker, Wildlife Trust BCN	16/12/2020
	Shaun Leonard, Wild Trout Trust

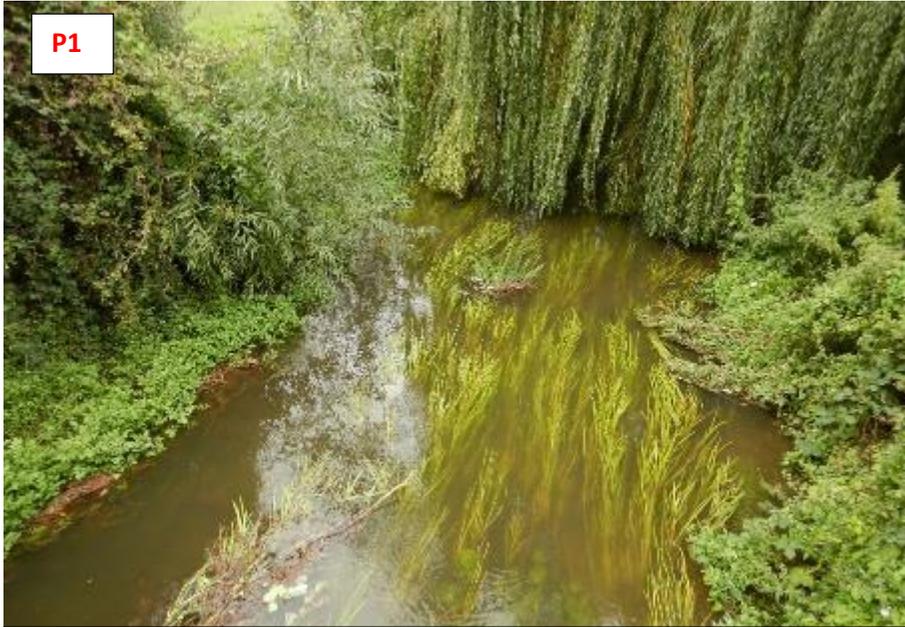
P1

View from Harston bridge, Aug '20 – the river is often turbid.

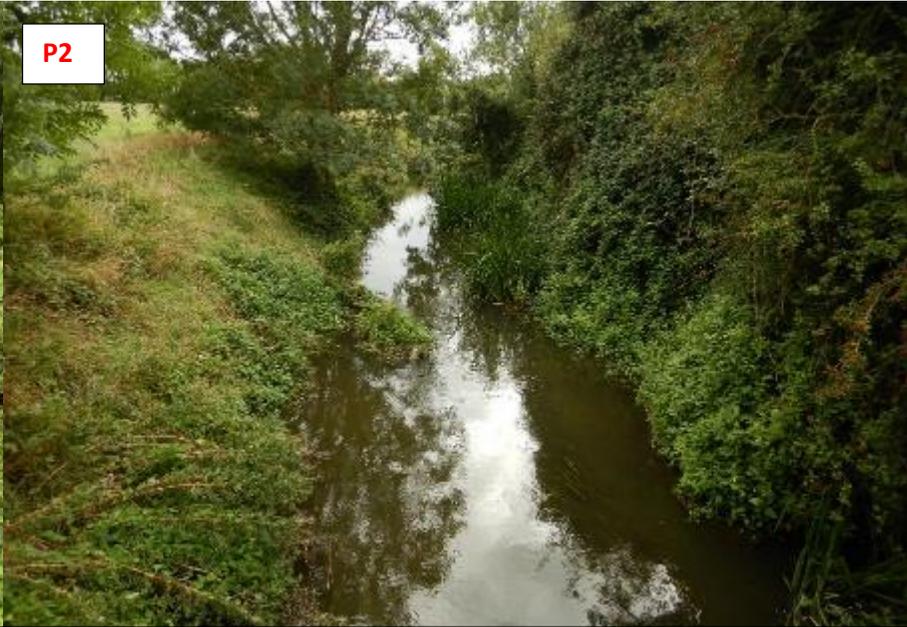
P2

View from Burnt Mill foot bridge, Aug 20 – the incised channel is apparent

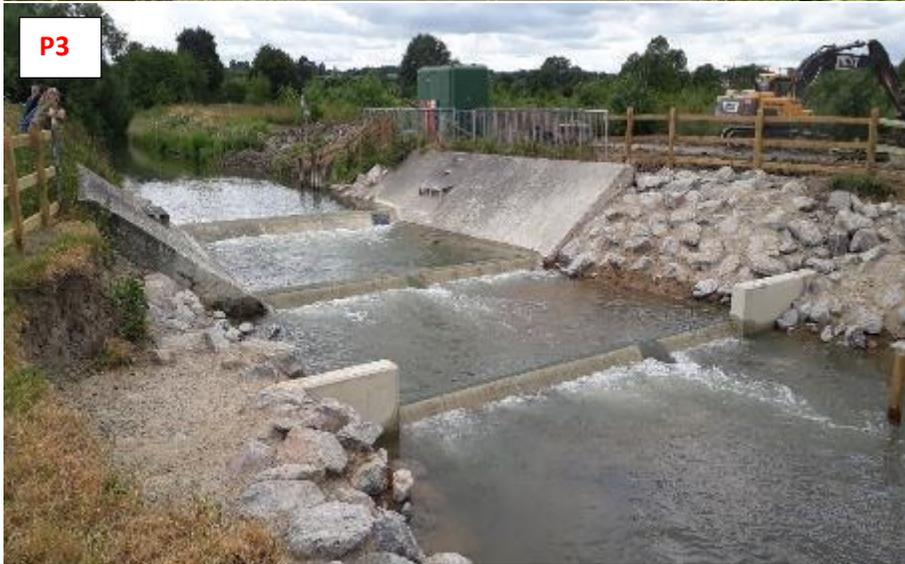
P3

The EA gauging station at Burnt Mill (Haslingfield), July '19 – fish passage has been eased by recent EA work.

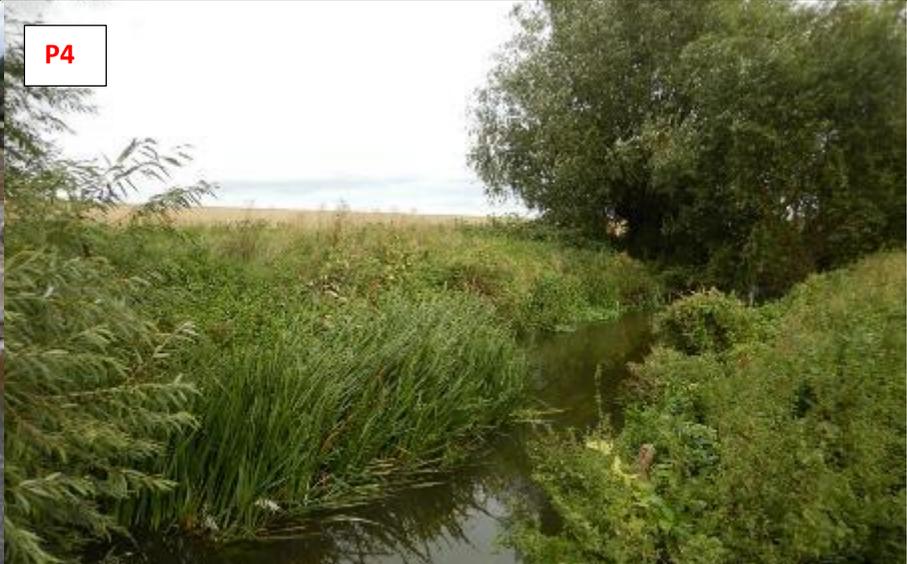
P4

Downstream of Haslingfield Aug '20 – good marginal cover but the river lacks flow diversity.

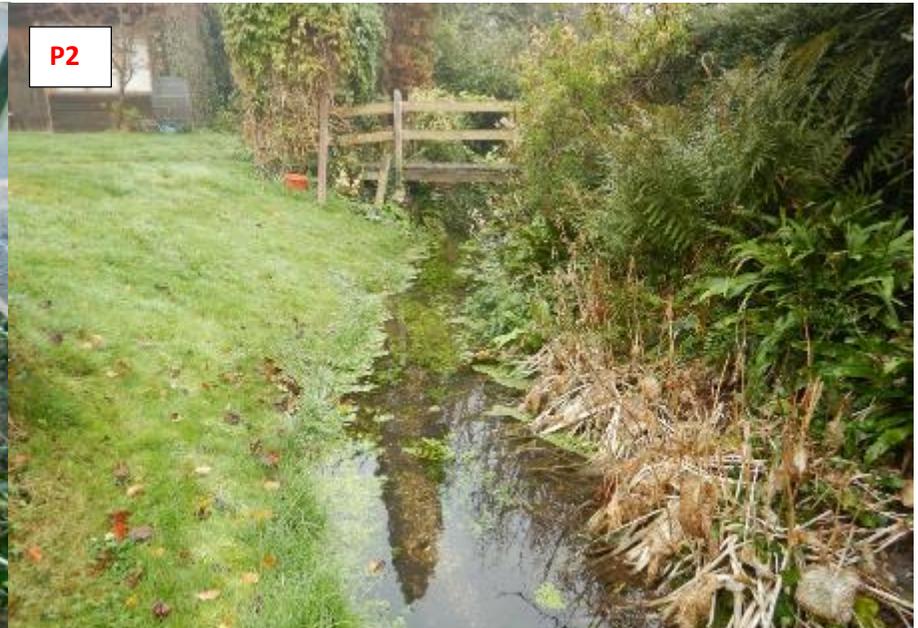
**P2**

The Riddy downstream of the High Street Nov 2020 - a small stream.

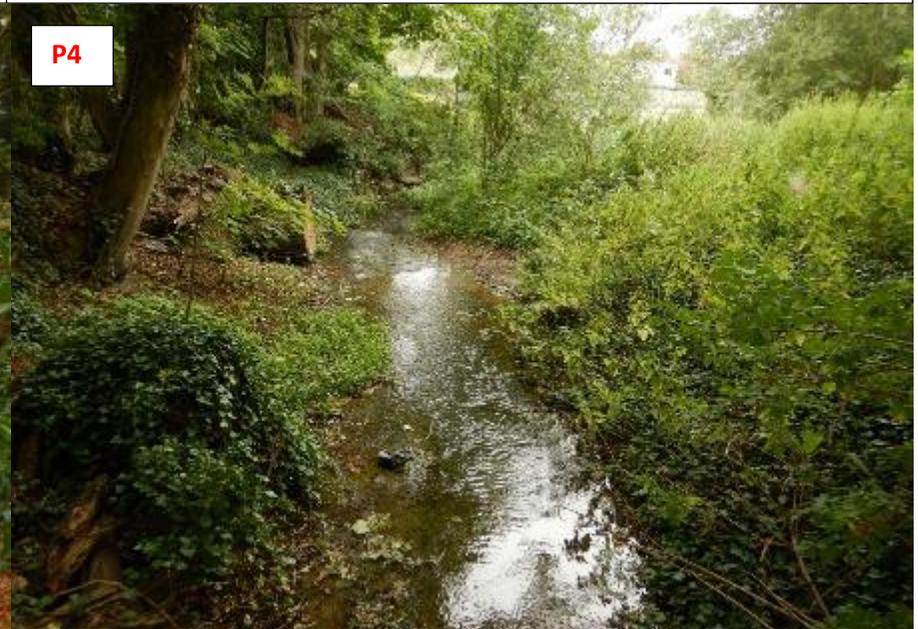
**P4**

Downstream of Hauxton mill, Oct 2020 – note the shallow gravel bed.

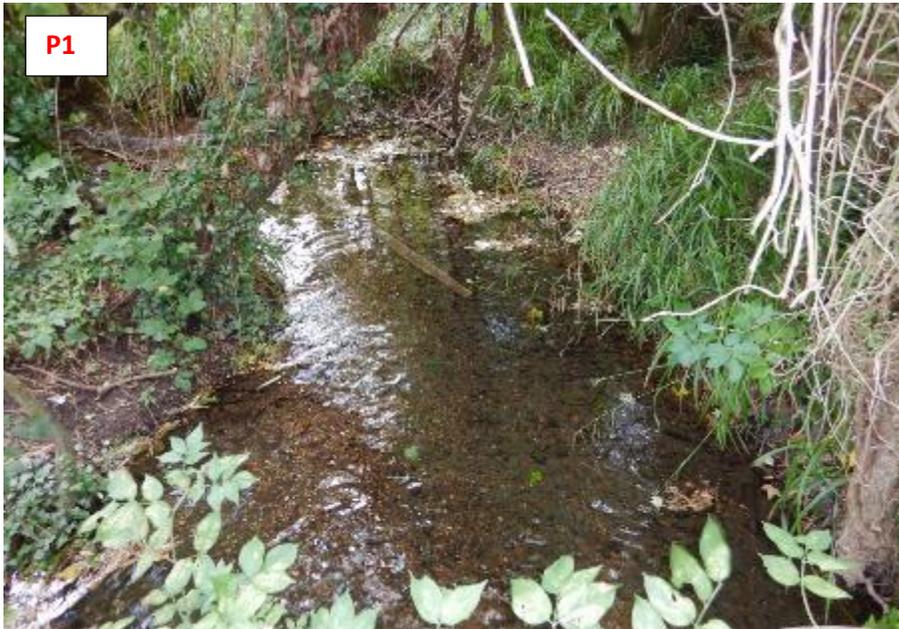
P1

The very upper reaches of the brook, Sept 2020 – a gravel lined stream.

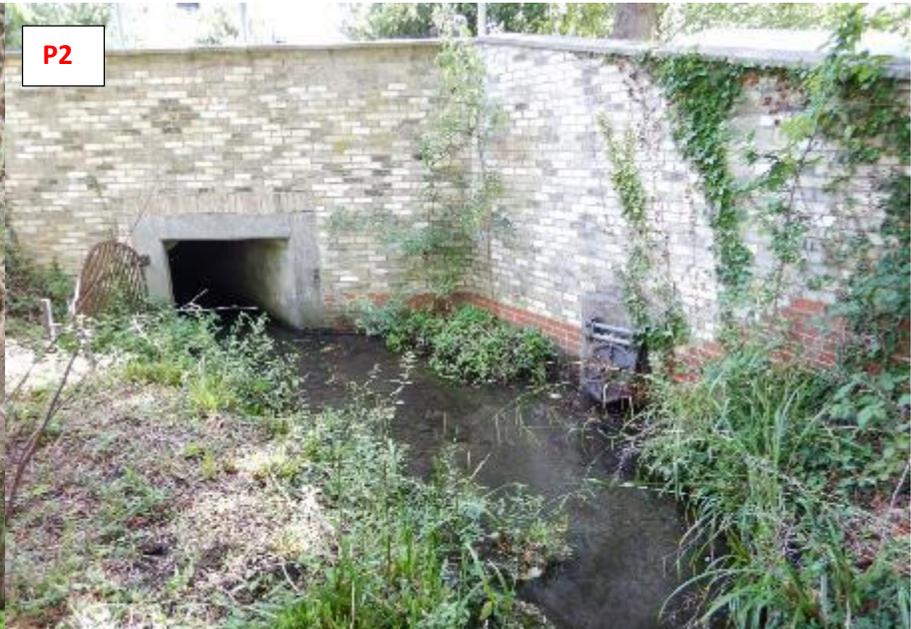
P2

The brook downstream of Trumpington Road, Sept 2020.
