(CCC) Cherry Hinton Park

Post Installation Report

Cherry Hinton Hall Play Area

Inspection Ref: 1316738

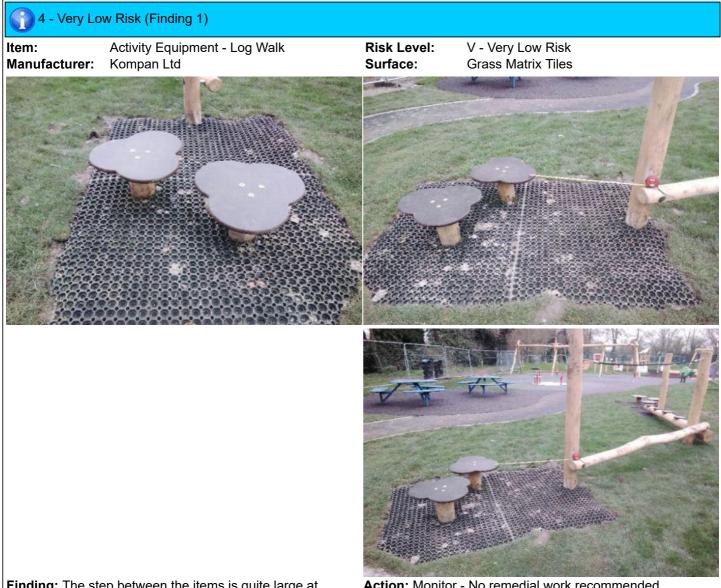
Finding: The step between the items is quite large at 700mm and users may not be able to complete the step without touching ground, the items could therefore be considered to be within the falling space of each other, however the intention of the play activity continuity is easily apparent and foreseeable to the user

Action: Monitor - No remedial work recommended

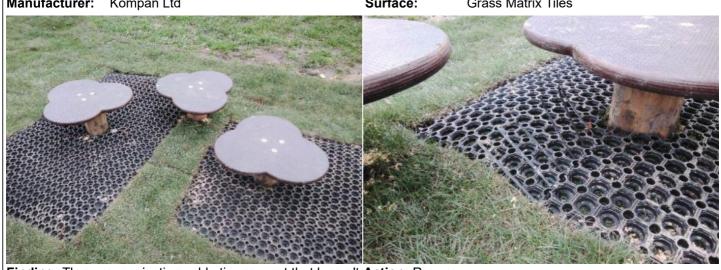
Activity Equipment - Log Walk Kompan Ltd

Finding: There are projecting cable ties present that haven't **Action:** Remove been cut back

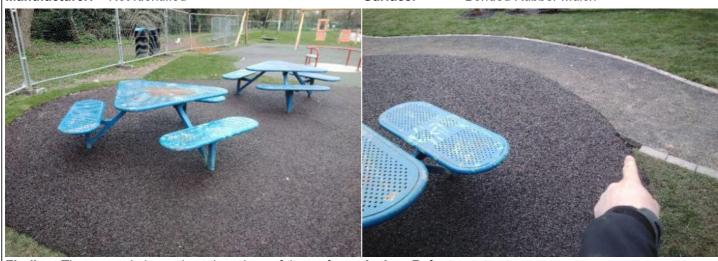
Ancillary Items - Picnic Table **Risk Level:** Item: Not Identified Surface: Manufacturer:

Finding: There are trip hazards at the edges of the surface Action: Refer to contractor

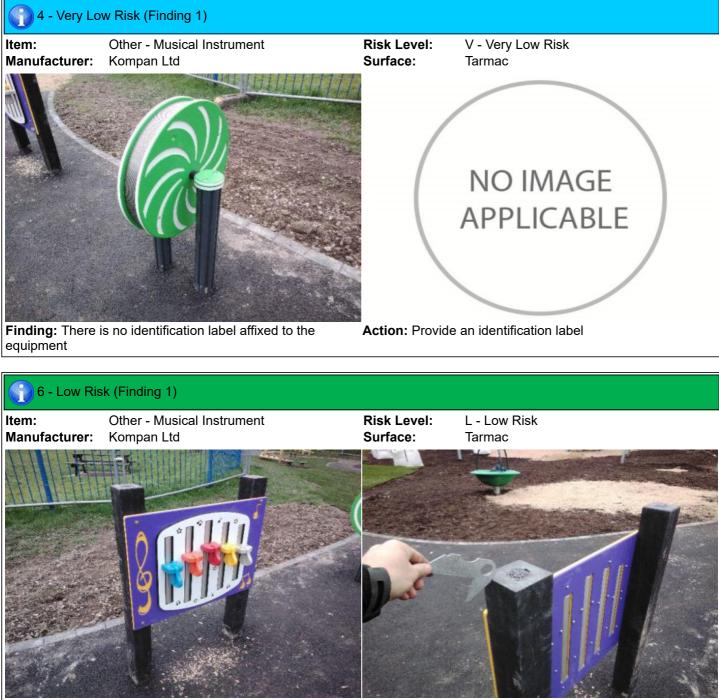
6 - Low Risk (Finding 1) Rotor Play - Inclusive Roundabout **Risk Level:** L - Low Risk Item: Manufacturer: Kompan Ltd Surface: Bonded Rubber Mulch Finding: The platform is catching on the outer framework Action: Refer to the contractor

Finding: One post has exposed edges and corners with a **Action:** Provide a 3mm radius to all exposed edges and radius of less than 3mm and fails the requirements of BS EN corners 1176

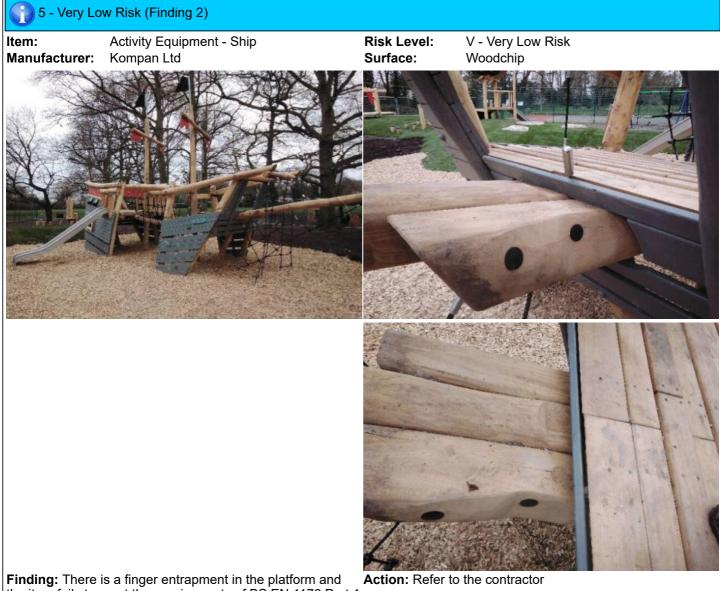
Finding: There is a finger entrapment in the platform and the item fails to meet the requirements of BS EN 1176 Part 1 4.2.7.6 Entrapment of fingers

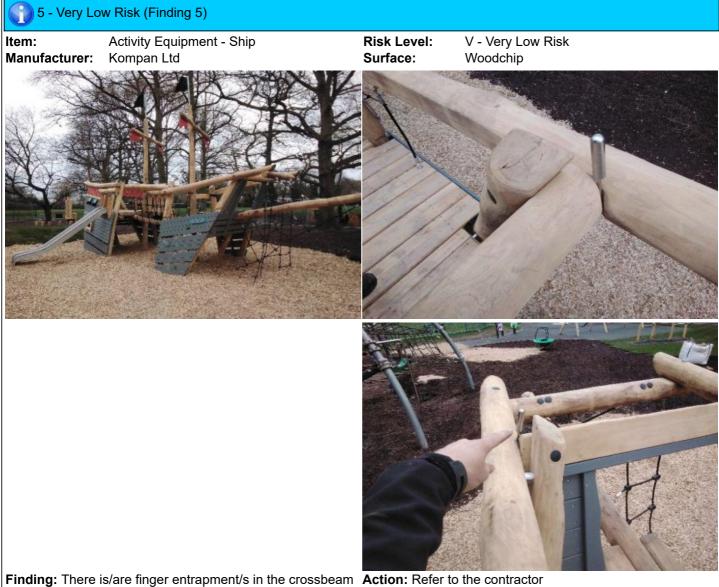
Finding: There is/are finger entrapment/s in the crossbeam **Action:** Refer to the contractor and the item fails to meet the requirements of BS EN 1176 Part 1 4.2.7.6 Entrapment of fingers

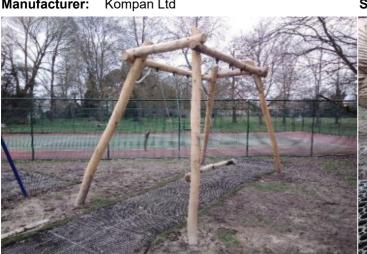
Item: Swings - Giant Rope Swing Manufacturer: Kompan Ltd Risk Level: Surface: L - Low Risk Grass Matrix Tiles

Finding: The seat clearance from finished surface level to the underside of the seat is too low (380mm) and does not meet the requirements of BS EN 1176 Part 2

Action: Install rope seat to a minimum clearance height of 400mm

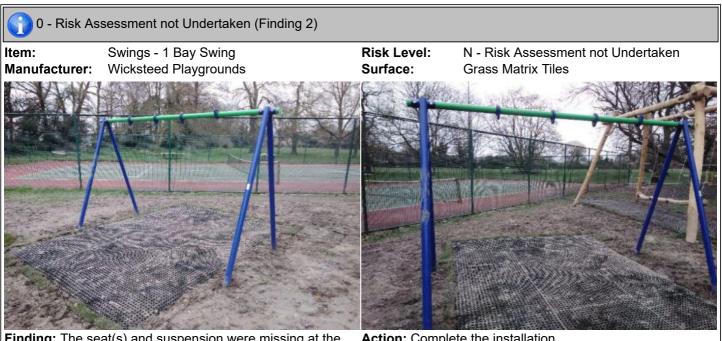
Finding: The seat(s) and suspension were missing at the time of inspection and the inspector was unable to make a full compliance assessment

Action: Complete the installation

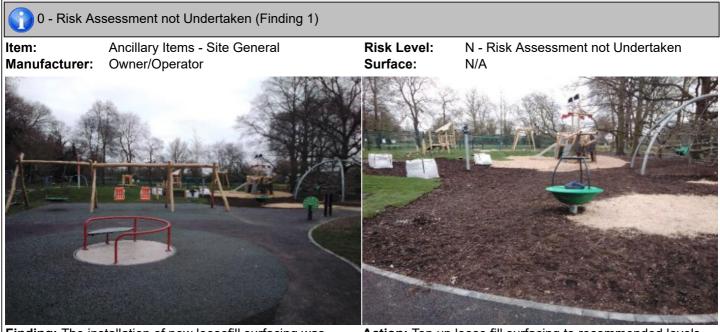
Finding: The installation of new loosefill surfacing was incomplete at the time of inspection

Action: Top up loose fill surfacing to recommended levels

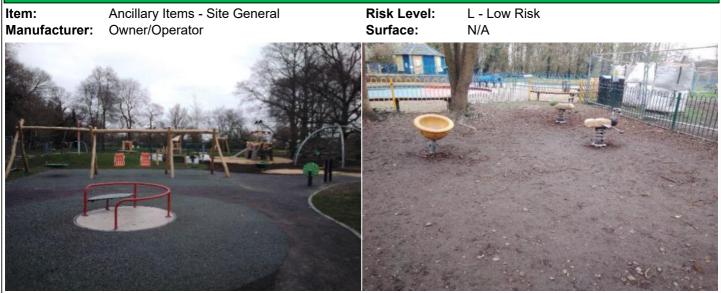
6 - Low Risk (Finding 3)

Finding: The loose fill safer surface within the toddler area **Action:** Rake and fork over to aerate the surface and top up surfacing has become compacted and the level has dropped to recommended levels
