HANOVER & PRINCESS COURT

MORIBUND REPORT

This report demonstrates how Hanover and Princess Court can be considered 'moribund housing' for the purpose of Homes England Grant Funding

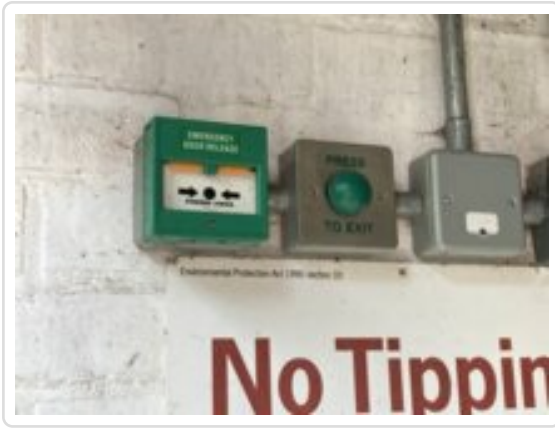
IMG_2371

There are no fire exit doors linked to a fire alarm system although manual over ride devices are installed adjacent the bib room doors.
— SC 22 Jun 2023 15:33:35

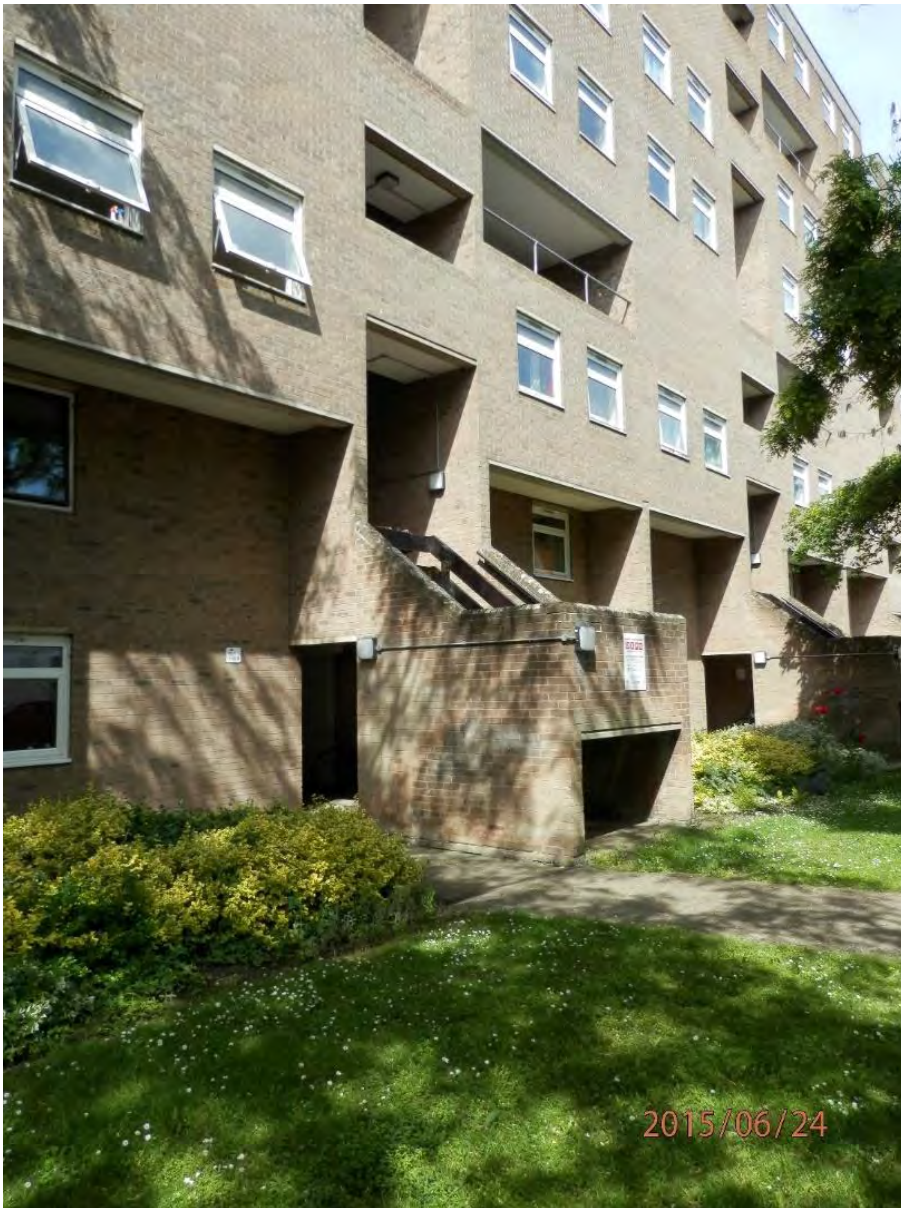
Eastern Side of Hanover Court Typical Entrance Structure Ditto Princess Court: -

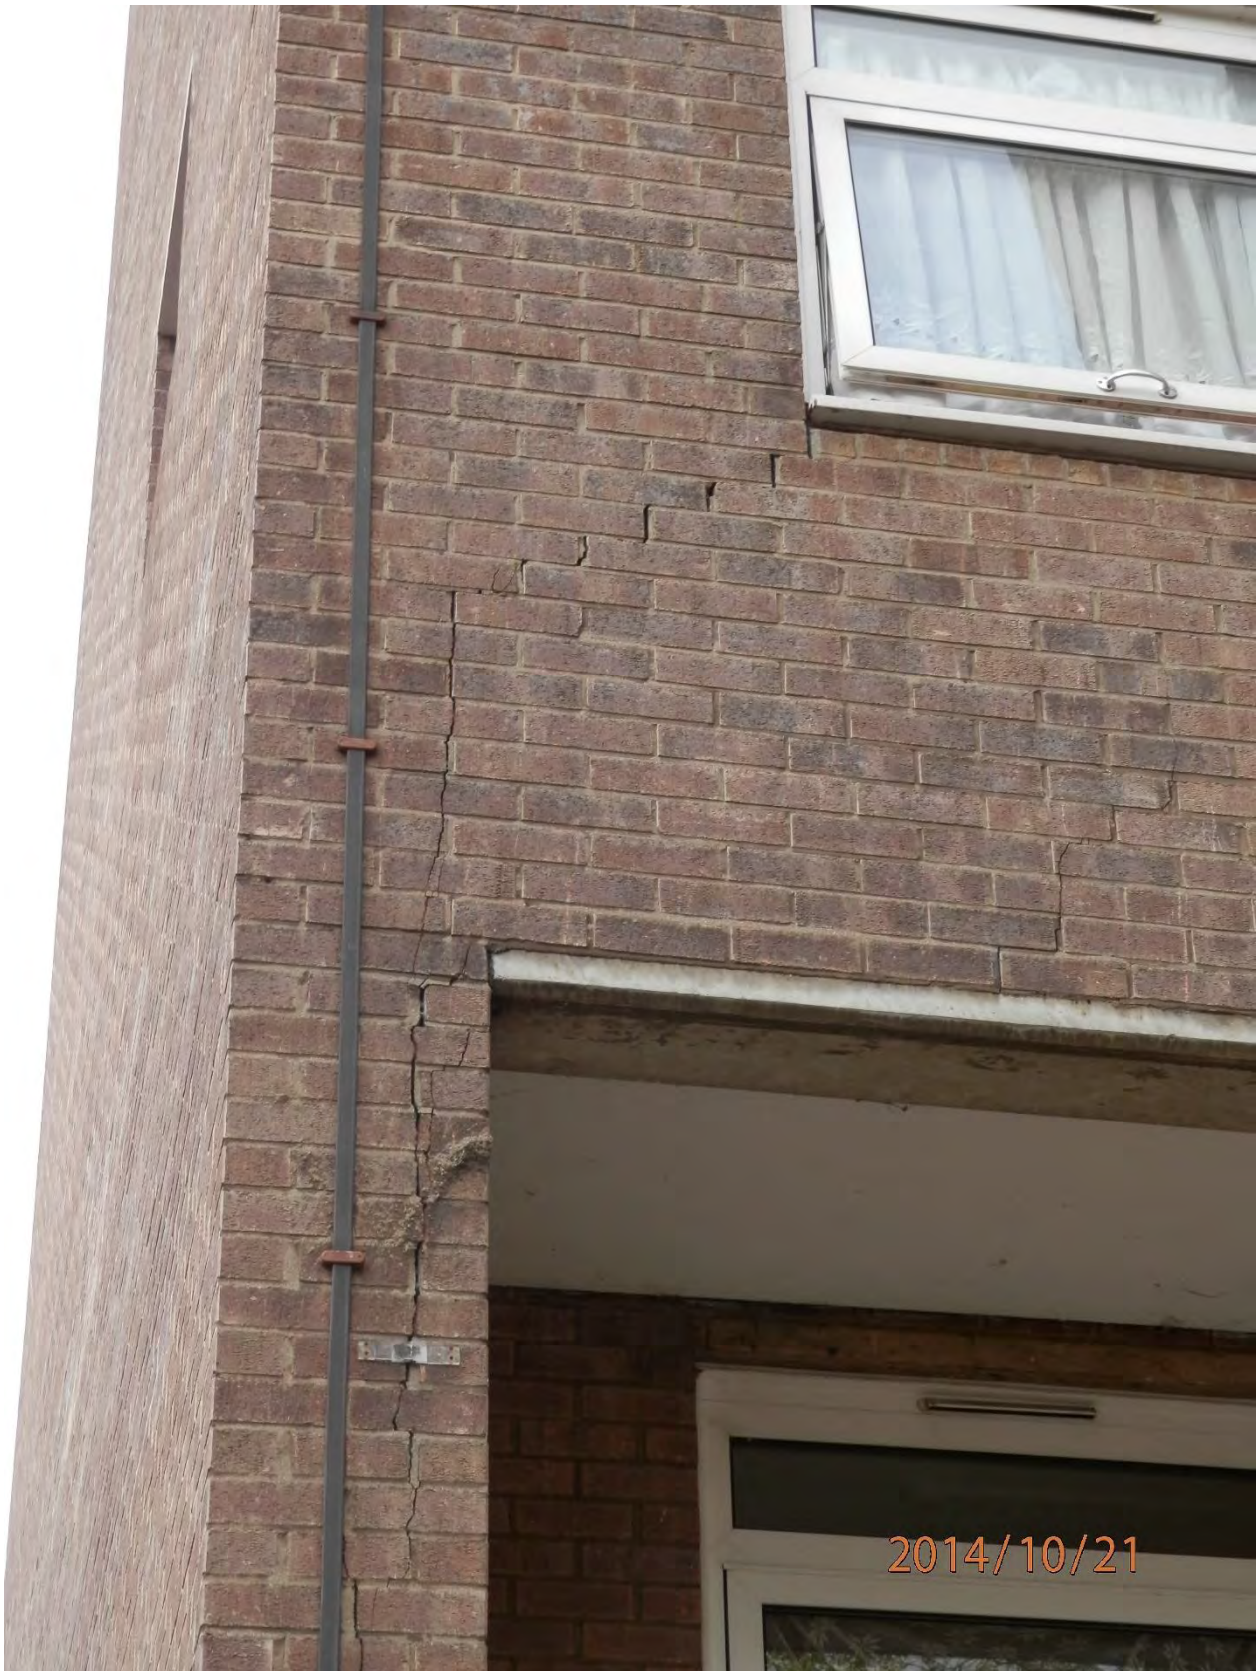
Corner of Hanover Court Before Year 1 Emergency / Urgent Repairs likely to be caused by strong wind loading causing lateral (east westerly direction) over tuning movement within the gable end wall.

Year 1 and 2 Emergency Repairs due to wind loading acting with dead and live loading

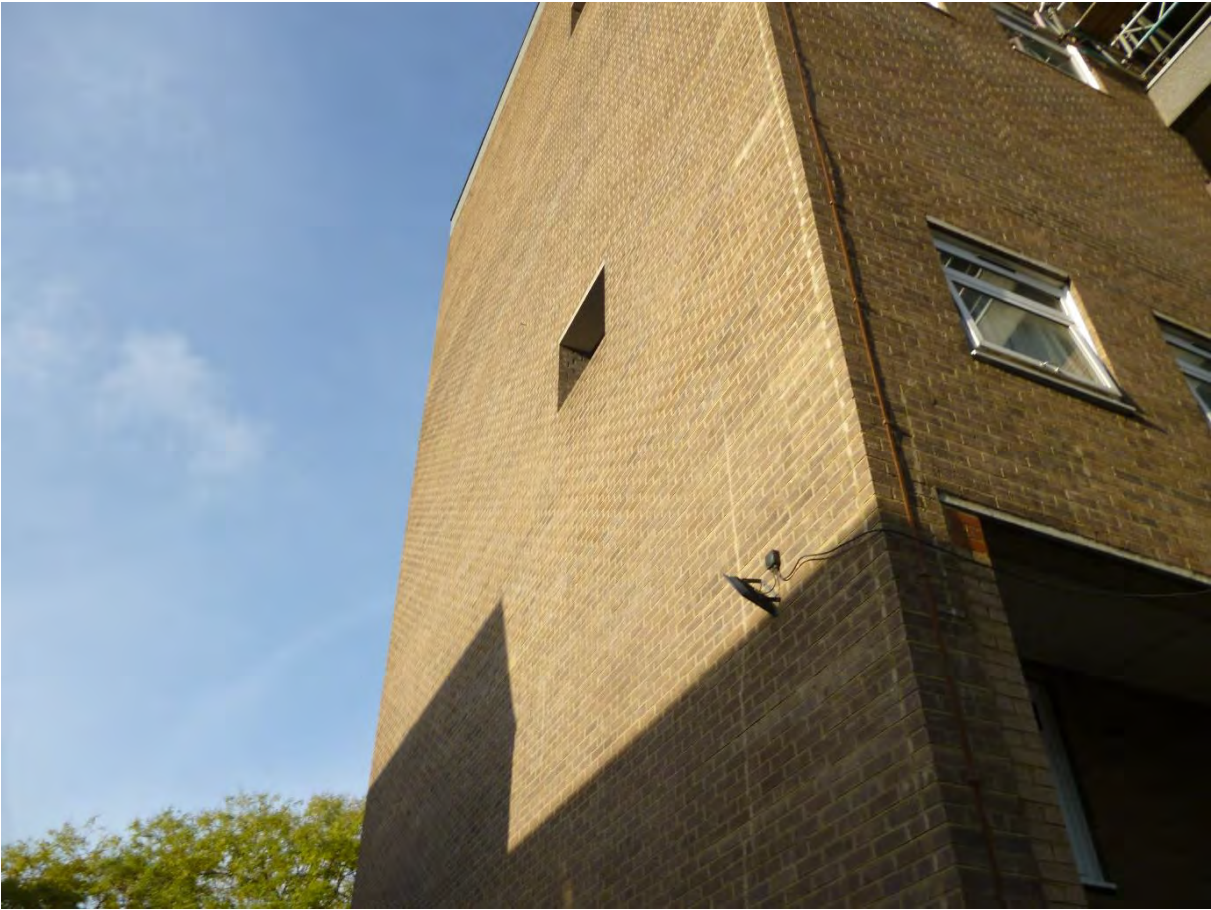
Corner of Hanover Court after Urgent Repairs 2017 / 2019 (Year 1 and 2)

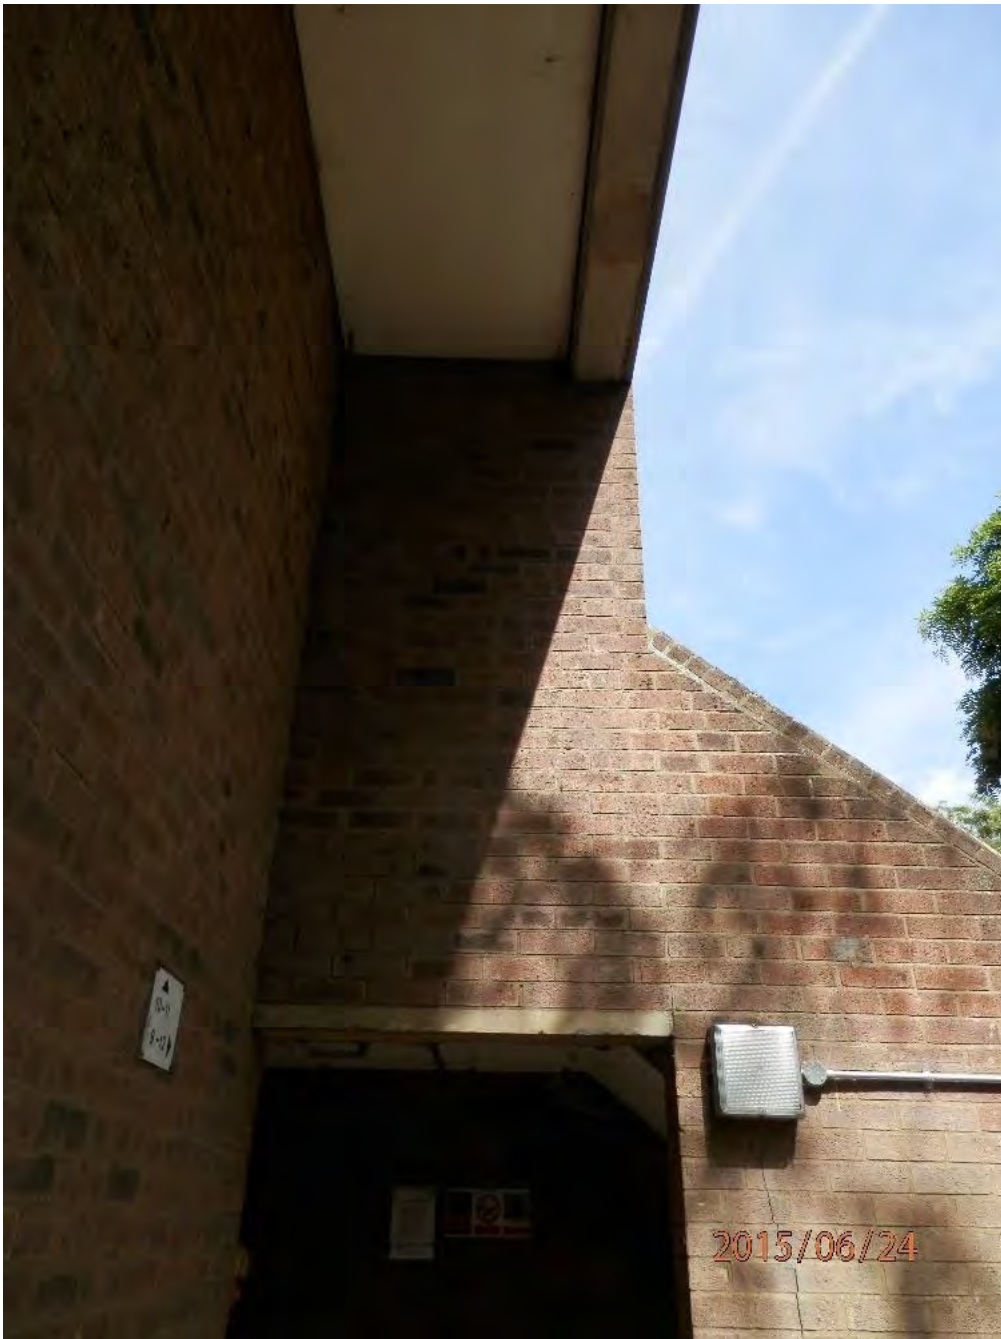
Eastern Side of Hanover Court Typical Entrance Structure Cracking - Repaired in Year 1 Urgent Works

NB: - The main drains are understood to run along under these staircase structures and the eastern slender bin chute towers adding to the issues and potential issues with structural movements caused by drains and trees.

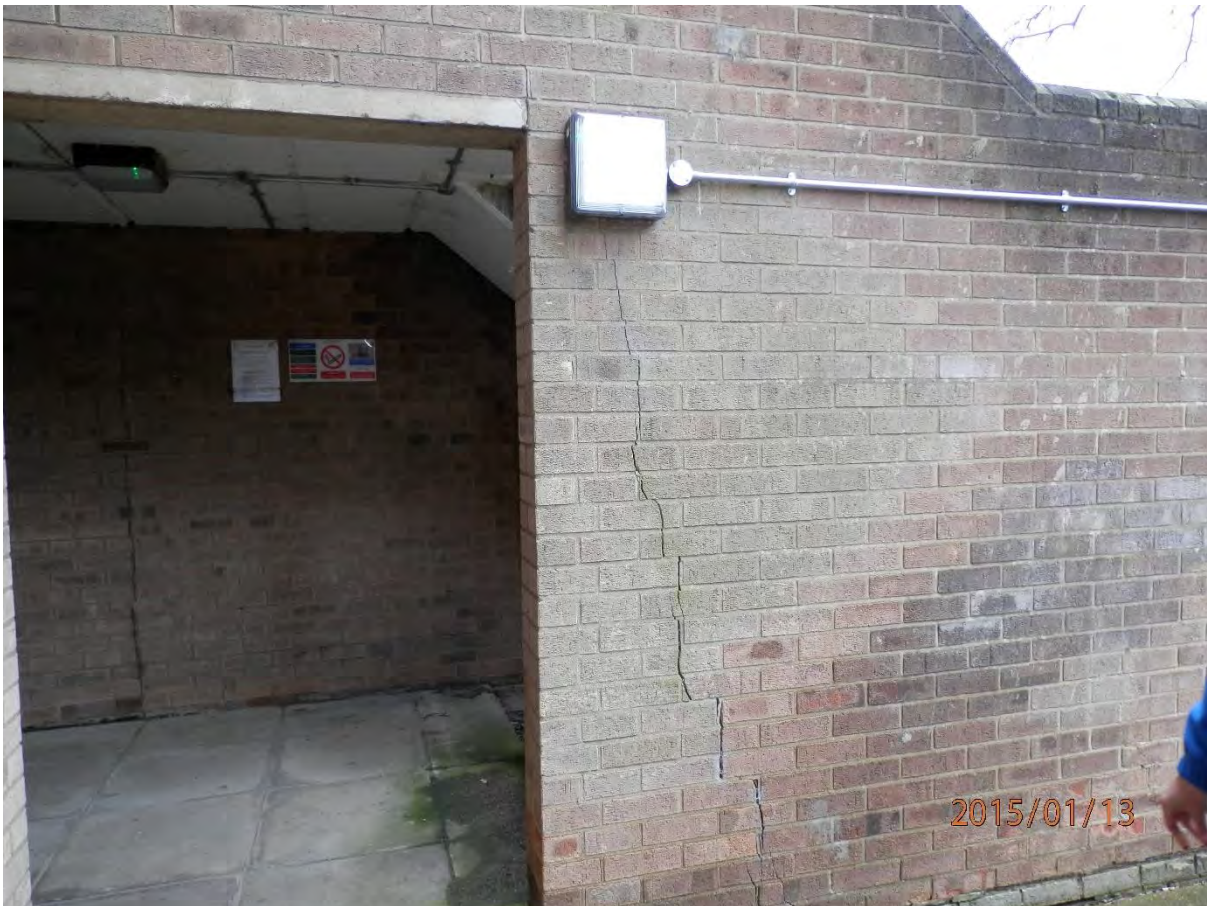
Eastern Side of Hanover Court Typical Entrance Structure Cracking -Repaired in Year 1 Urgent Works: -

NB: - The main drains are understood to run along under these staircase structures and the eastern slender bin chute towers adding to the issues and potential issues with structural movements caused by drains and trees. Thus, it is imperative that the drains are maintained and do not leak and compromise the formation supporting the foundations.

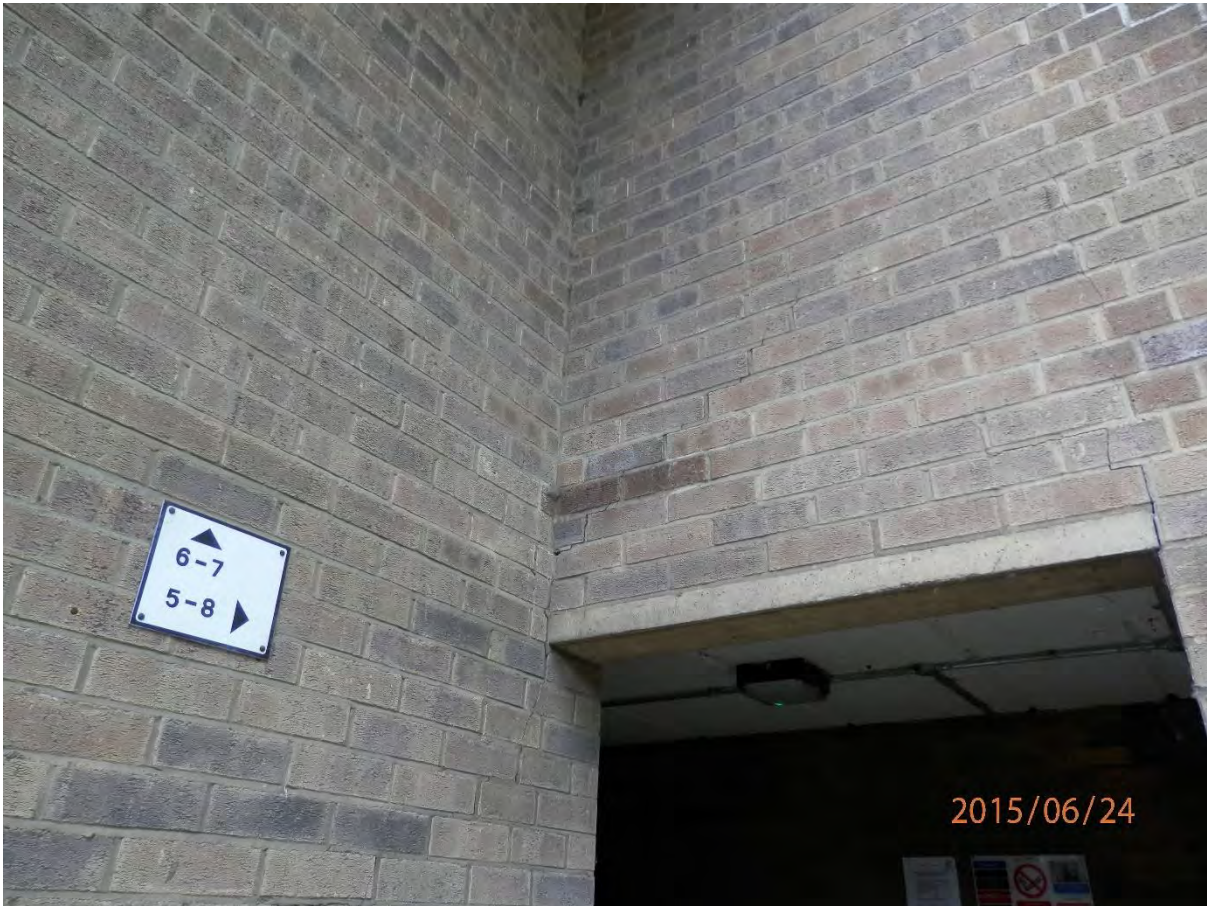
Eastern Side of Hanover Court Typical Entrance Structure Cracking -Repaired in Year 1 Urgent Works

NB: - The main drains are understood to run along under these staircase structures and the eastern slender bin chute towers adding to the issues and potential issues with structural movements caused by drains and trees. Thus, it is imperative that the drains are maintained and do not leak and compromise the formation supporting the foundations.

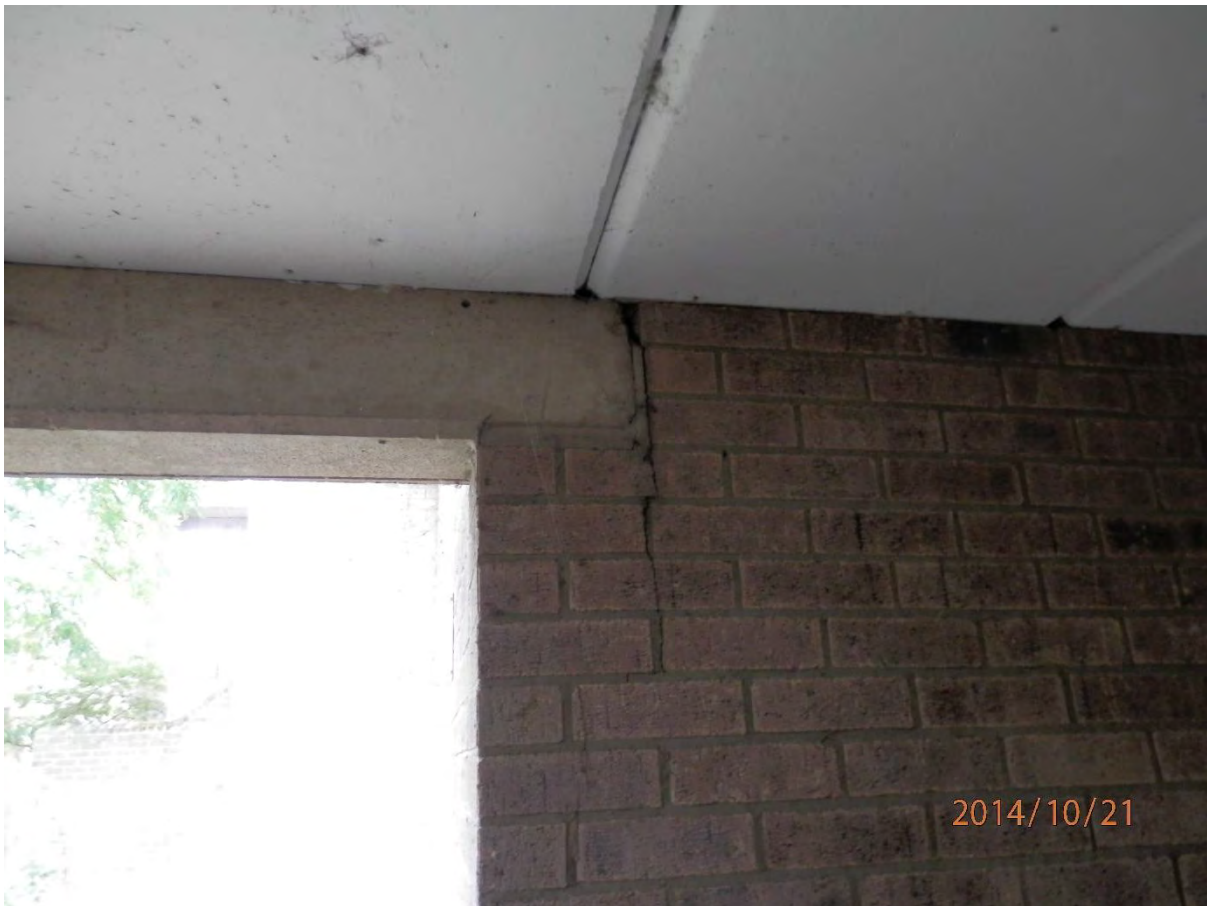
Eastern Side of Hanover Court Typical Entrance Structure Cracking: Internal View - Repaired in Year 1 Urgent Works

NB: - The main drains are understood to run along under these staircase structures and the eastern slender bin chute towers adding to the issues and potential issues with structural movements caused by drains and trees. Thus, it is imperative that the drains are maintained and do not leak and compromise the formation supporting the foundations.

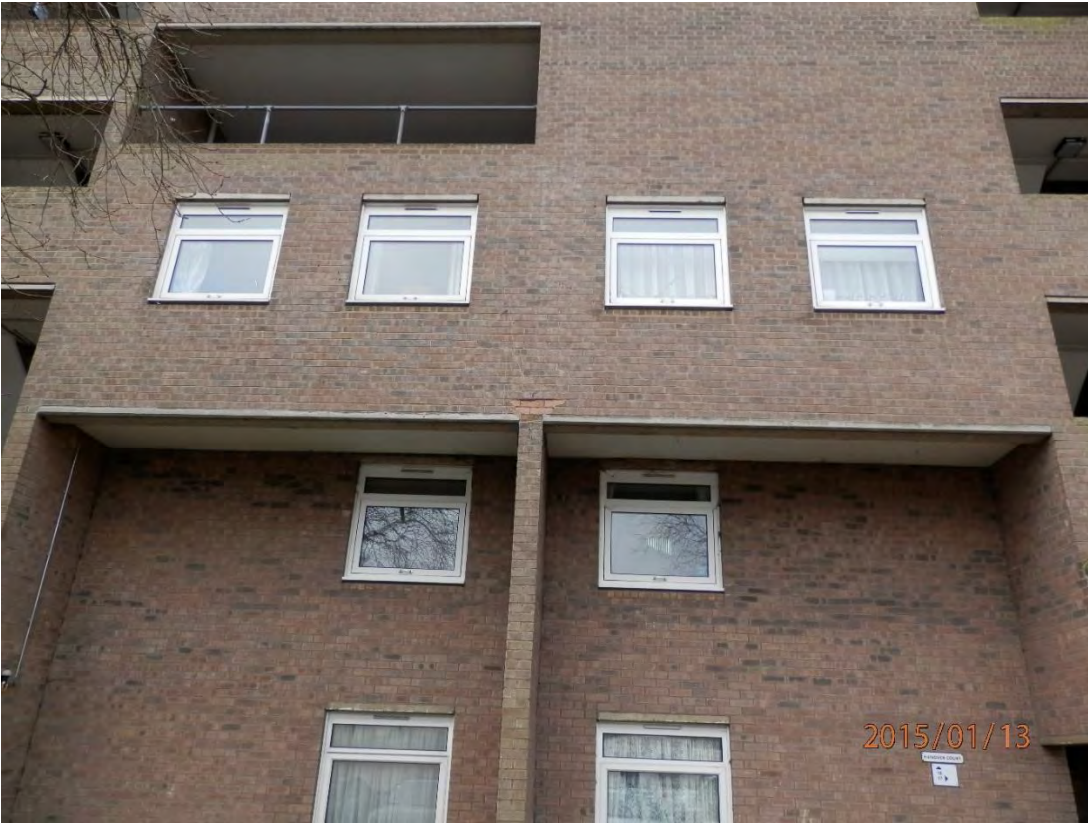
Typical example of the Eastern Flank Wall Cracking due to vertical load overloading by the two heavily concrete lintels on both sides supporting the brickwork façade above probably exacerbated by additional vertical load due wind load on the western side and possibly exacerbated by frost attack.

Note the very slender 225mm wide pier below and the stress concentration at the top of the pier under the lintels with 112mm of bearing at the most for each lintel.

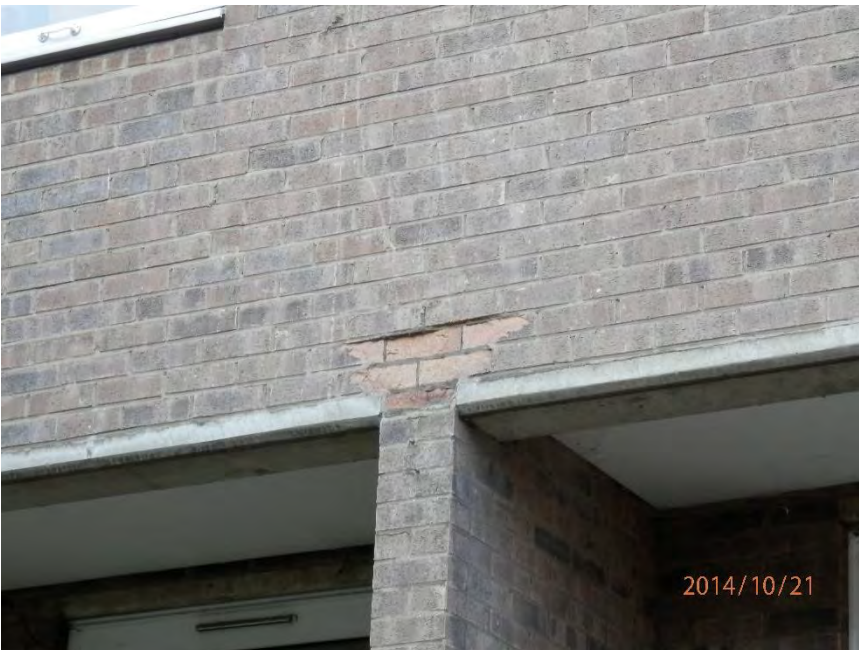
Ditto a closer view. Repaired and Piers stiffened - Repaired in Year 1 Urgent Works

Note: - apparently only 100mm of bearing onto the central pier by both heavily loaded lintels on either side. Note the crushed bricks in the façade located immediately above the pier.

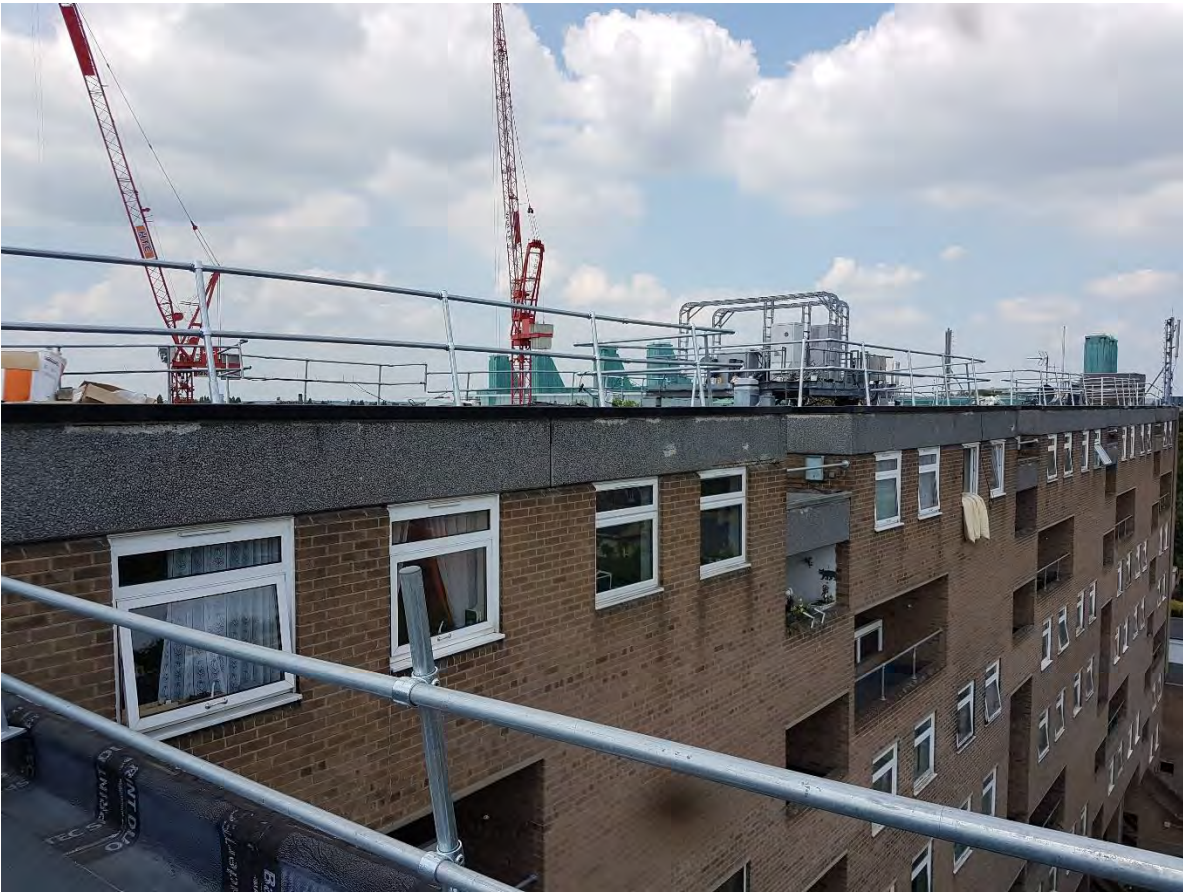
General View of North Eastern Elevation Typical Parapet Panel Tap Test in Year 1 Prior to Year 2 SIKA Repairs SIKA 903 SIKA 610 SIKA 612 and Anti-carbonation Coating SIKA 675

Year 2 Parapet Panel Repairs See MLTS Drawings 200 Series

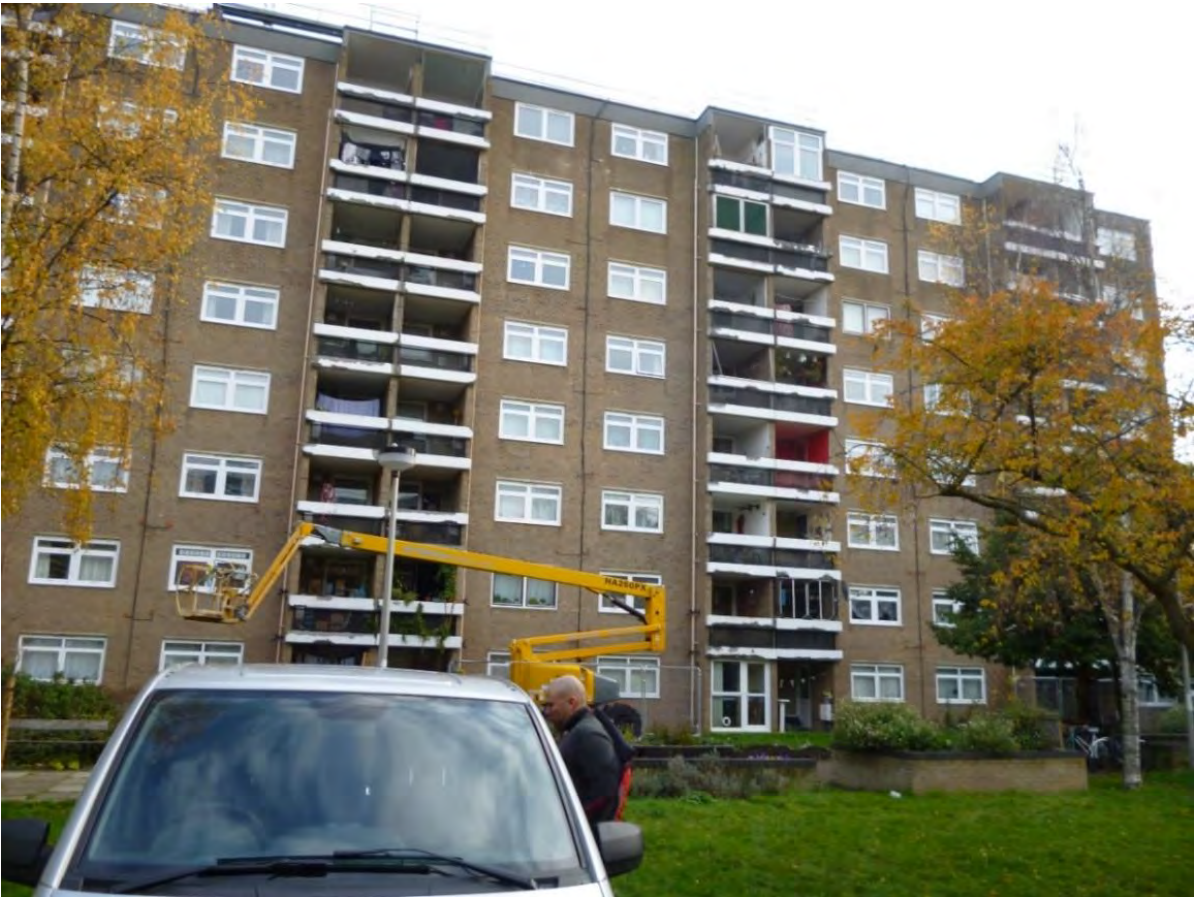
Hanover Western Side - Note the mobile access platform used to access and repair Hanover Court Building initially the Parapet panel Repairs and then the Balcony panels Tap Testing to remove loose concrete. .

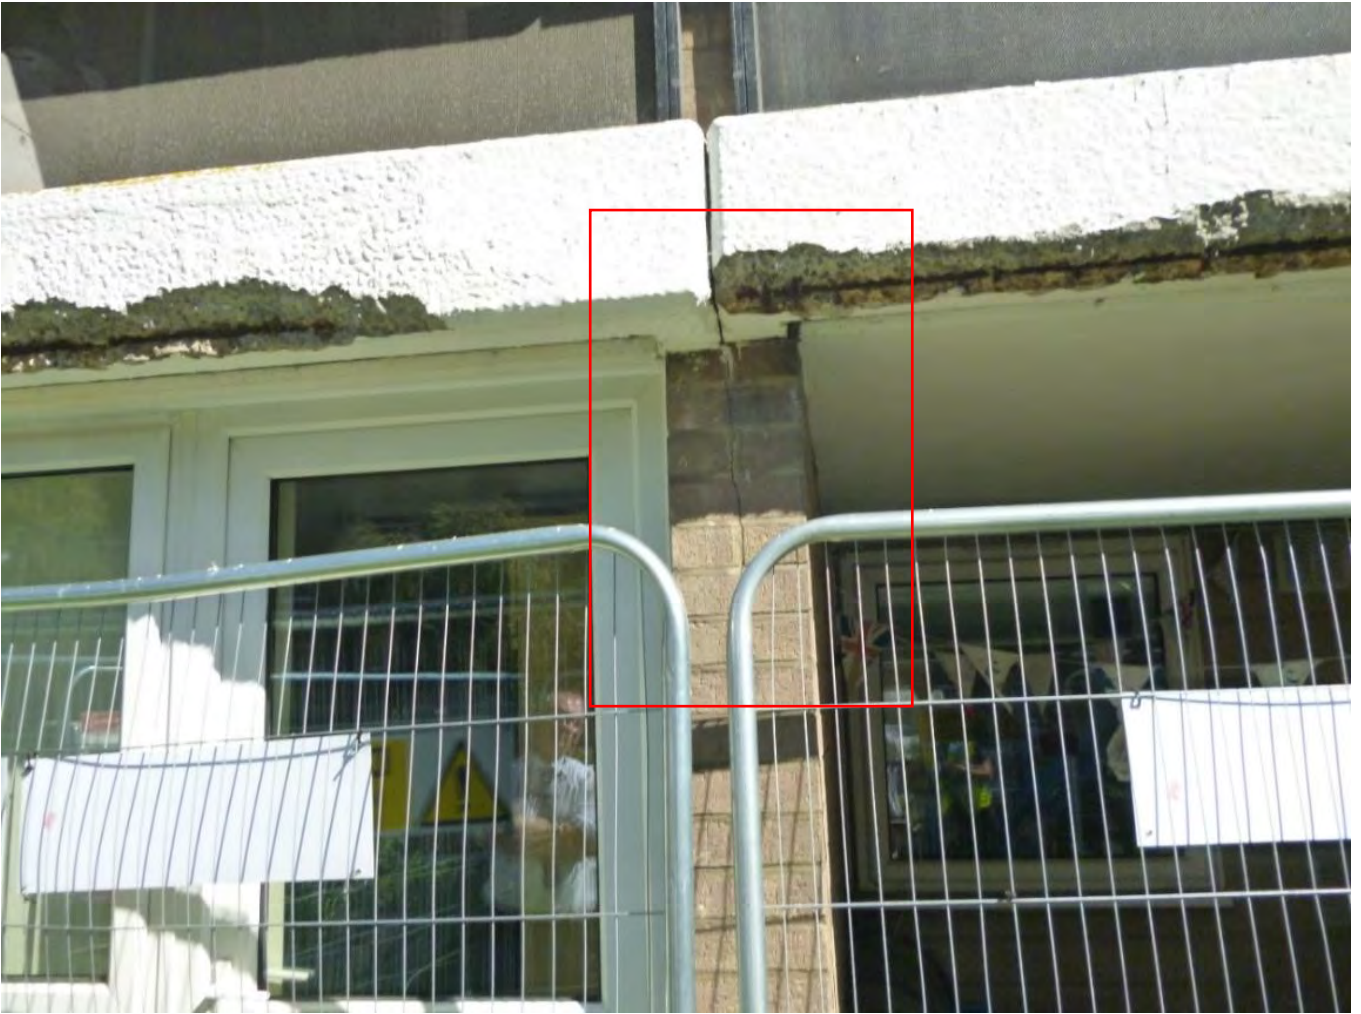
Balcony Beam Typical Loose Concrete Removal: - Note the rusty square twist reinforcing bars buried within the precast concrete balcony panels.

Also note the crack in the masonry party wall on the western side due to the loading including wind loading compression load due to wind acting on the eastern side of the building.

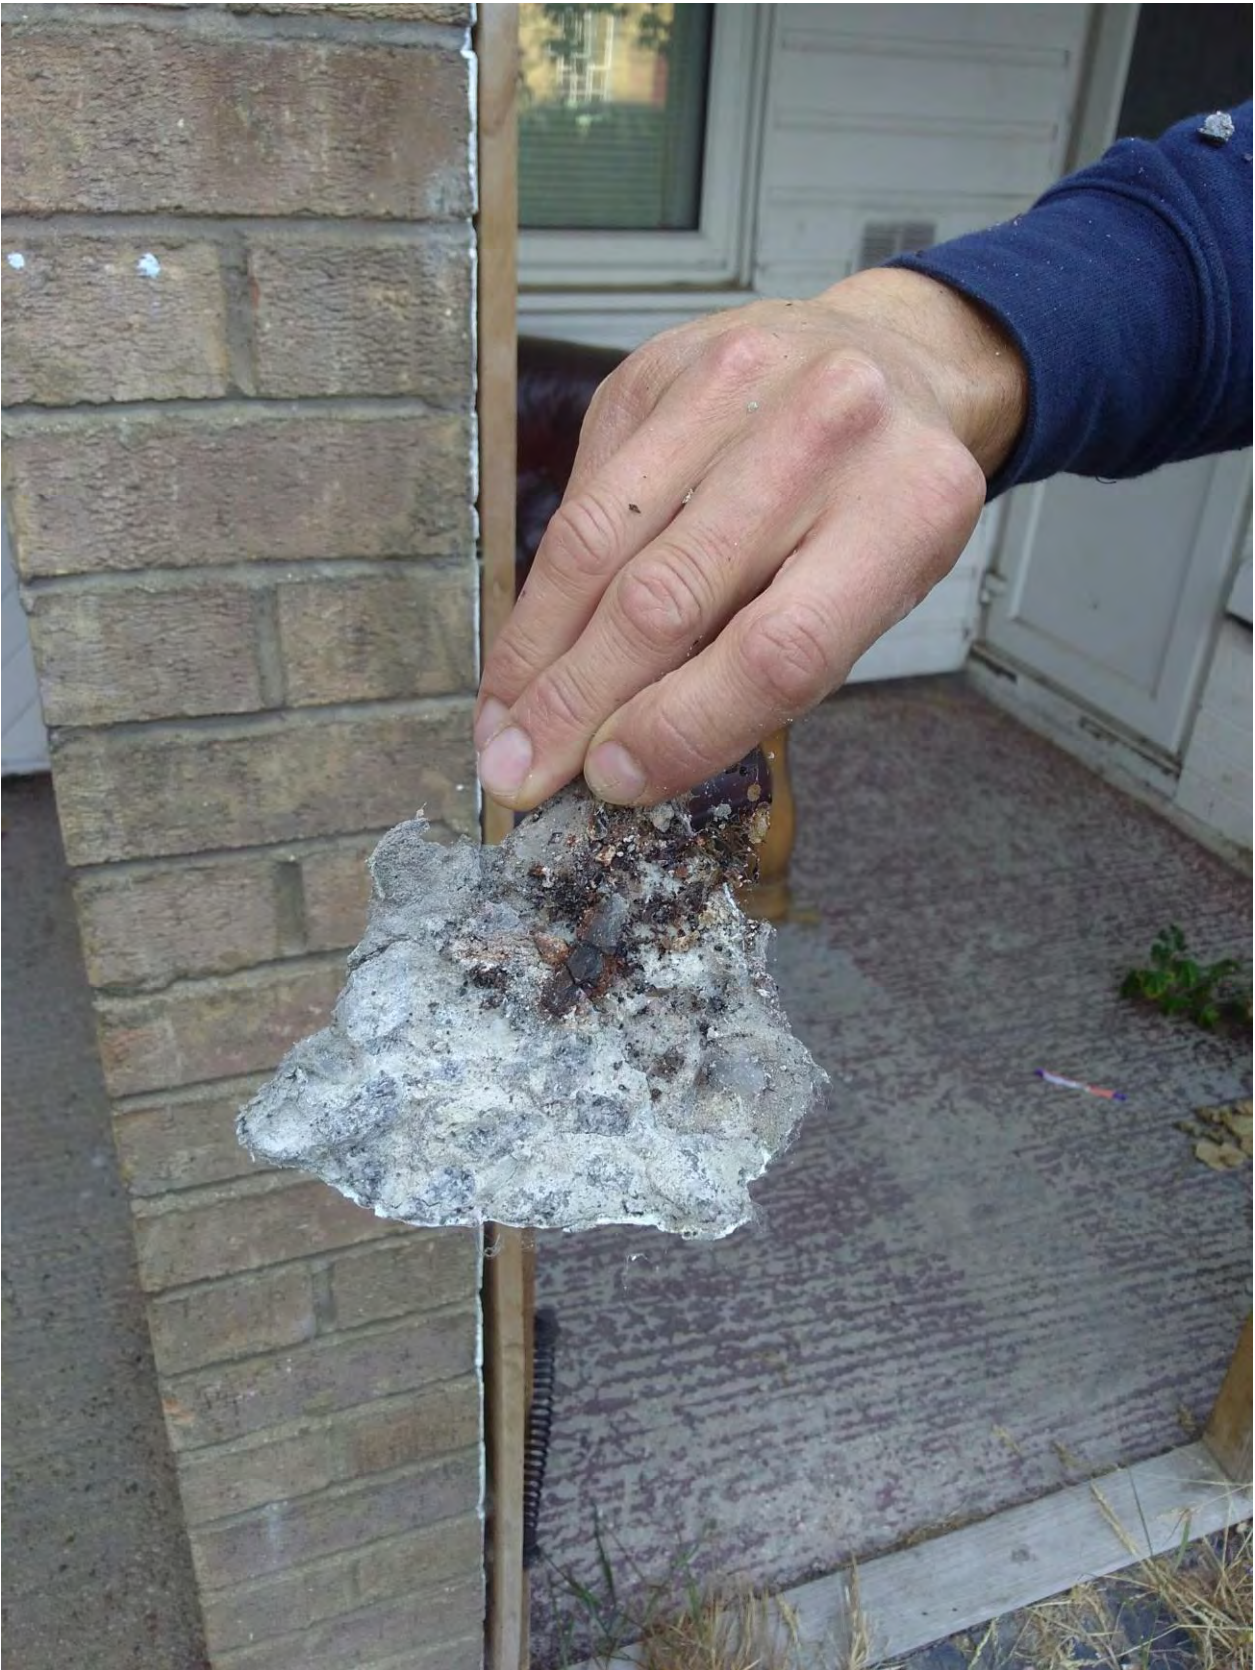
Typical loose Balcony panel corner Removed Easily by Hand.

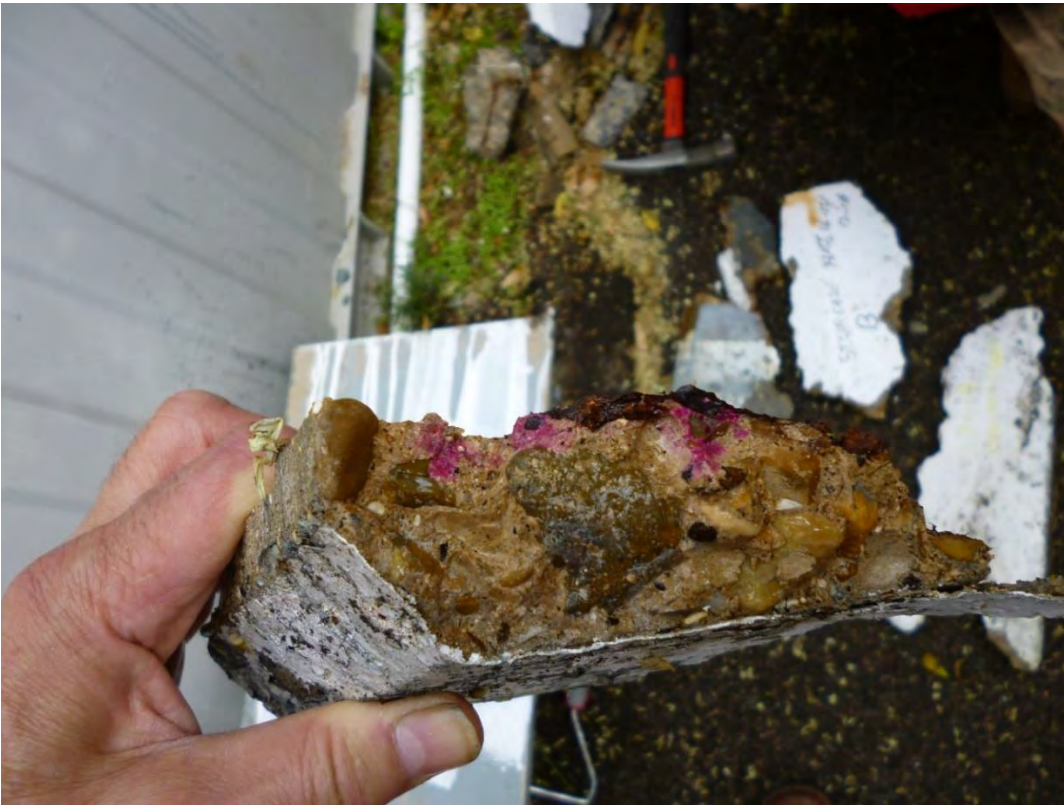
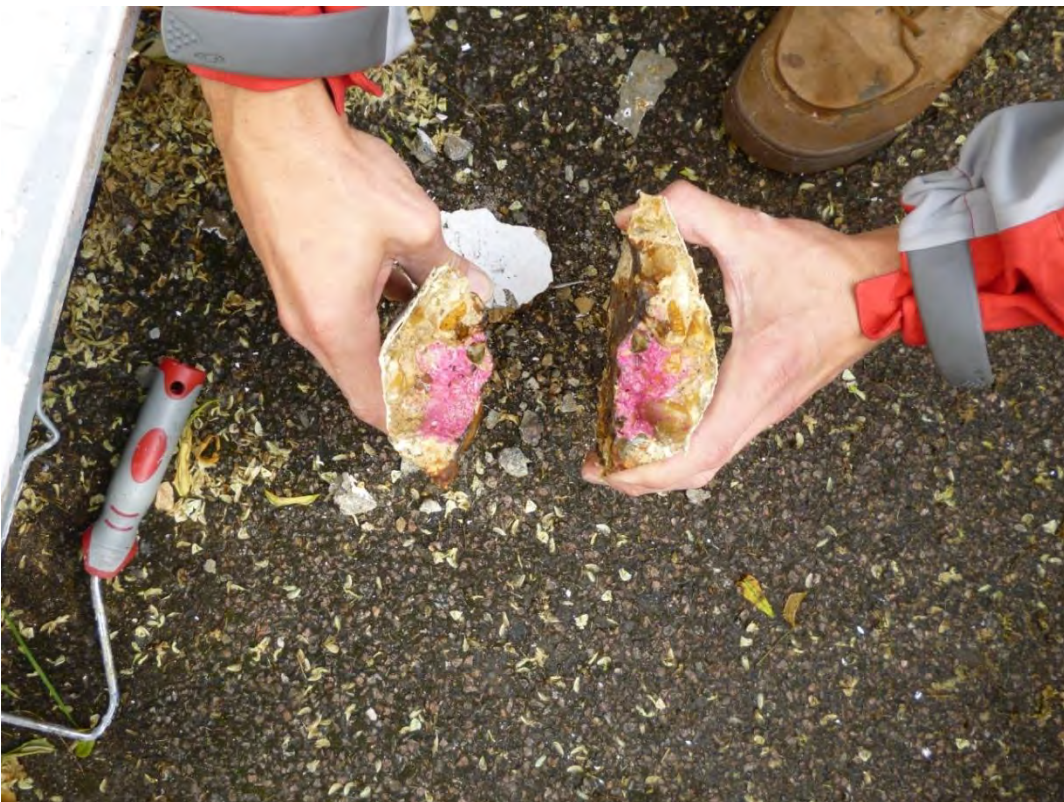
Note the only concrete retaining any alkalinity to help bars resist corrosion is turned pink by the carbonation test the remaining concrete is carbonated and has lost its natural alkalinity due to exposure to the environment. Note: - the almost complete carbonation of the lower drip detail on the panels containing the corroded reinforcing bars.

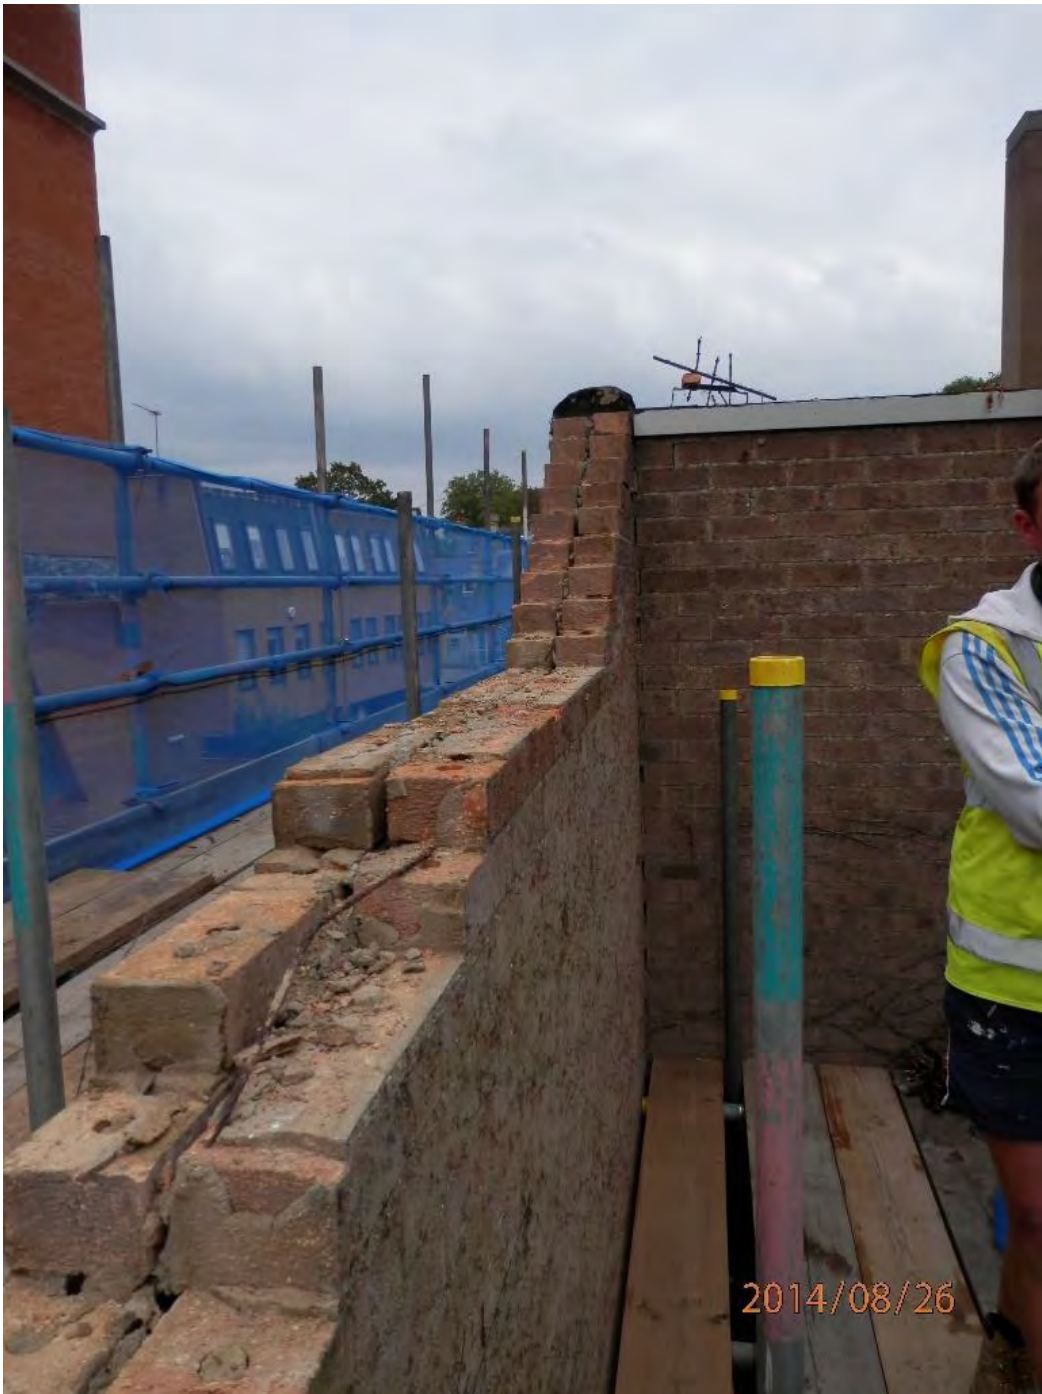
Removal by hand of the loose and frost damaged brickwork – Note the easy separation of the bed joint mortar from the bricks and at the perpend joints. Indicating that the bond between the mortar and the bricks was not especially good possibly as result of the early use of plasticizers to keep the mortar workable for longer periods. Note the clean mortar bed separation with the removed bricks.

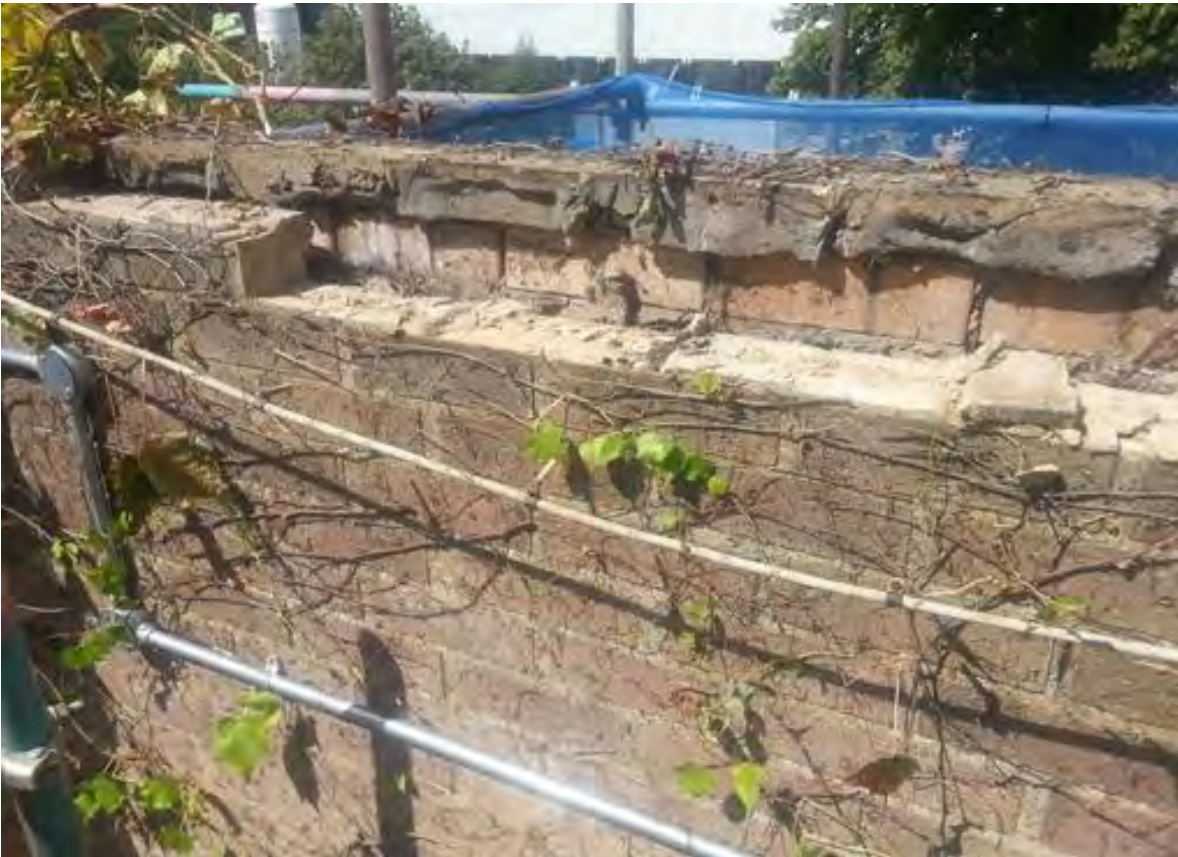
Ditto another view: - Removal by hand of the loose and frost damaged brickwork – Note the easy separation of the bed joint mortar from the bricks and at the perpend joints. Indicating that the bond between the mortar and the bricks was not especially good possibly as result of the early use of plasticizers to keep the mortar workable for longer periods.

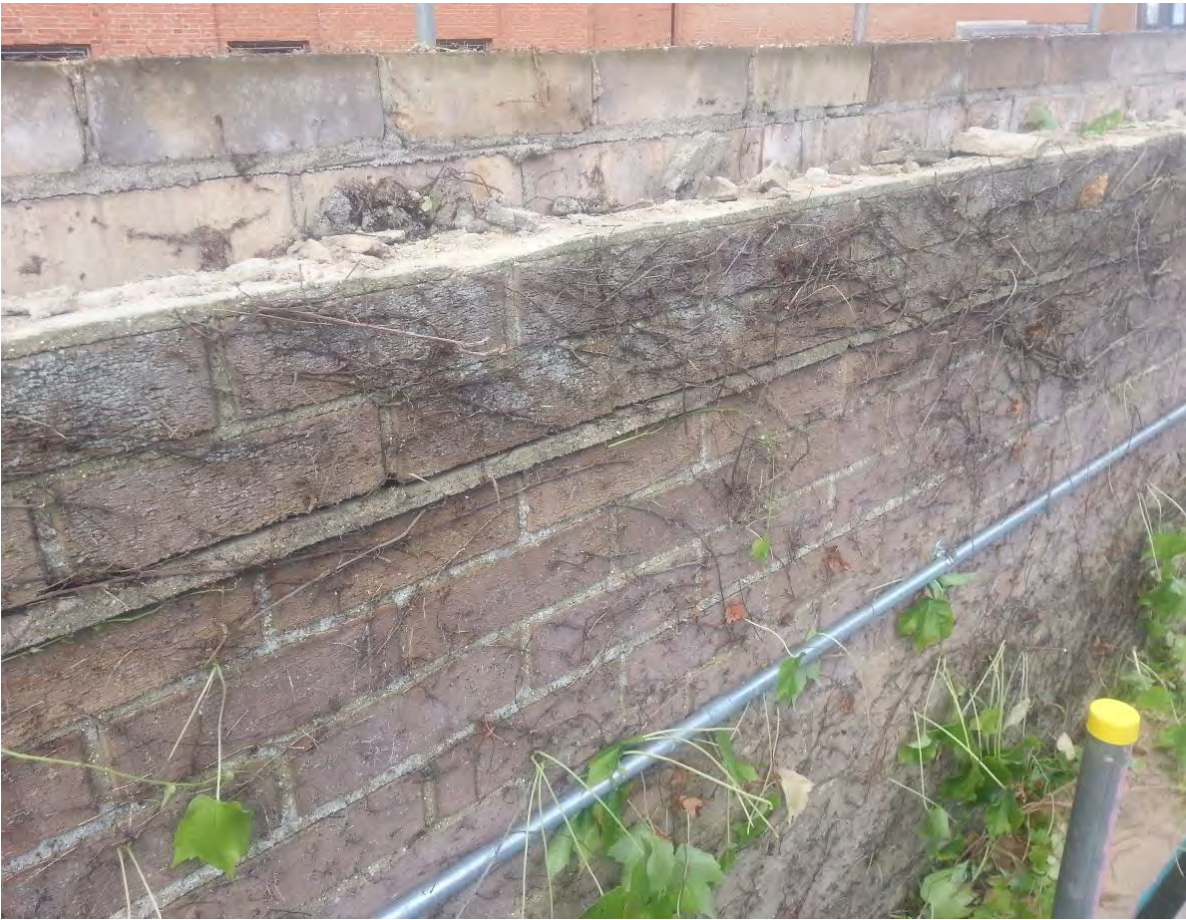
Ditto: -Note the dislodged bed joints two courses below the removal beds suggesting lateral shear failure and separation of the bed joints.
