HANOVER & PRINCESS COURT

MORIBUND REPORT

This report demonstrates how Hanover and Princess Court can be considered 'moribund housing' for the purpose of Homes England Grant Funding

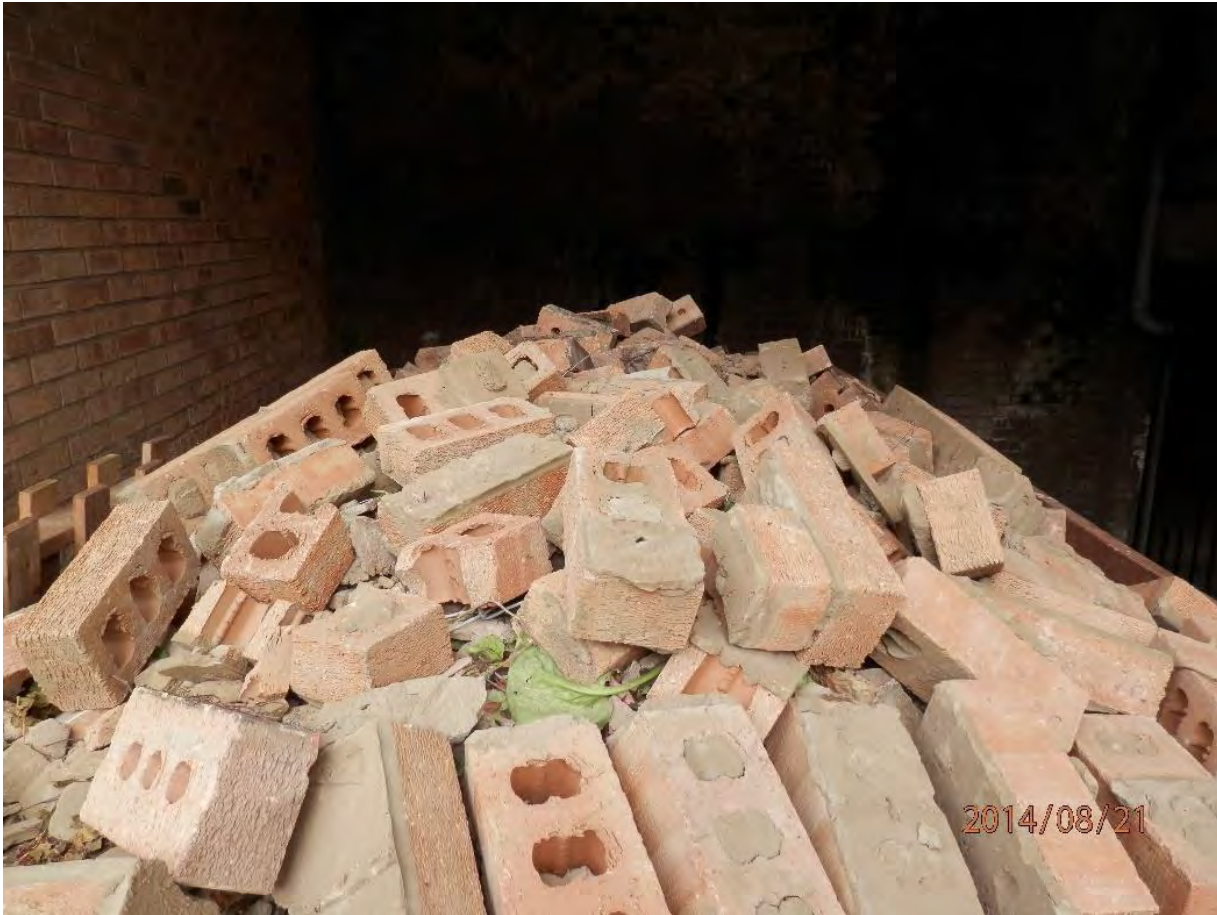
Removal by hand of the loose and frost damaged brickwork – Note the easy separation of the bed joint mortar from the bricks and at the perpend joints. Indicating that the bond between the mortar and the bricks was not especially good possibly as result of the early use of plasticizers to keep the mortar workable for longer periods.

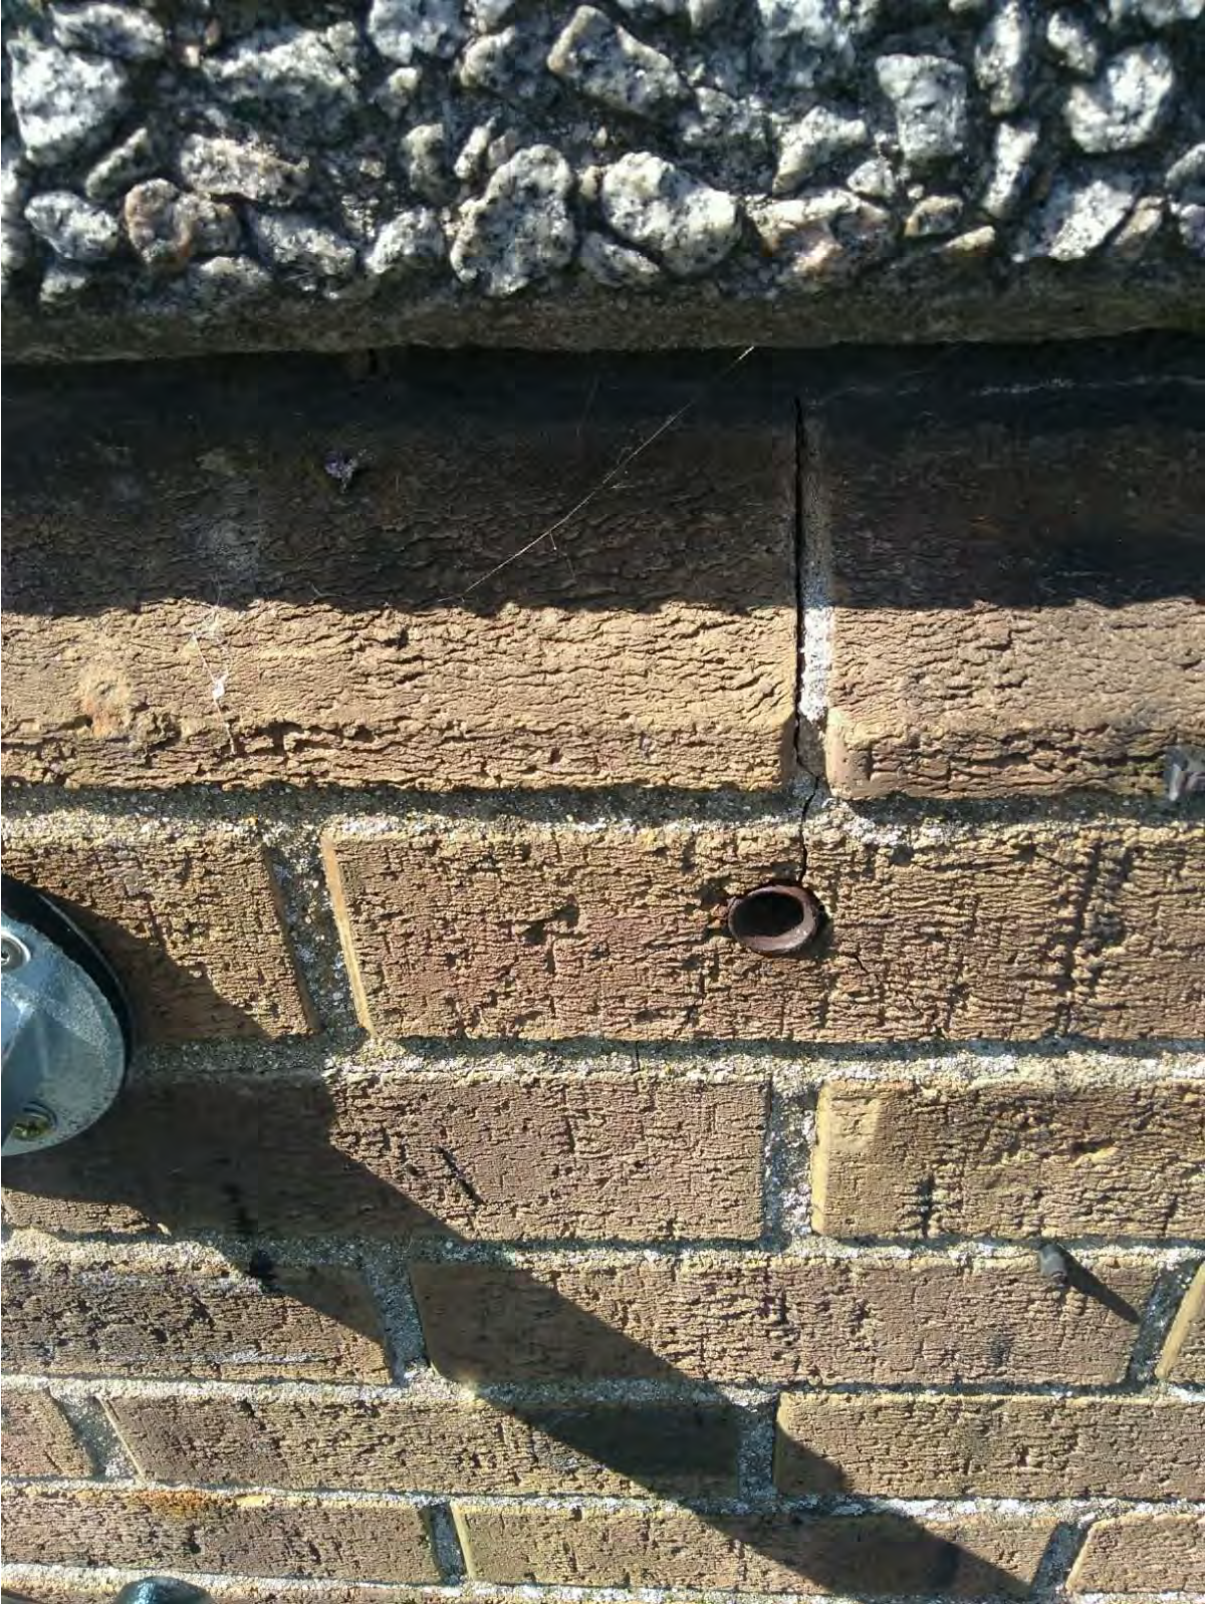
Typical Examples of Old Fixings left Rusting and Expanding within the Masonry Façade of the Buildings

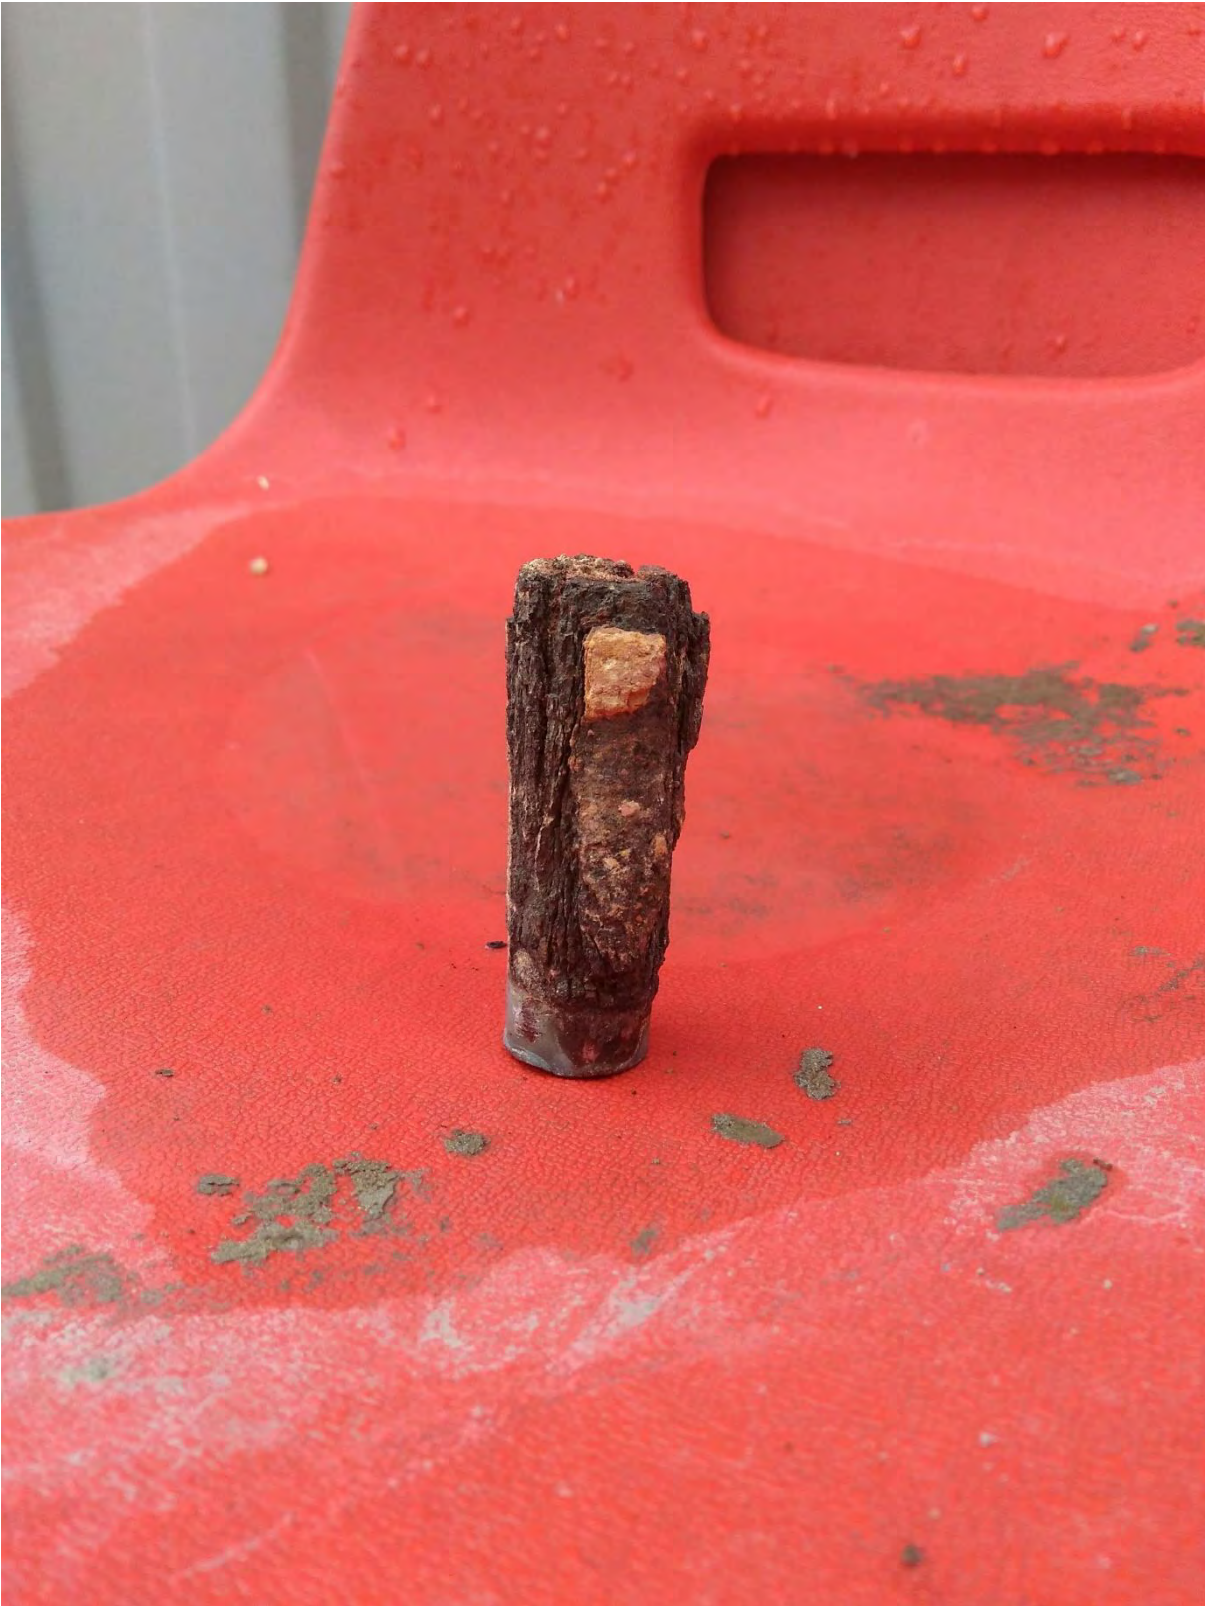
Typical example of a badly corroded fixing, presumably used to laterally restrain scaffolding, removed from high up on one of the buildings note the apparent increase in diameter bursting the brickwork. On no account should such ferrous / steel fixings be used on the building again nor any type that causes expansion of the brickwork causing splitting of the bed joints, the perpend and the bricks.

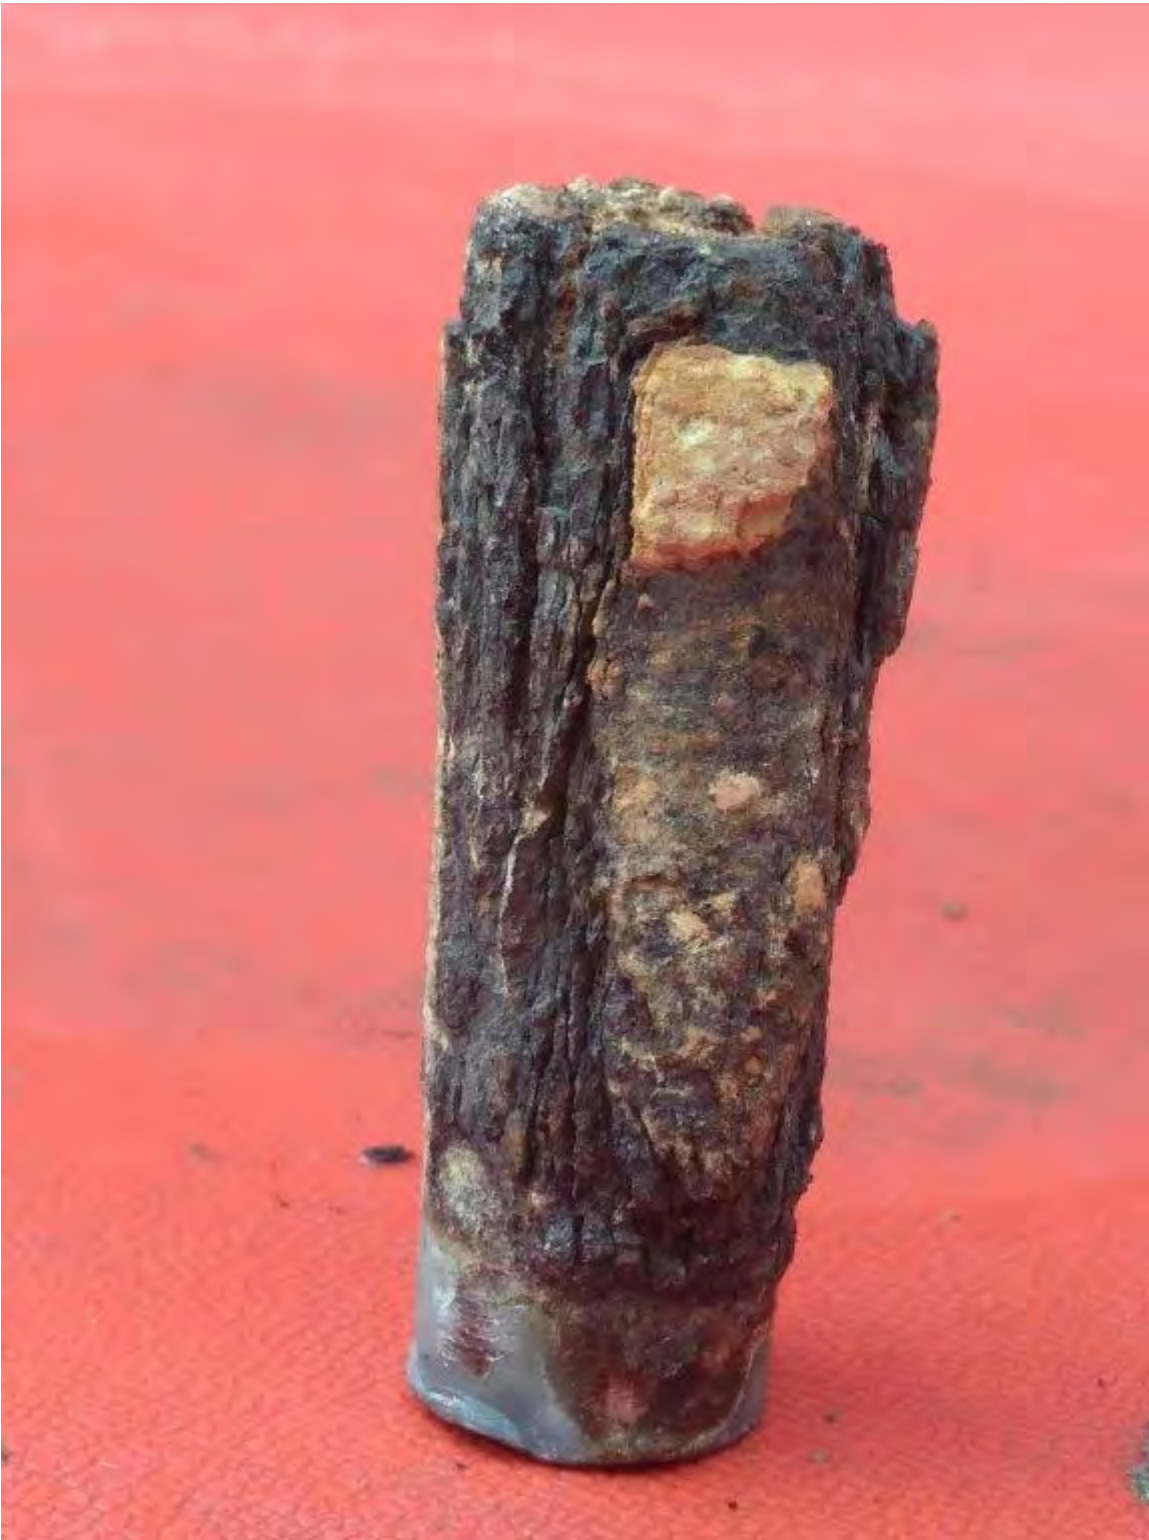
Ditto Another Closer View: - Typical example of a badly corroded fixing, presumably used to laterally restrain scaffolding, removed from high up on one of the buildings note the apparent increase in diameter bursting the brickwork. On no account should such ferrous / steel fixings be used on the building again nor any type that causes expansion of the brickwork causing splitting of the bed joints, the perpend and the bricks.

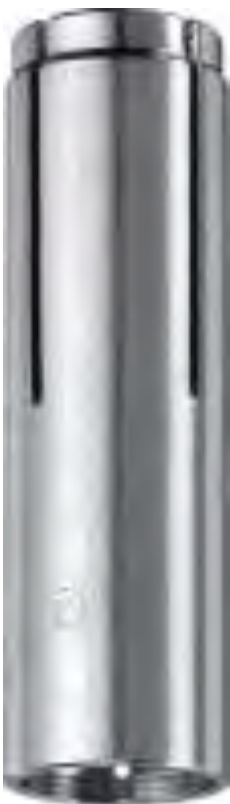
Typical example of a type of fixing, presumably used to laterally restrain scaffolding, removed from high up on one of the buildings note the apparent increase in diameter bursting the brickwork.

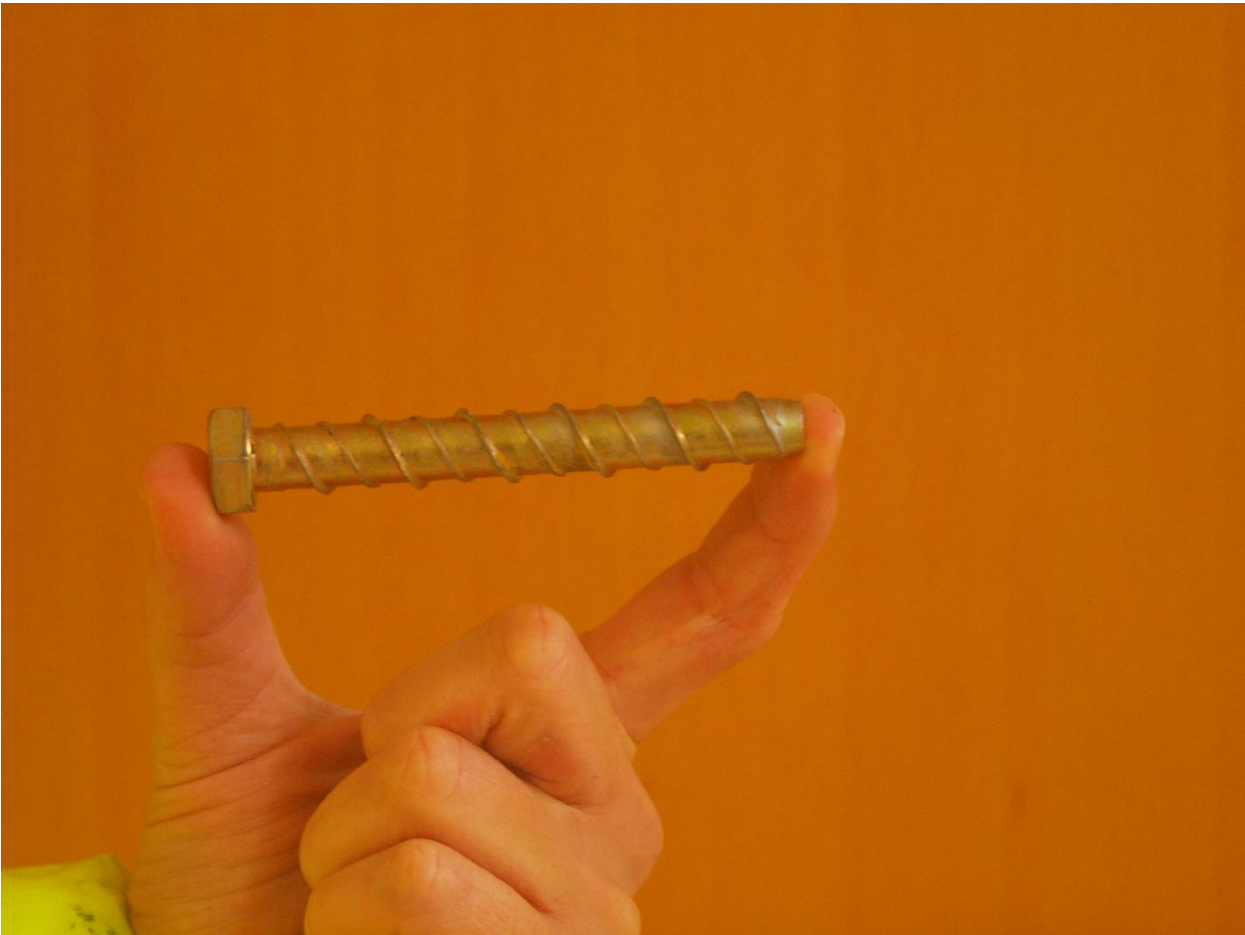
Similar fixing which is removable but is installed in a predrilled hole and wound in and out with a battery powered impact hammer thus splitting the reinforced concrete and brickwork – **Again a type of fixing to be avoided for use on the buildings which could split the bricks, the bed joints and the perpends or will split the concrete panels.**

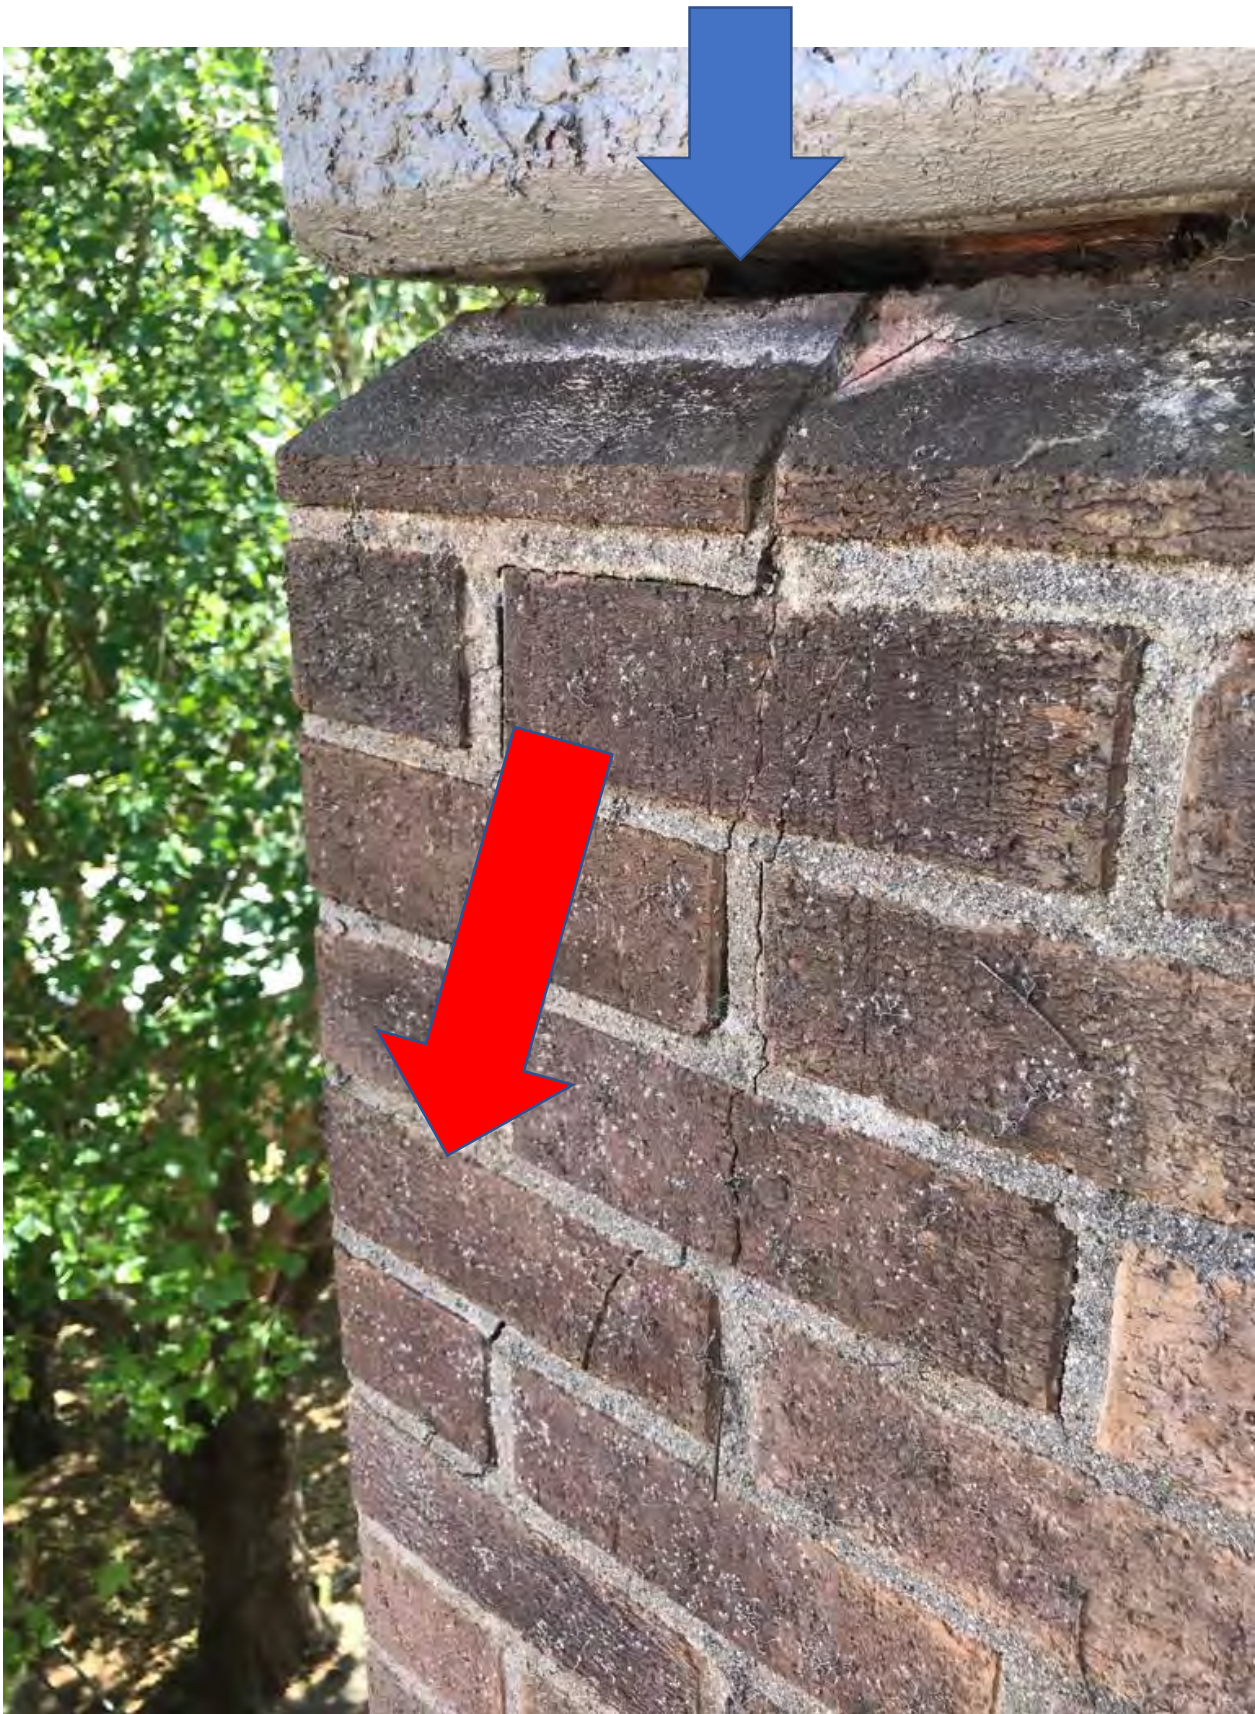
Typical example of the brickwork splitting under the weight of the parapet panels and thermal / moisture movements at the corners - located at the corner over a communal stairwell. Note the typical failure through the beds and perpends and the bricks under the weight of the concrete panel above exacerbated over years of cyclic freezing and thawing and thermal stress pushing out the brickwork locally at the corners. Helical Repair required at every fourth course to the brickwork back into the building – Note the height this is occurring at the very top of the buildings. Note the stress under the parapet panel Shims see Blue Arrow

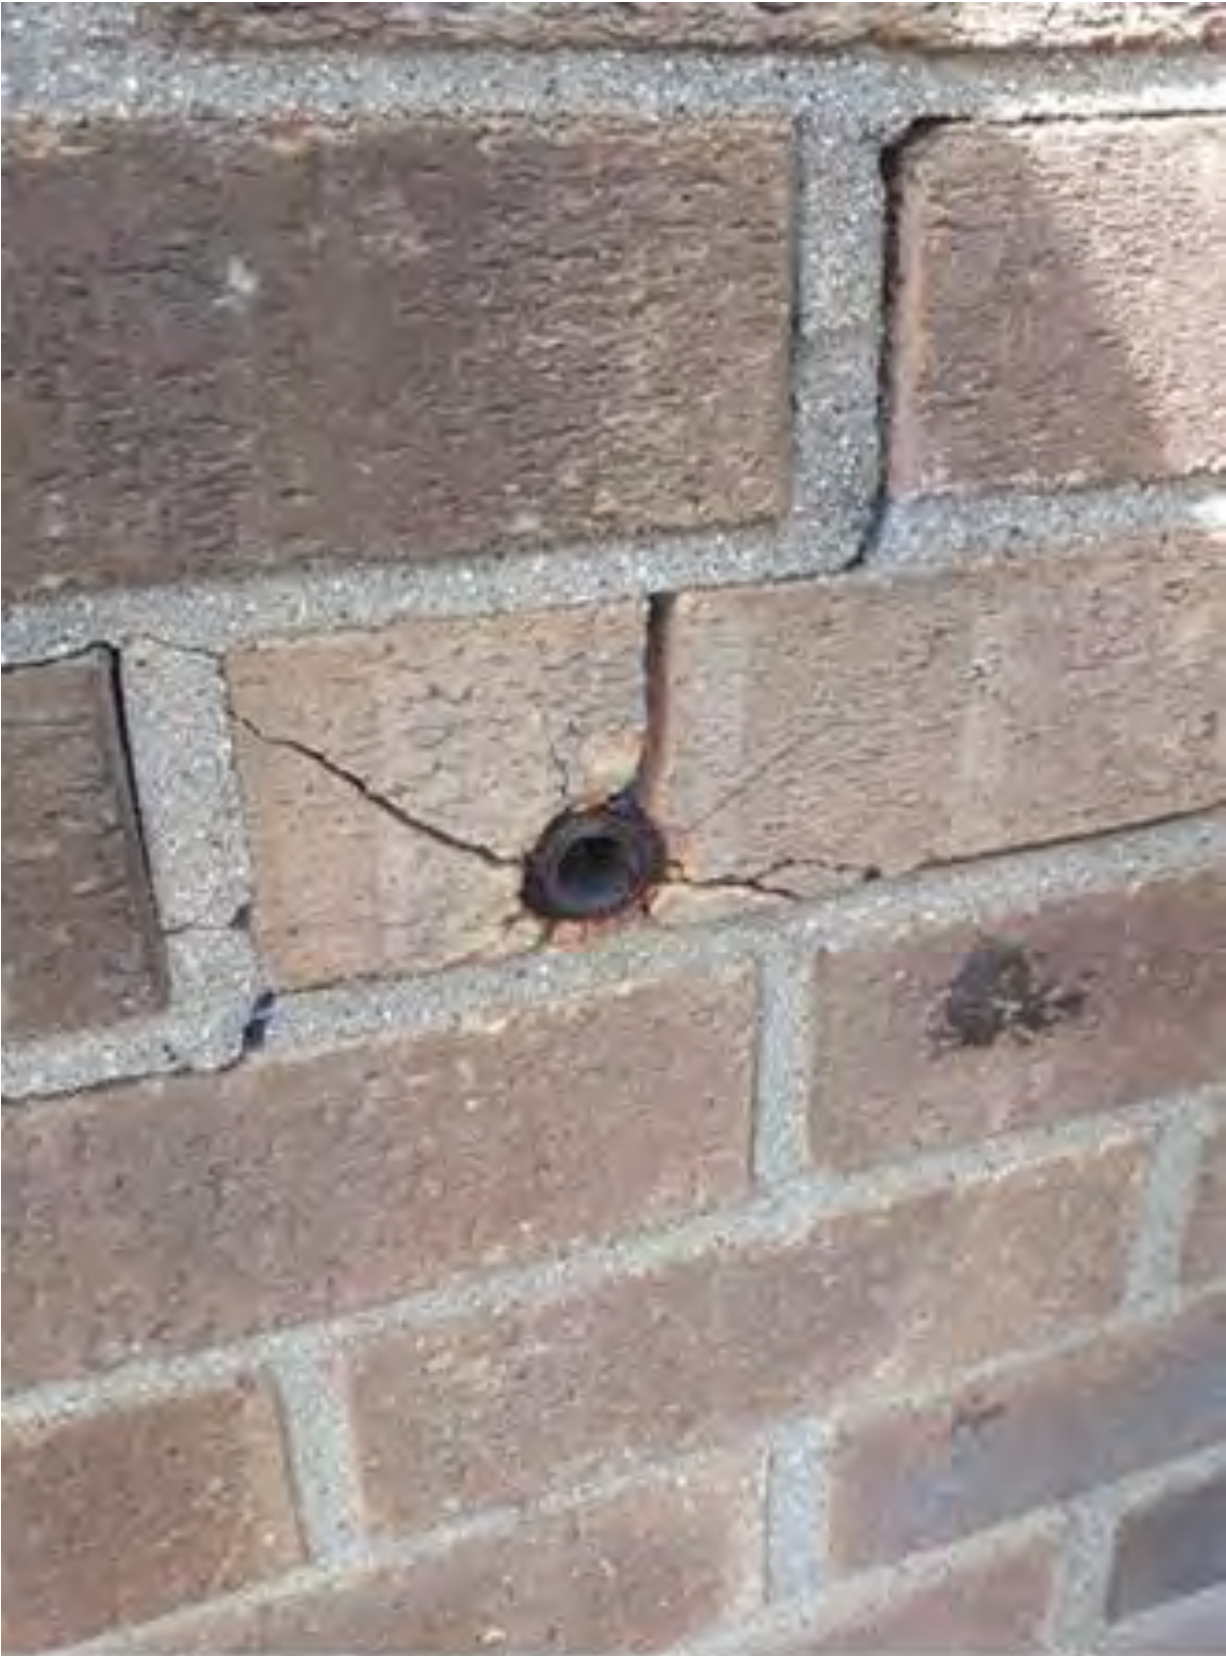
Top of Princess Court Bin Chute Tower corroded old Scaffold Fixing bursting the brickwork at High level

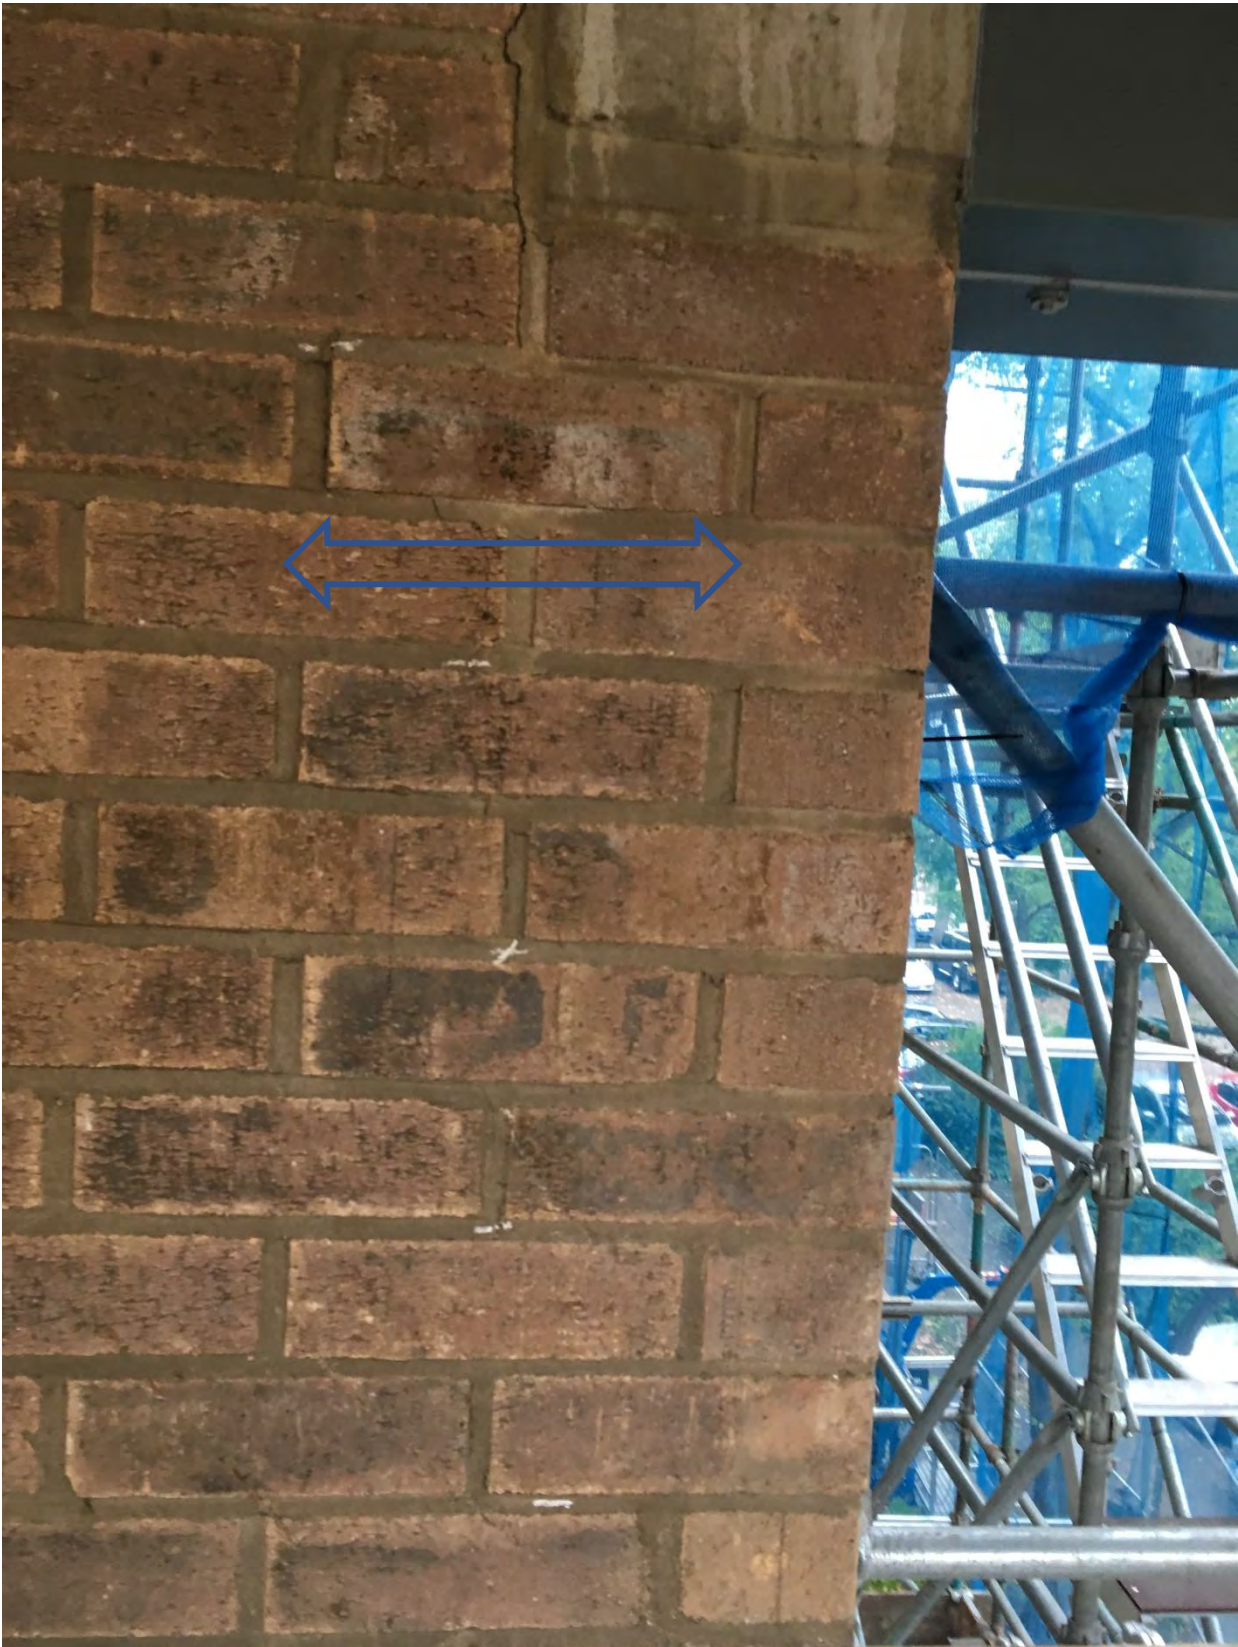
Cracked Walkway Beam Bearing onto the Hanover Court Building – Note the tracing of the brickwork ties

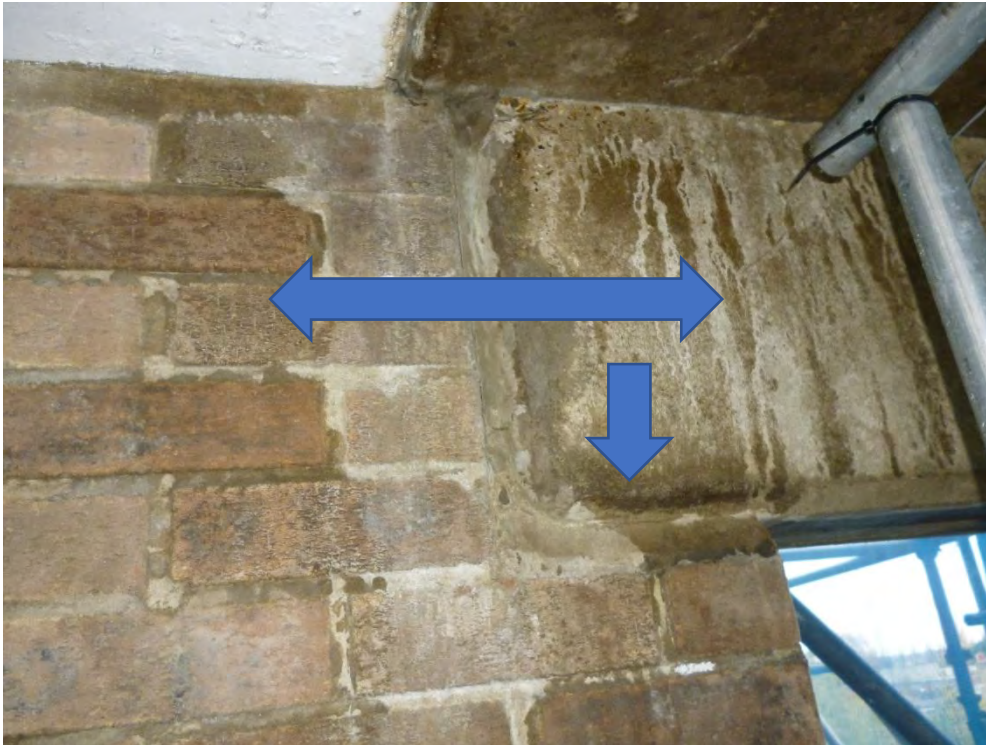
Typical Bearing onto the brickwork in the Building note the forces pulling the walkways support beams in and out! Of the building due to sway caused by wind loading causing the cracking at the bearings.

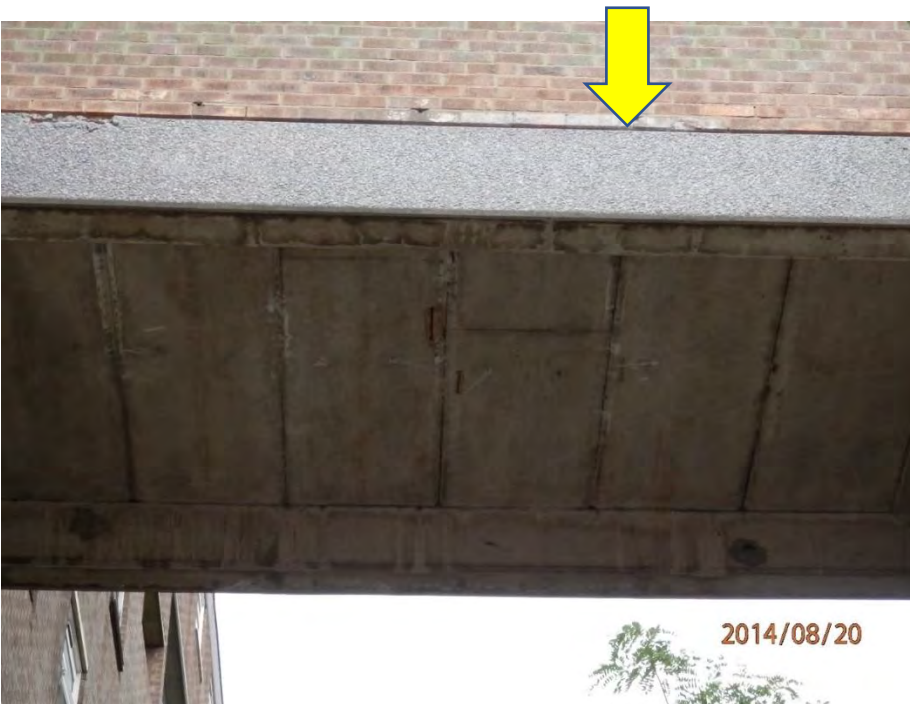
Walkways support beams deterioration of the concrete beams and the bottom brickwork bed joints inadequately restraining these brickwork panels from overturning out of the building - prior to remedial works. Note defects to walkway flooring and walkway beam understood to be treated with SIKKA 903 and 680c Anti-carbonation paint.

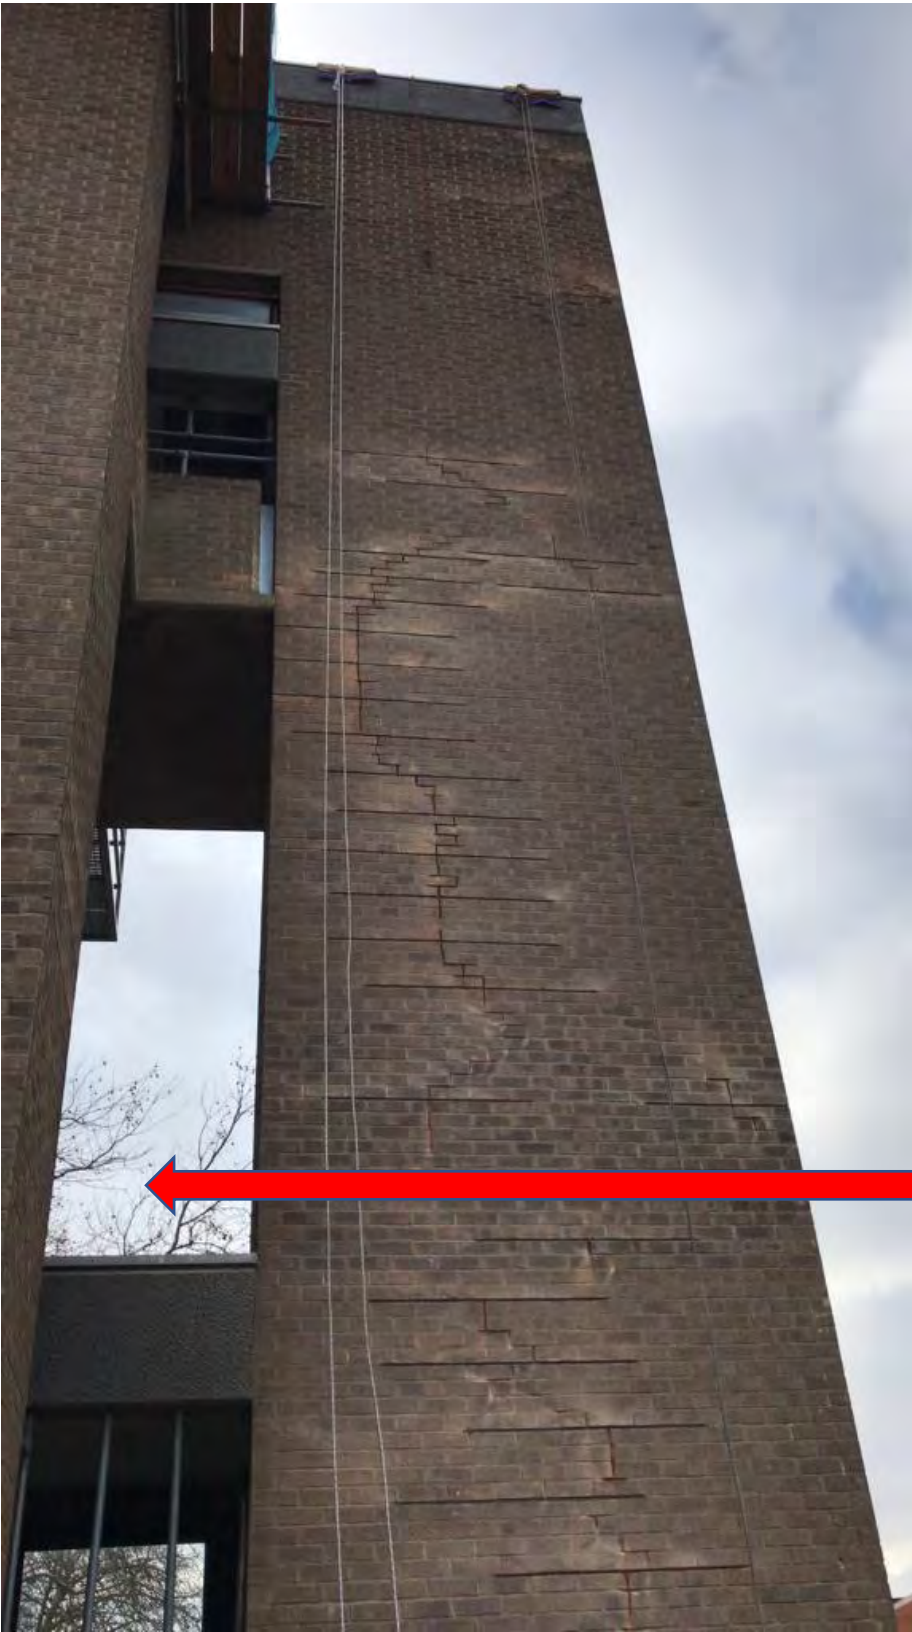
Hanover lift shaft tower repairs chased out ready for helical bar reinforcements showing the nature of the cracking presumably caused by the lift cage expanding during hot weather and binding in the gauge of the vertical rails within the tower itself causing bursting forces. Possibly exacerbated by wind loading. Note the lift rails will wear more towards the bottom of the lift than the top as the car always returns to the ground floor no matter what floor the lift serves as required by the user. If the cracking does not abate then consideration should be given to binding the tower all around the tower with reinforcement at for example every fourth bed courses to contain the bursting forces.

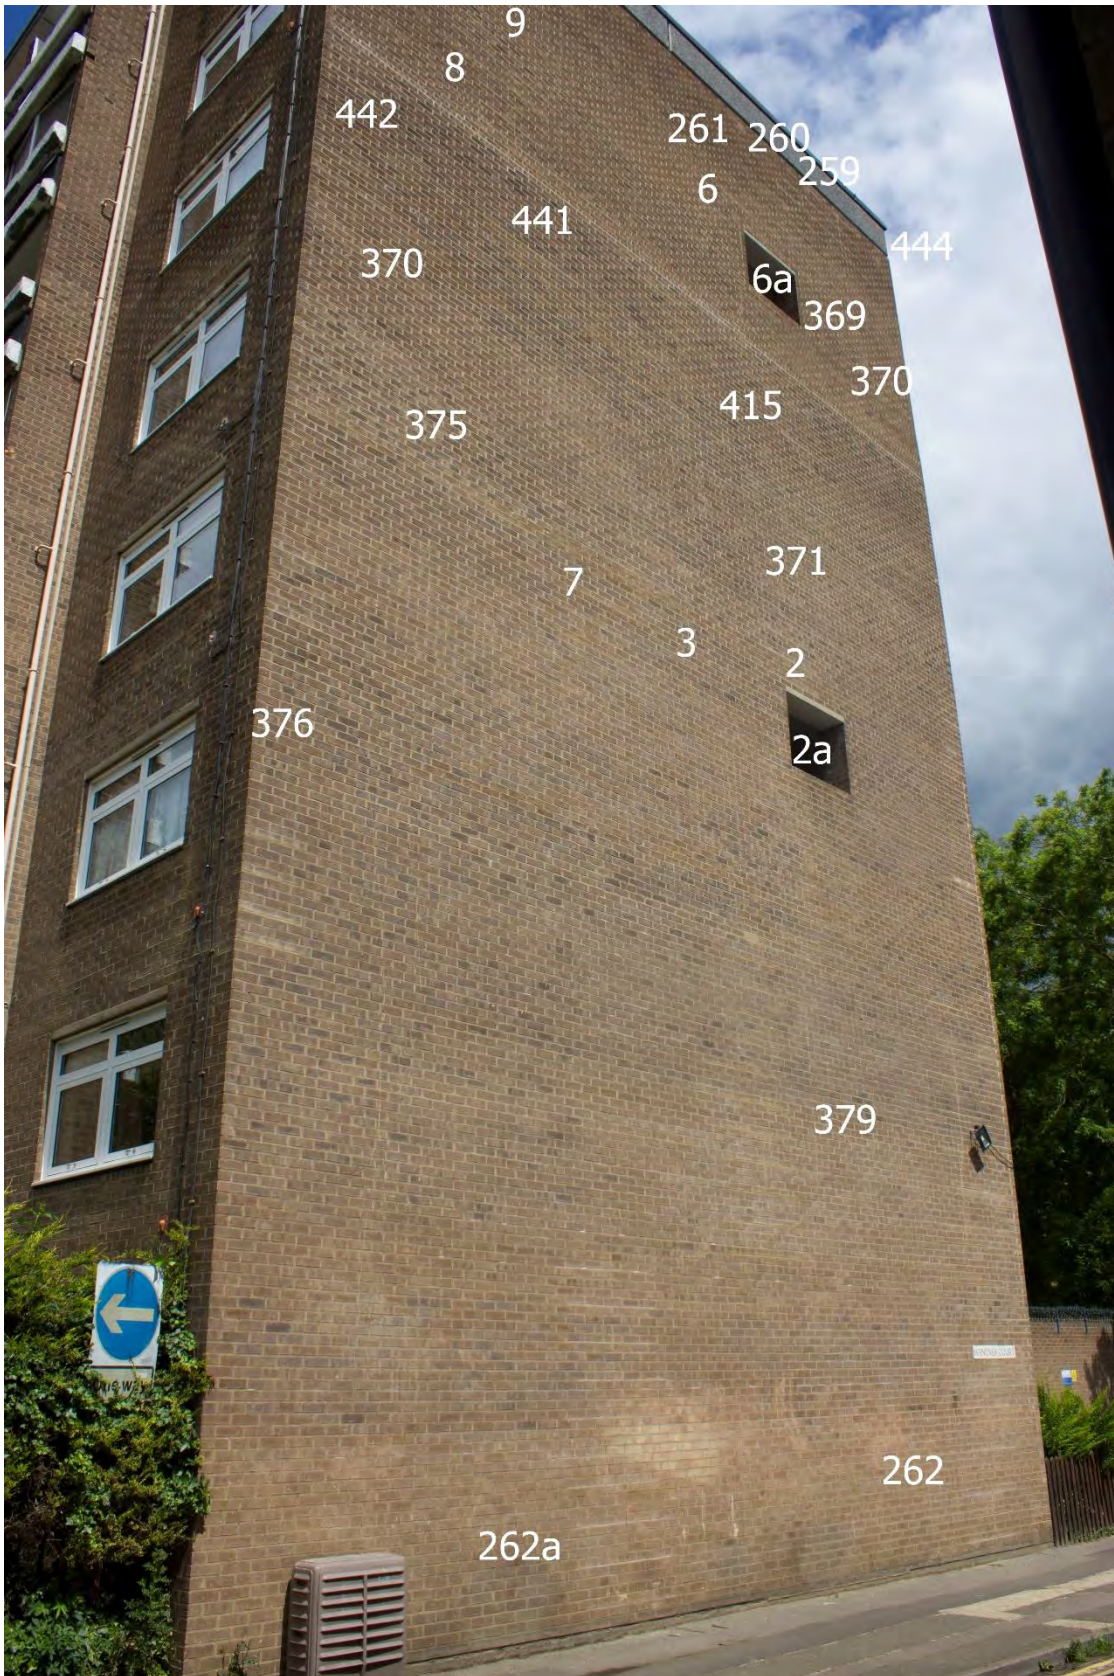
Typical Noted Elevation on Hanover court of Repair Locations Recording Defects and Repairs by Photograph Number using a whit wipe board
