**MLTS Limited,**  
*Structural Engineers,*  
55 Mill Road,  
Lode,  
Cambridge.,  
CB25 9EN  
Tel.: - 01223 812644  
Email: -mlts@btopenworld.com

Date: 28<sup>th</sup> February 2020

**Preliminary Report on the Apparent Cracking within the External Façade Brickwork, Concrete Façade Panels and Year 2 Urgent Remedial Works of Princess and Hanover Courts, Cambridge, CB2 1JJ and CB21 JH**

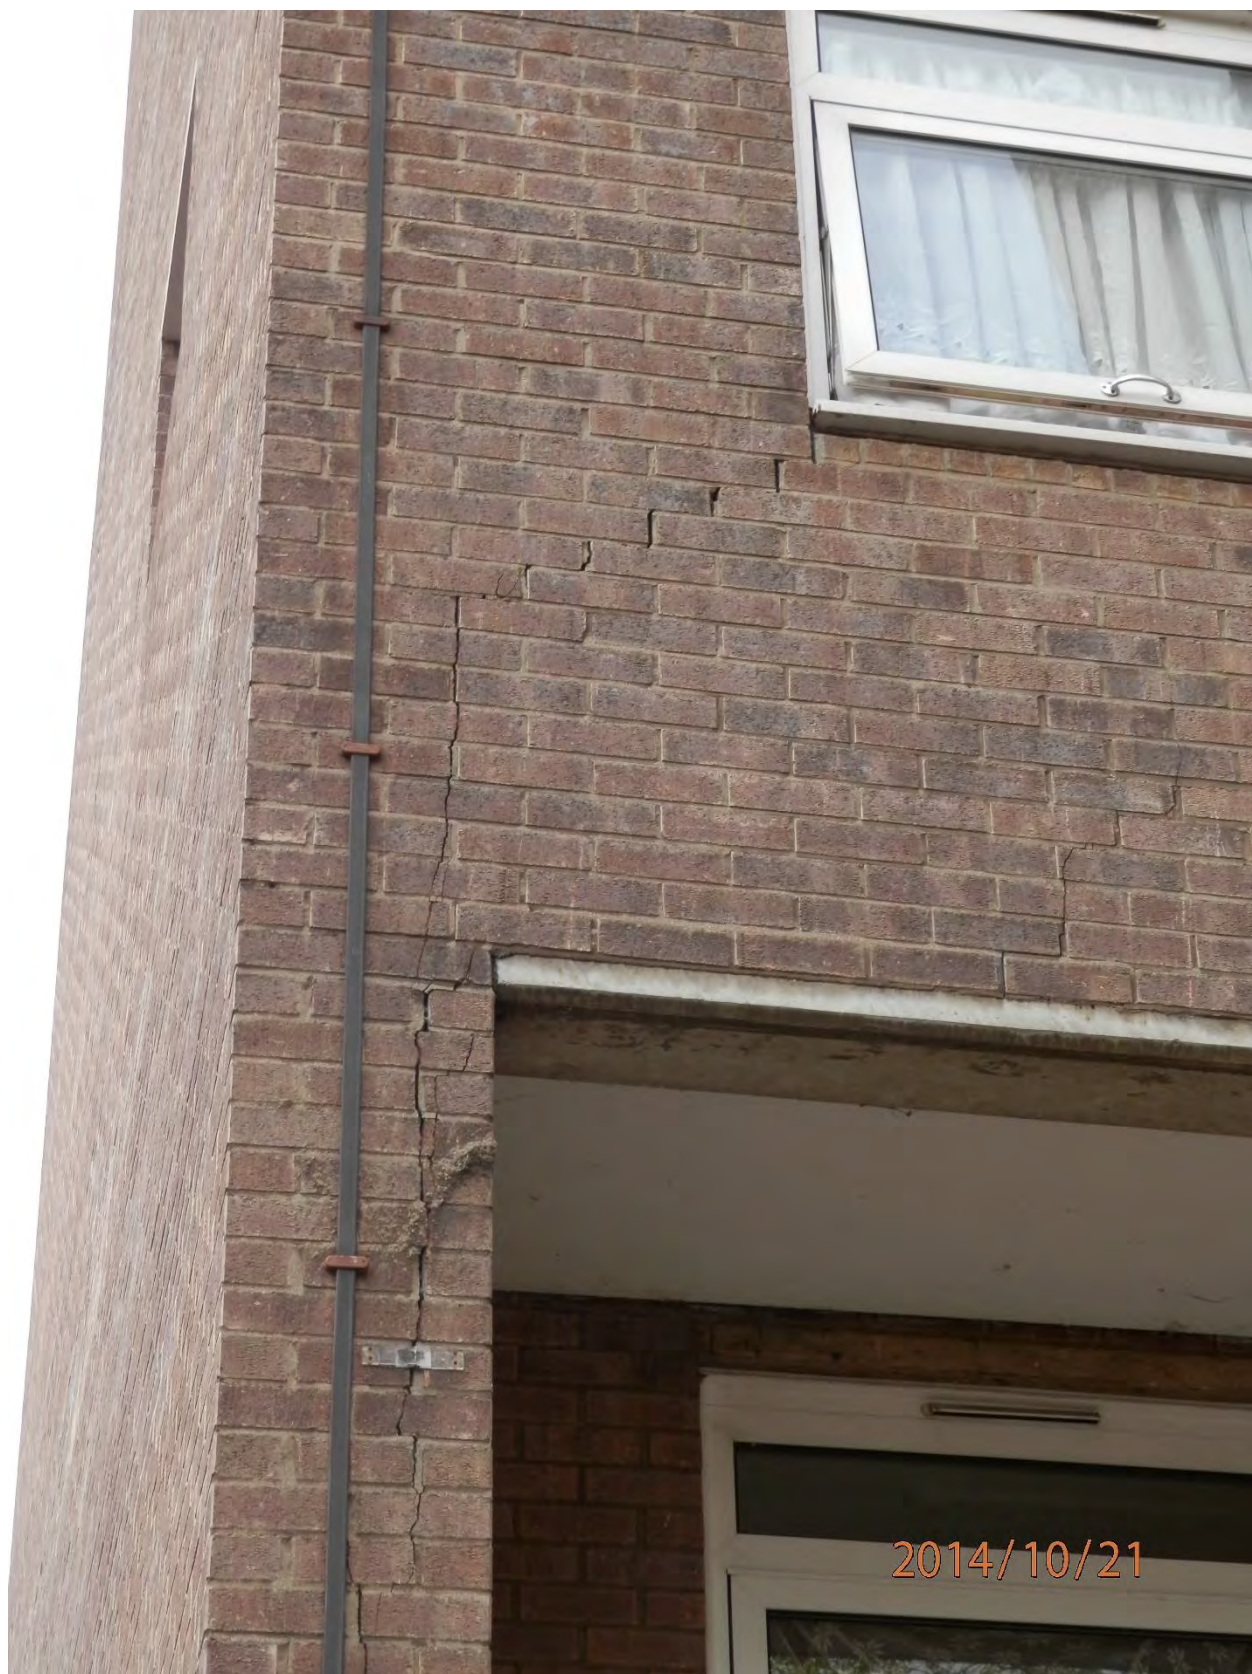
**Corner of Hanover Court Before Year 1 Emergency / Urgent Repairs likely to be caused by strong wind loading causing lateral (east westerly direction) over tuning movement within the gable end wall.**

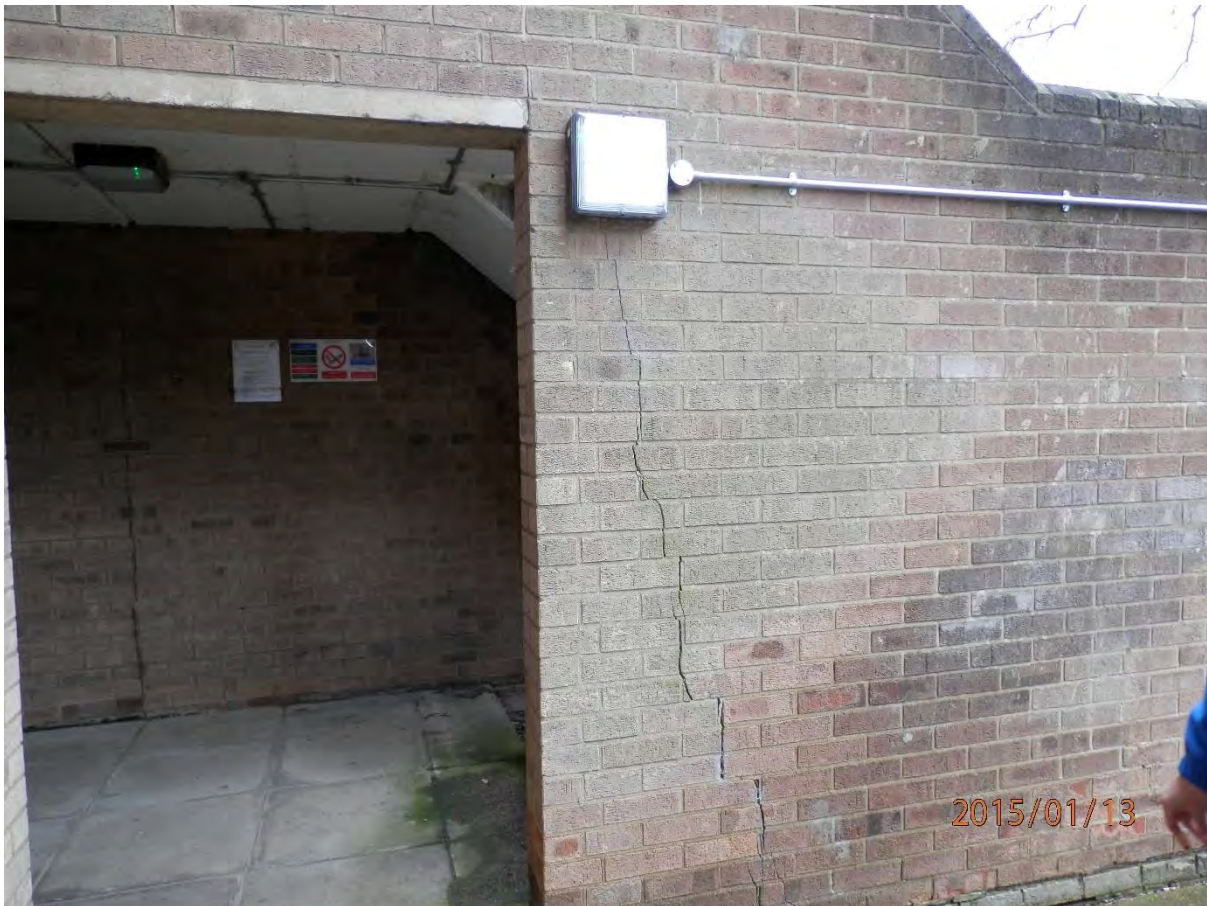
**Eastern Side of Hanover Court Typical Entrance Structure Cracking - Repaired in Year 1 Urgent Works**

**NB:** - The main drains are understood to run along under these staircase structures and the eastern slender bin chute towers adding to the issues and potential issues with structural movements caused by drains and trees.

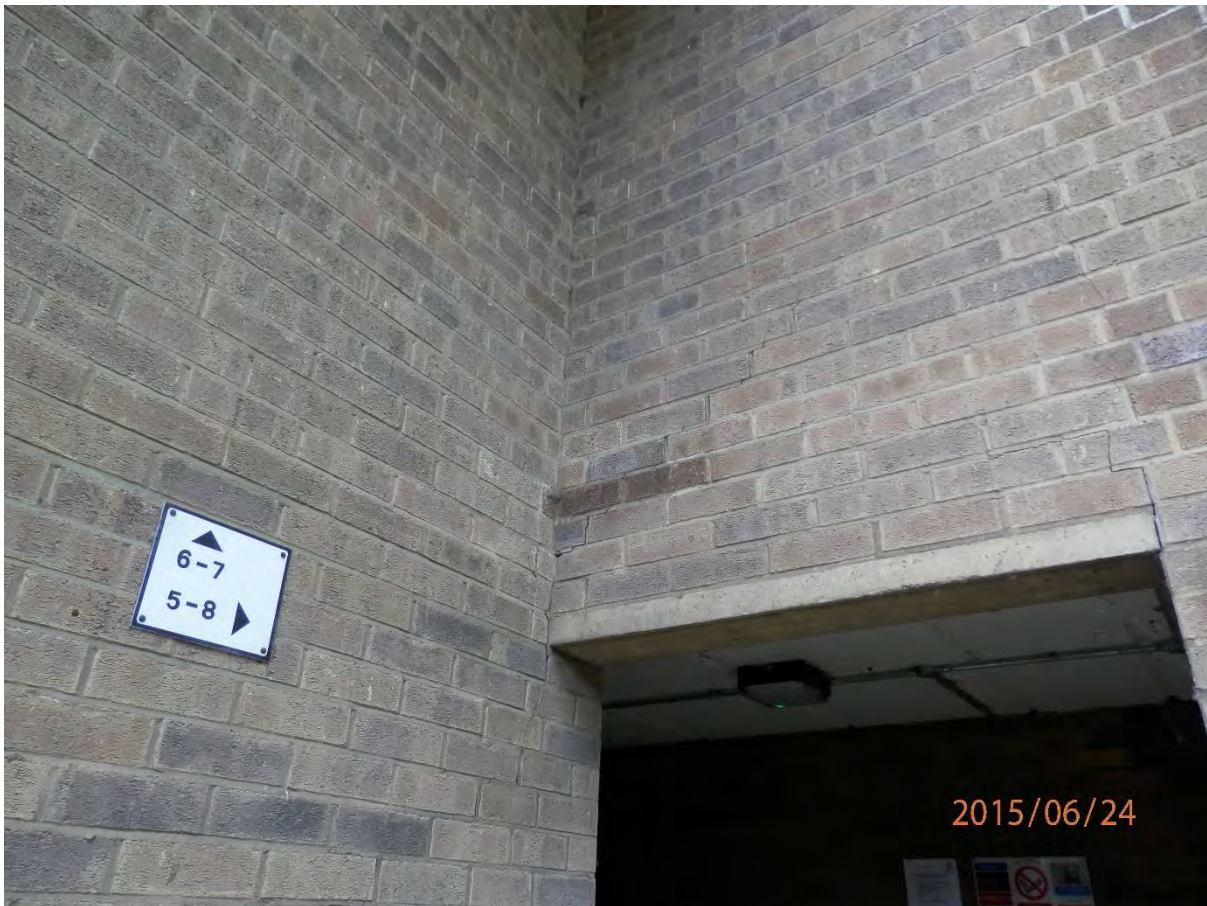
**Eastern Side of Hanover Court Typical Entrance Structure Cracking -Repaired in Year 1 Urgent Works: -**

**NB:** - The main drains are understood to run along under these staircase structures and the eastern slender bin chute towers adding to the issuers and potential issues with structural movements caused by drains and trees. Thus, it is imperative that the drains are maintained and do not leak and compromise the formation supporting the foundations.

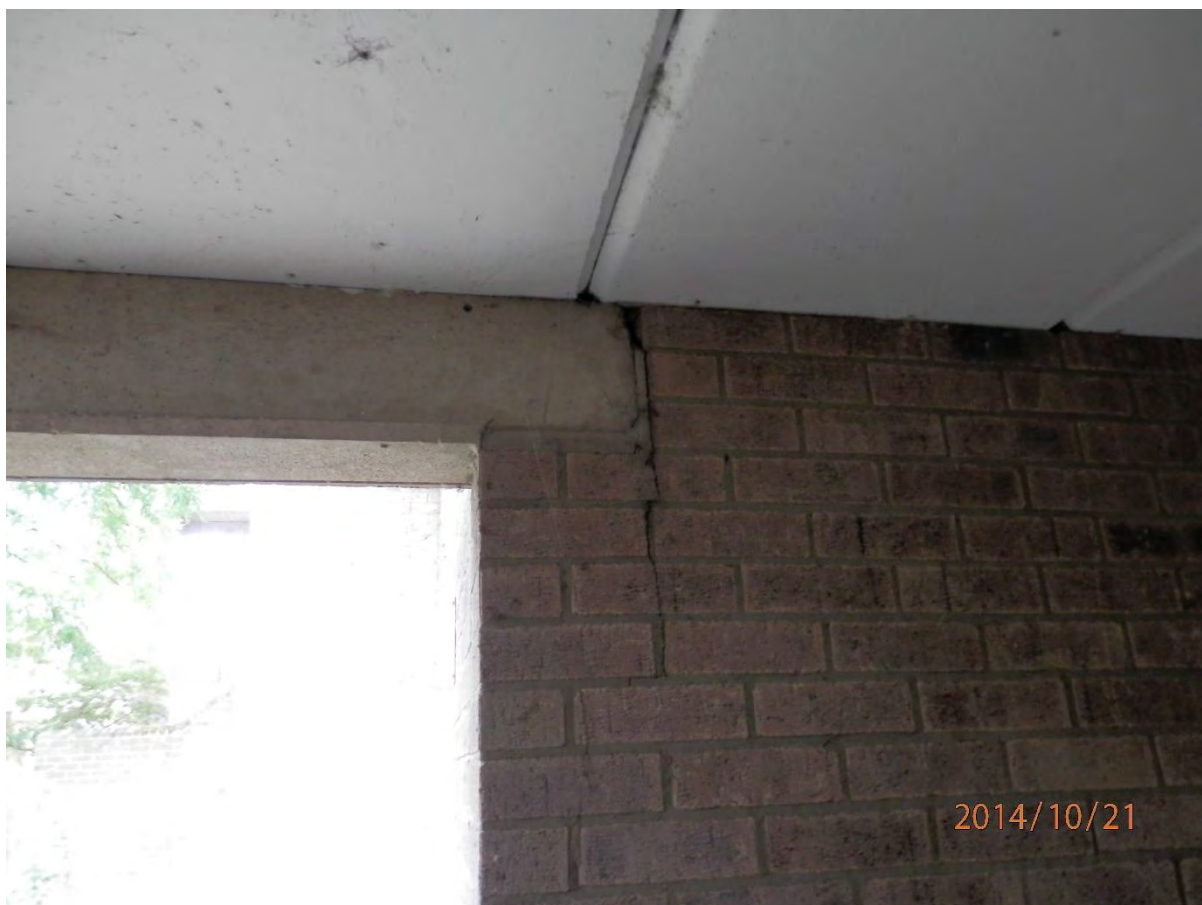
**Eastern Side of Hanover Court Typical Entrance Structure Cracking -Repaired in Year 1 Urgent Works**

**NB:** - The main drains are understood to run along under these staircase structures and the eastern slender bin chute towers adding to the issues and potential issues with structural movements caused by drains and trees. Thus, it is imperative that the drains are maintained and do not leak and compromise the formation supporting the foundations.

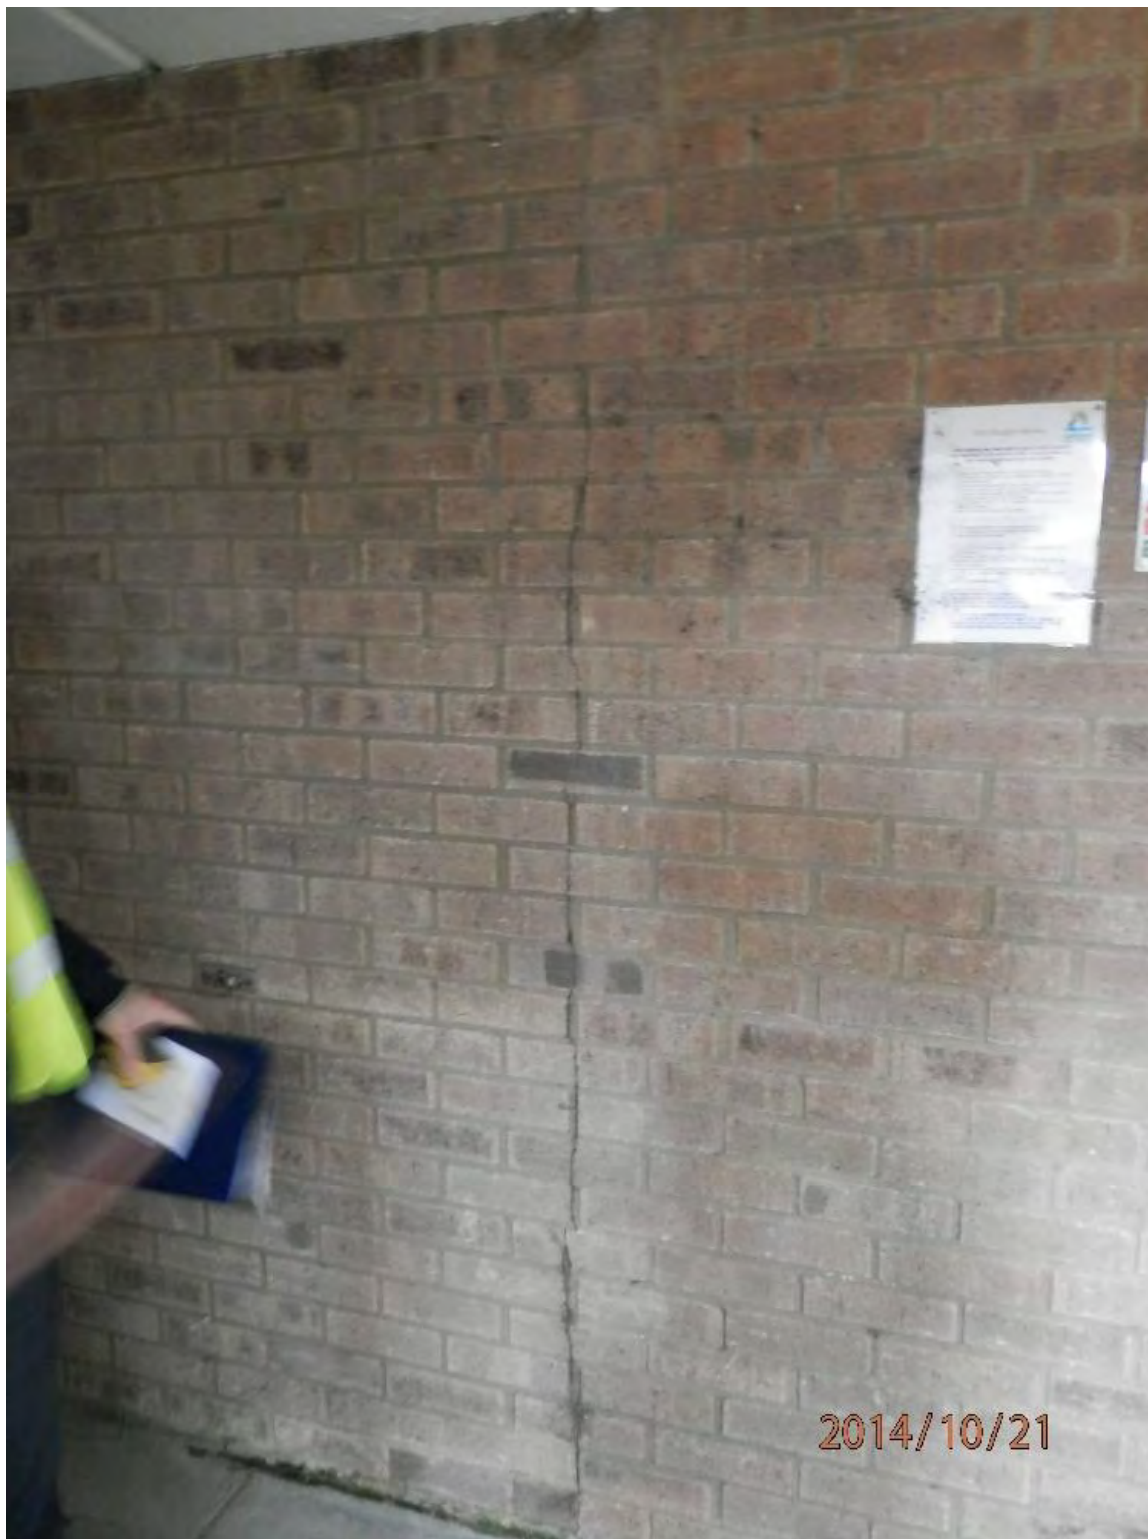
**Eastern Side of Hanover Court Typical Entrance Structure Cracking: Internal View - Repaired in Year 1 Urgent Works**

**NB:** - The main drains are understood to run along under these staircase structures and the eastern slender bin chute towers adding to the issues and potential issues with structural movements caused by drains and trees. Thus, it is imperative that the drains are maintained and do not leak and compromise the formation supporting the foundations.

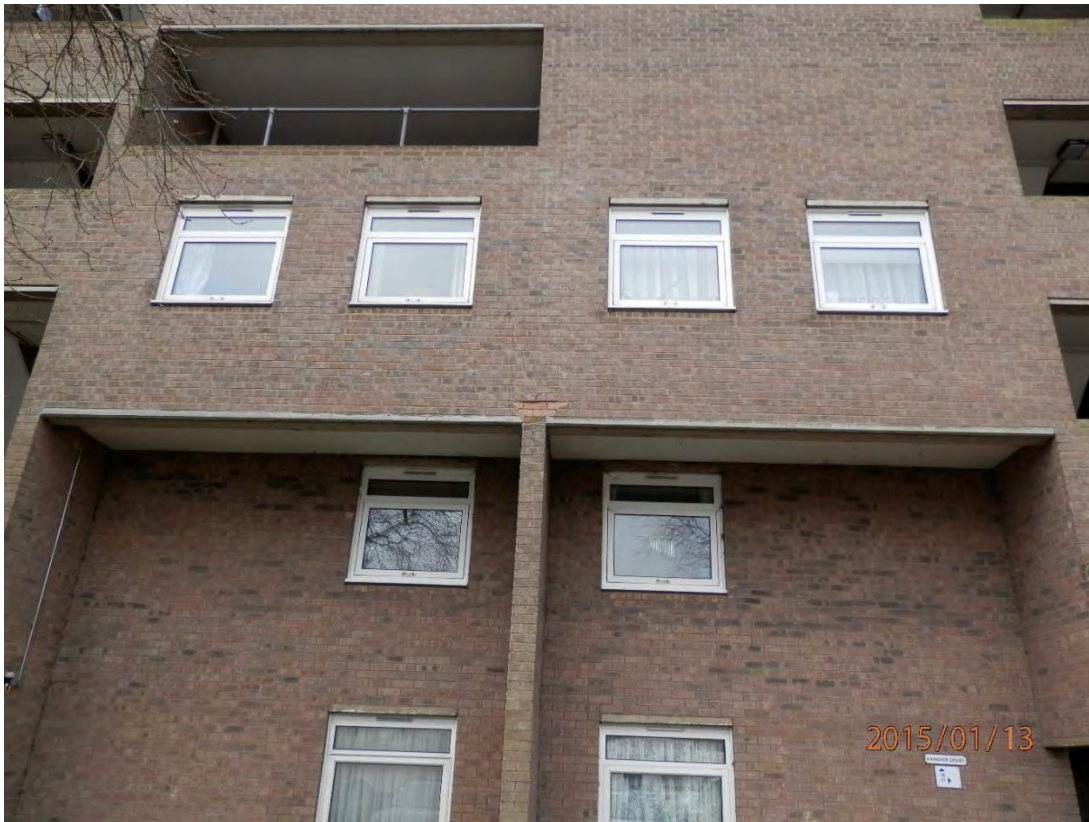
**Eastern Staircase of Hanover Court Typical Entrance Structure - Cracking Internal Northern Side:  
Repaired in Year 1 Urgent Works**

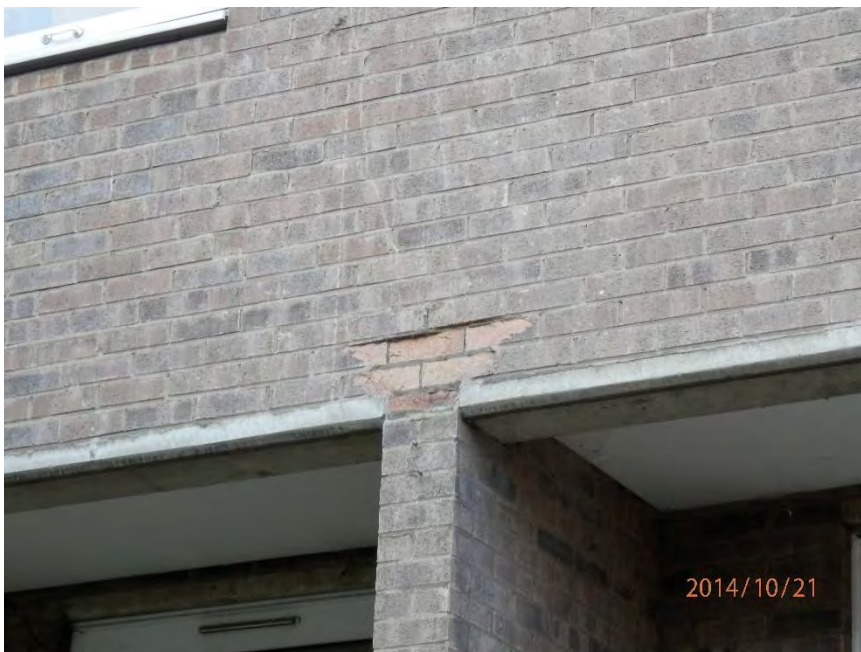
Typical example of the Eastern Flank Wall Cracking due to vertical load overloading by the two heavily concrete lintels on both sides supporting the brickwork façade above probably exacerbated by additional vertical load due wind load on the western side and possibly exacerbated by frost attack.

Note the very slender 225mm wide pier below and the stress concentration at the top of the pier under the lintels with 112mm of bearing at the most for each lintel.

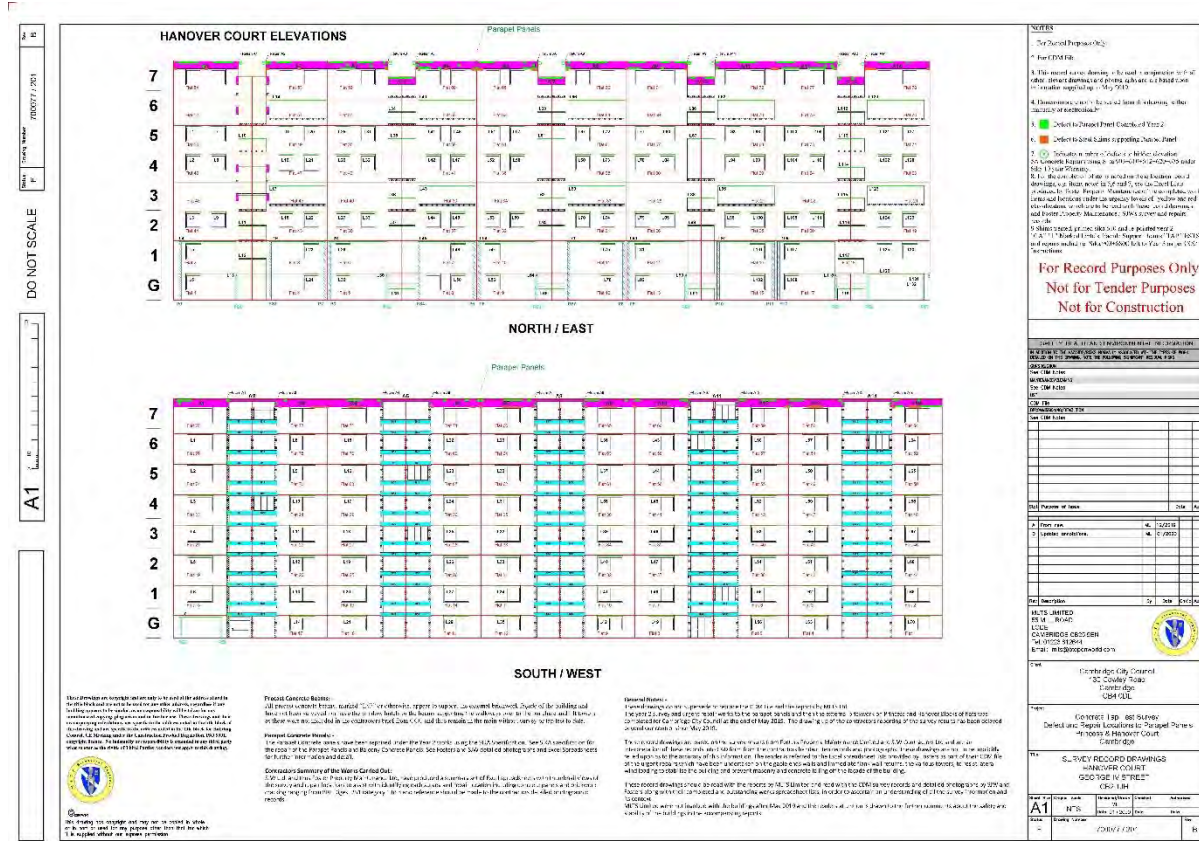
**General View of North Eastern Elevation Typical Parapet Panel Tap Test in Year 1 Prior to Year 2 Sika Repairs Sika 903 Sika 610 Sika 612 and Anti-carbonation Coating Sika 675**

**Year 2 Parapet Panel Repairs See MLTS Drawings 200 Series**

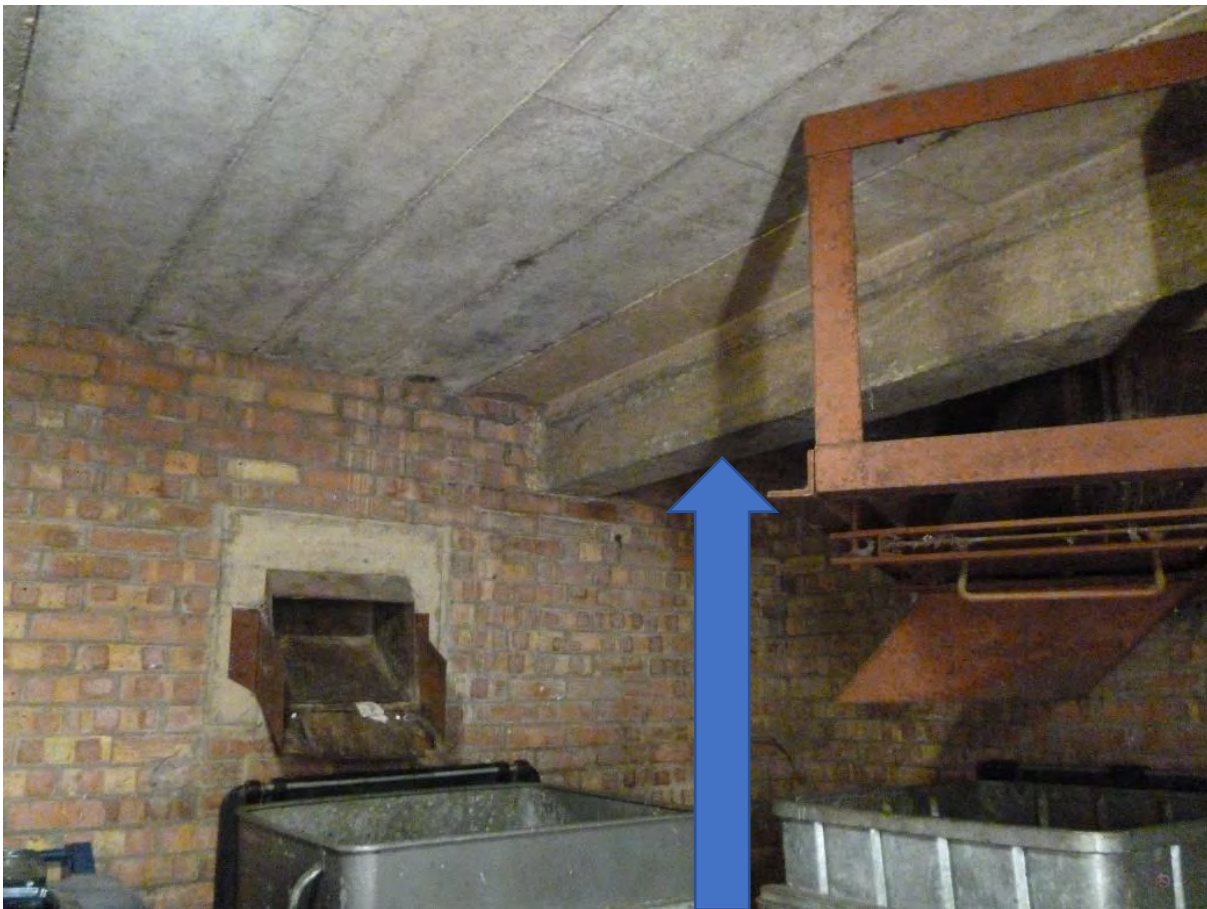
See photograph below taken in a typical bin store of the transfer slab over the bins supporting the bottom of the tower above reducing the tower stiffness at the transfer slab to resist lateral sway and so partially forming in structural terms, a partial pinned base and supporting arrangement at the transfer slab level. This arrangement naturally exacerbates the sway and the movement of the top of the tower structure above.

**Note:** -Bin Chute Tower supported over the bin store

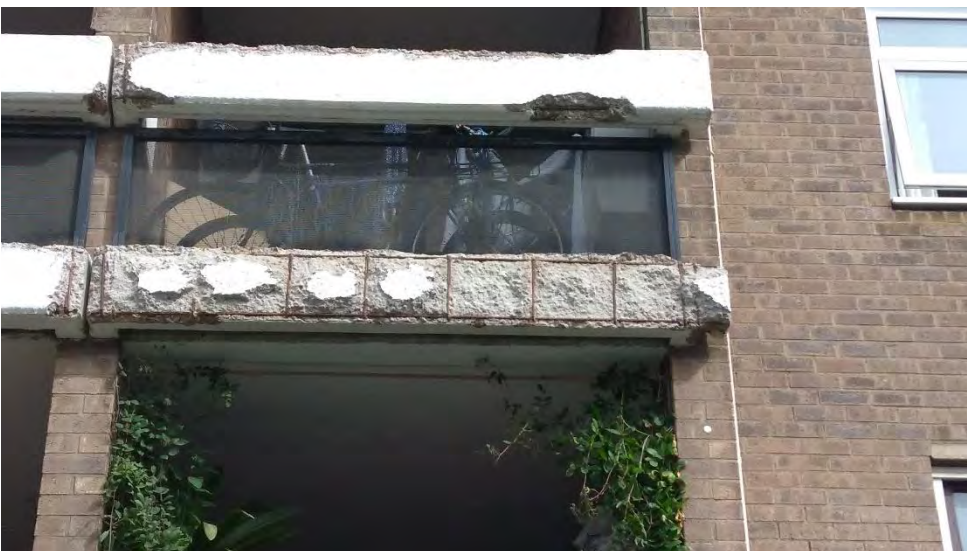
**Balcony Beam Typical Loose Concrete Removal:** - Note the rusty square twist reinforcing bars buried within the precast concrete balcony panels.

Also note the crack in the masonry party wall on the western side due to the loading including wind loading compression load due to wind acting on the eastern side of the building.

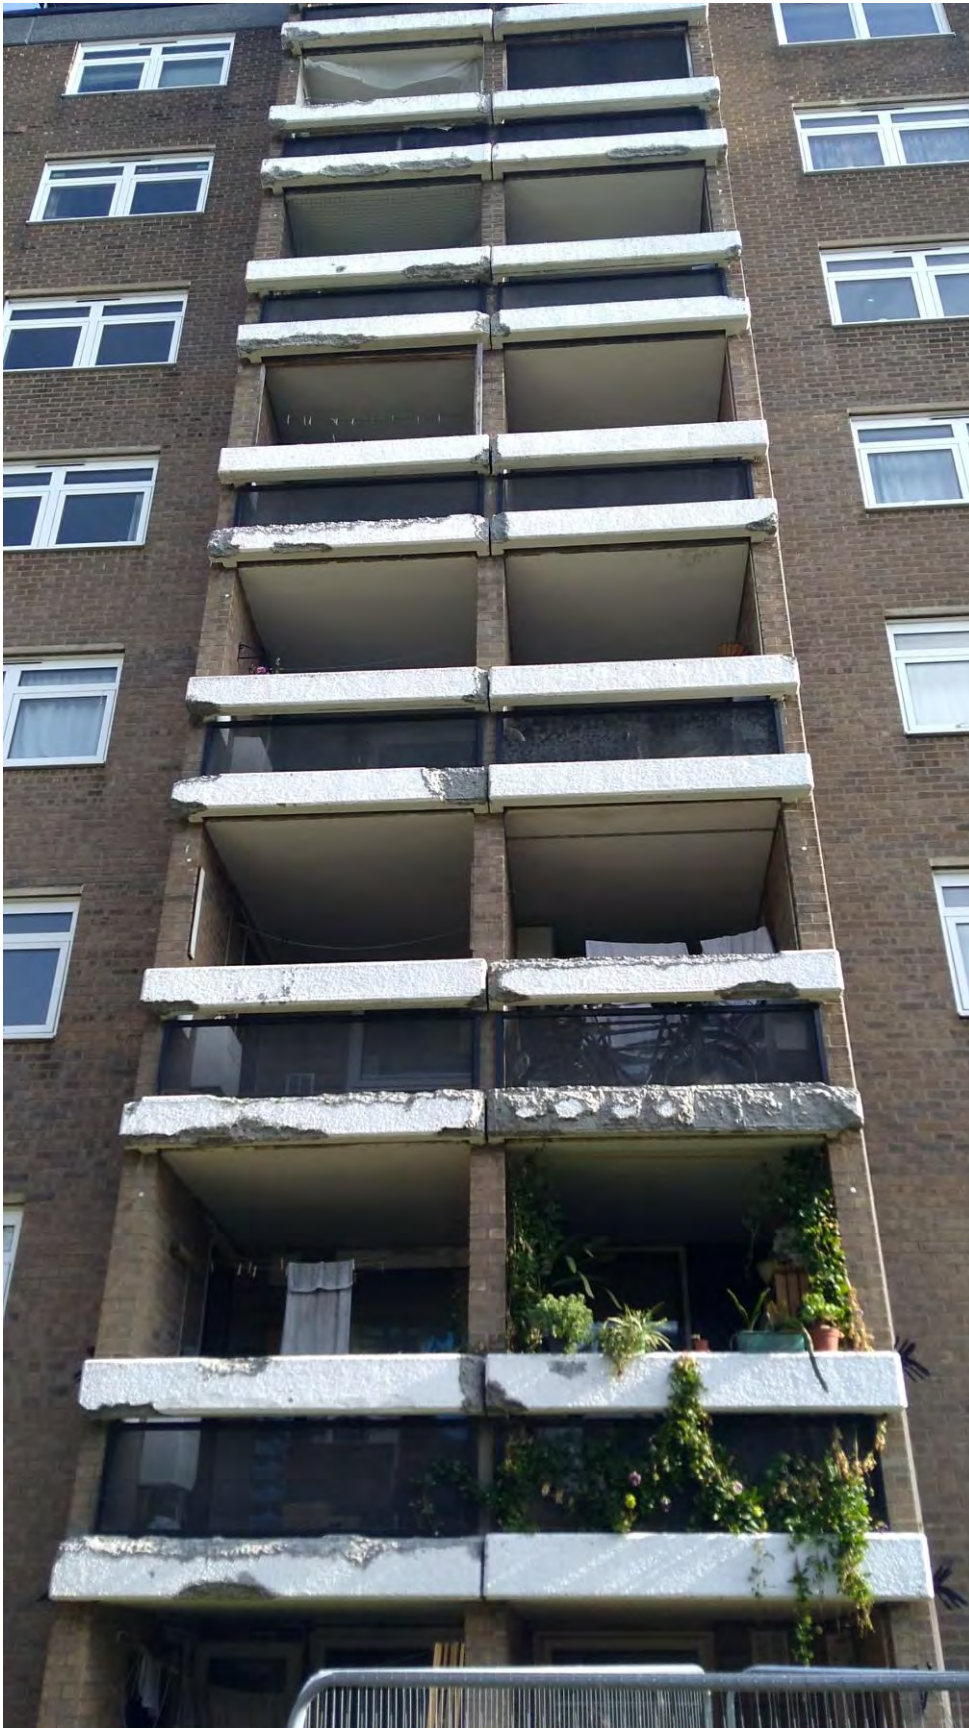
**Typical loose Balcony panel corner Removed Easily by Hand.**

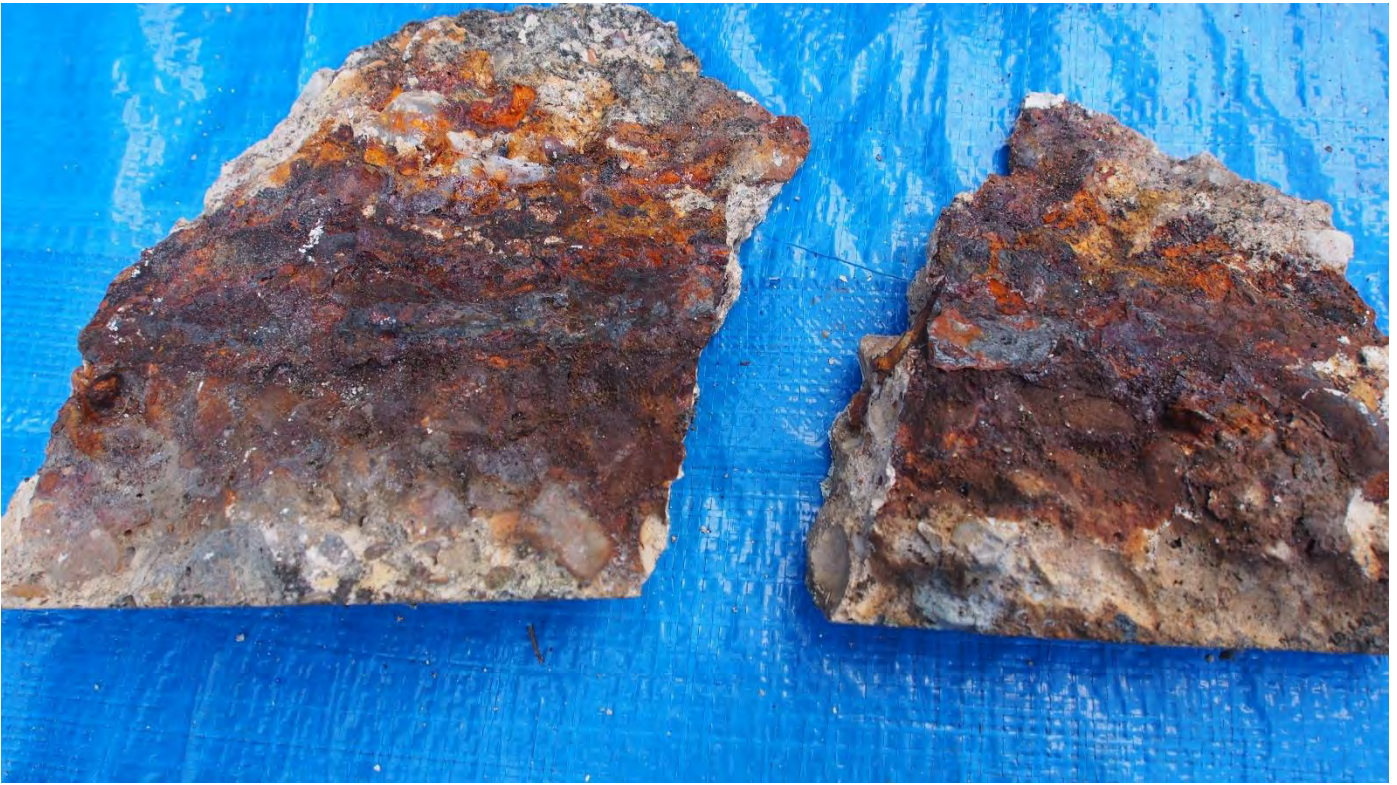
**Typical Removed Section of Balcony Panel Bottom Drip Detail found loose and painted over  
Loosened due to steel bar corrosion**

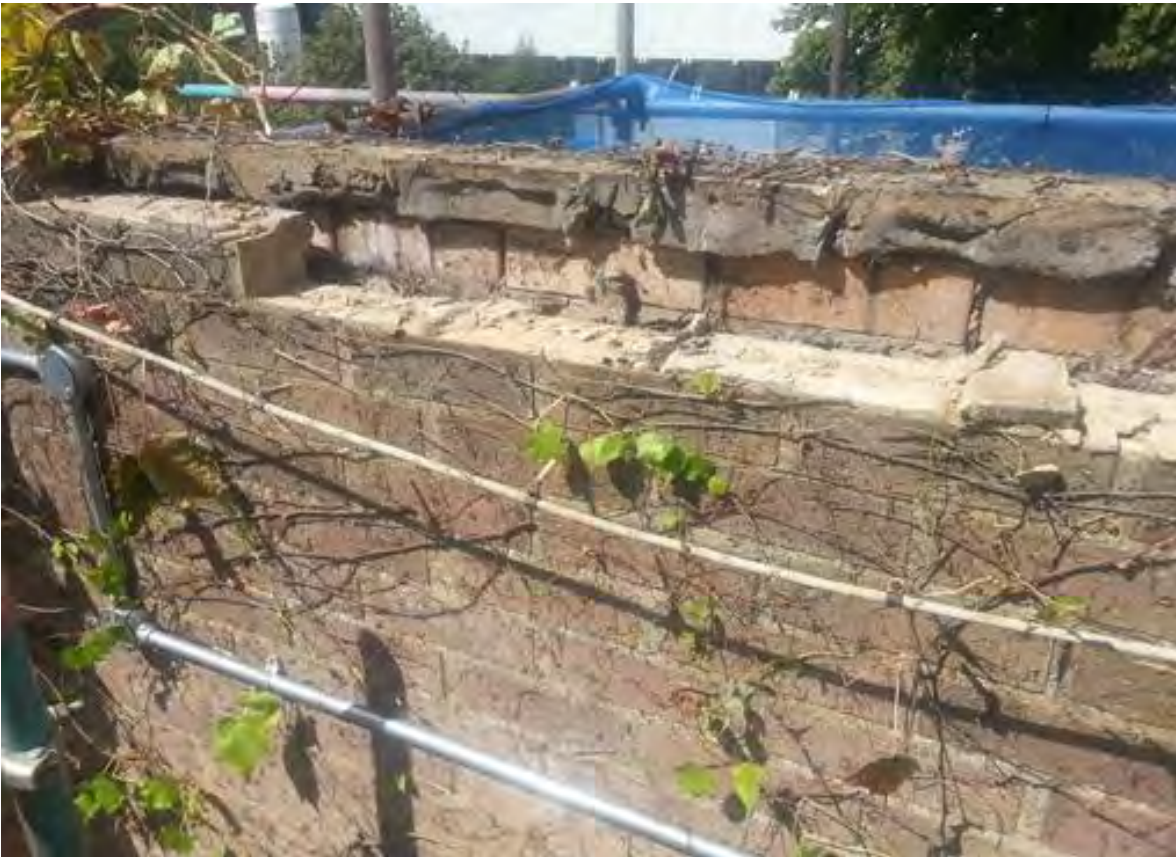
**Removal by hand of the loose and frost damaged brickwork – Note the easy separation of the bed joint mortar from the bricks and at the perpend joints. Indicating that the bond between the mortar and the bricks was not especially good possibly as result of the early use of plasticizers to keep the mortar workable for longer periods. Note the clean mortar bed separation with the removed bricks.**

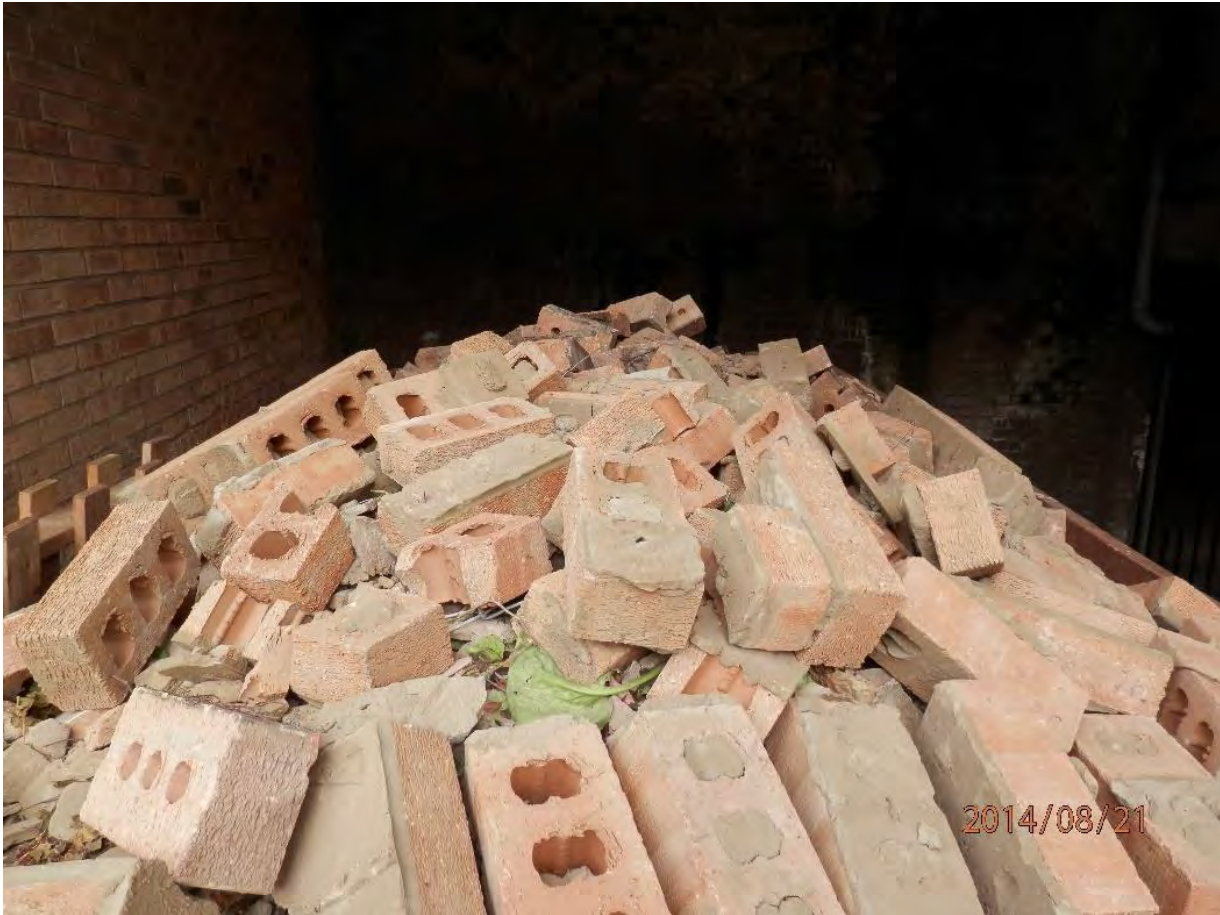
**Ditto: -Note the dislodged bed joints two courses below the removal beds suggesting lateral shear failure and separation of the bed joints.**

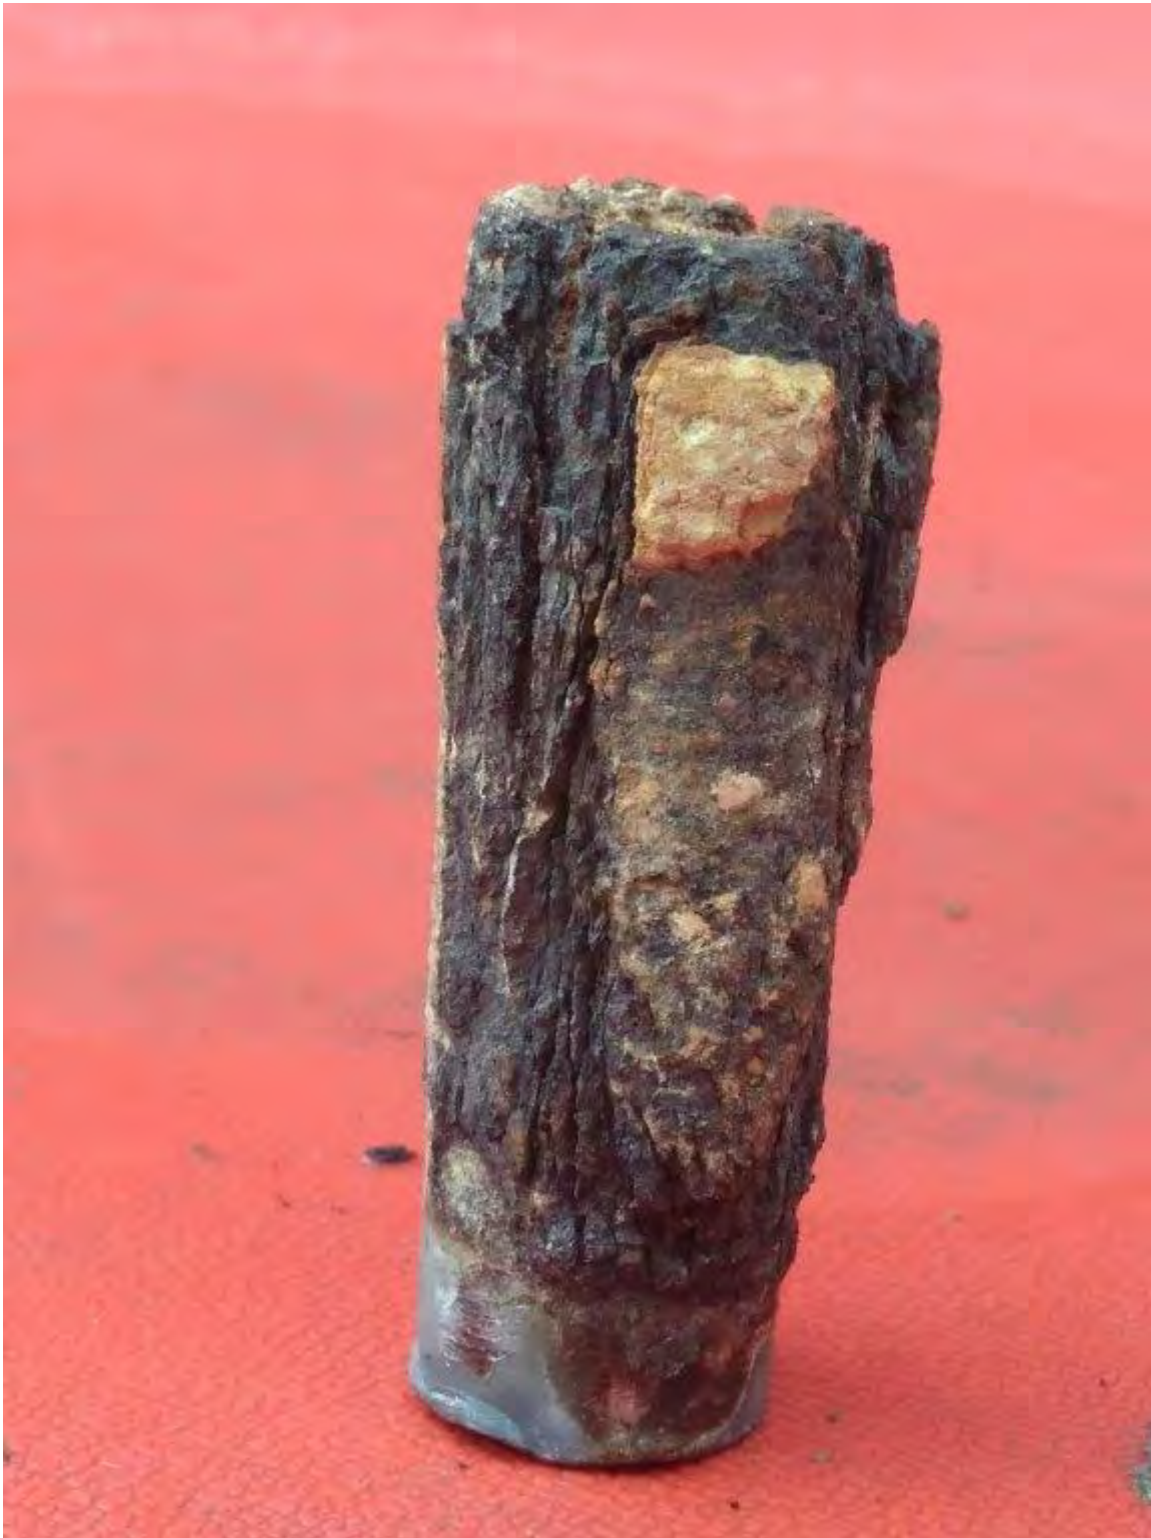
Typical example of a badly corroded fixing, presumably used to laterally restrain scaffolding, removed from high up on one of the buildings note the apparent increase in diameter bursting the brickwork. On no account should such ferrous / steel fixings be used on the building again nor any type that causes expansion of the brickwork causing splitting of the bed joints, the perpend and the bricks.

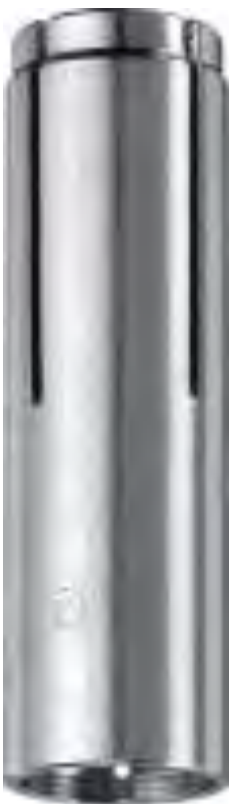
Typical example of a type of fixing, presumably used to laterally restrain scaffolding, removed from high up on one of the buildings note the apparent increase in diameter bursting the brickwork.

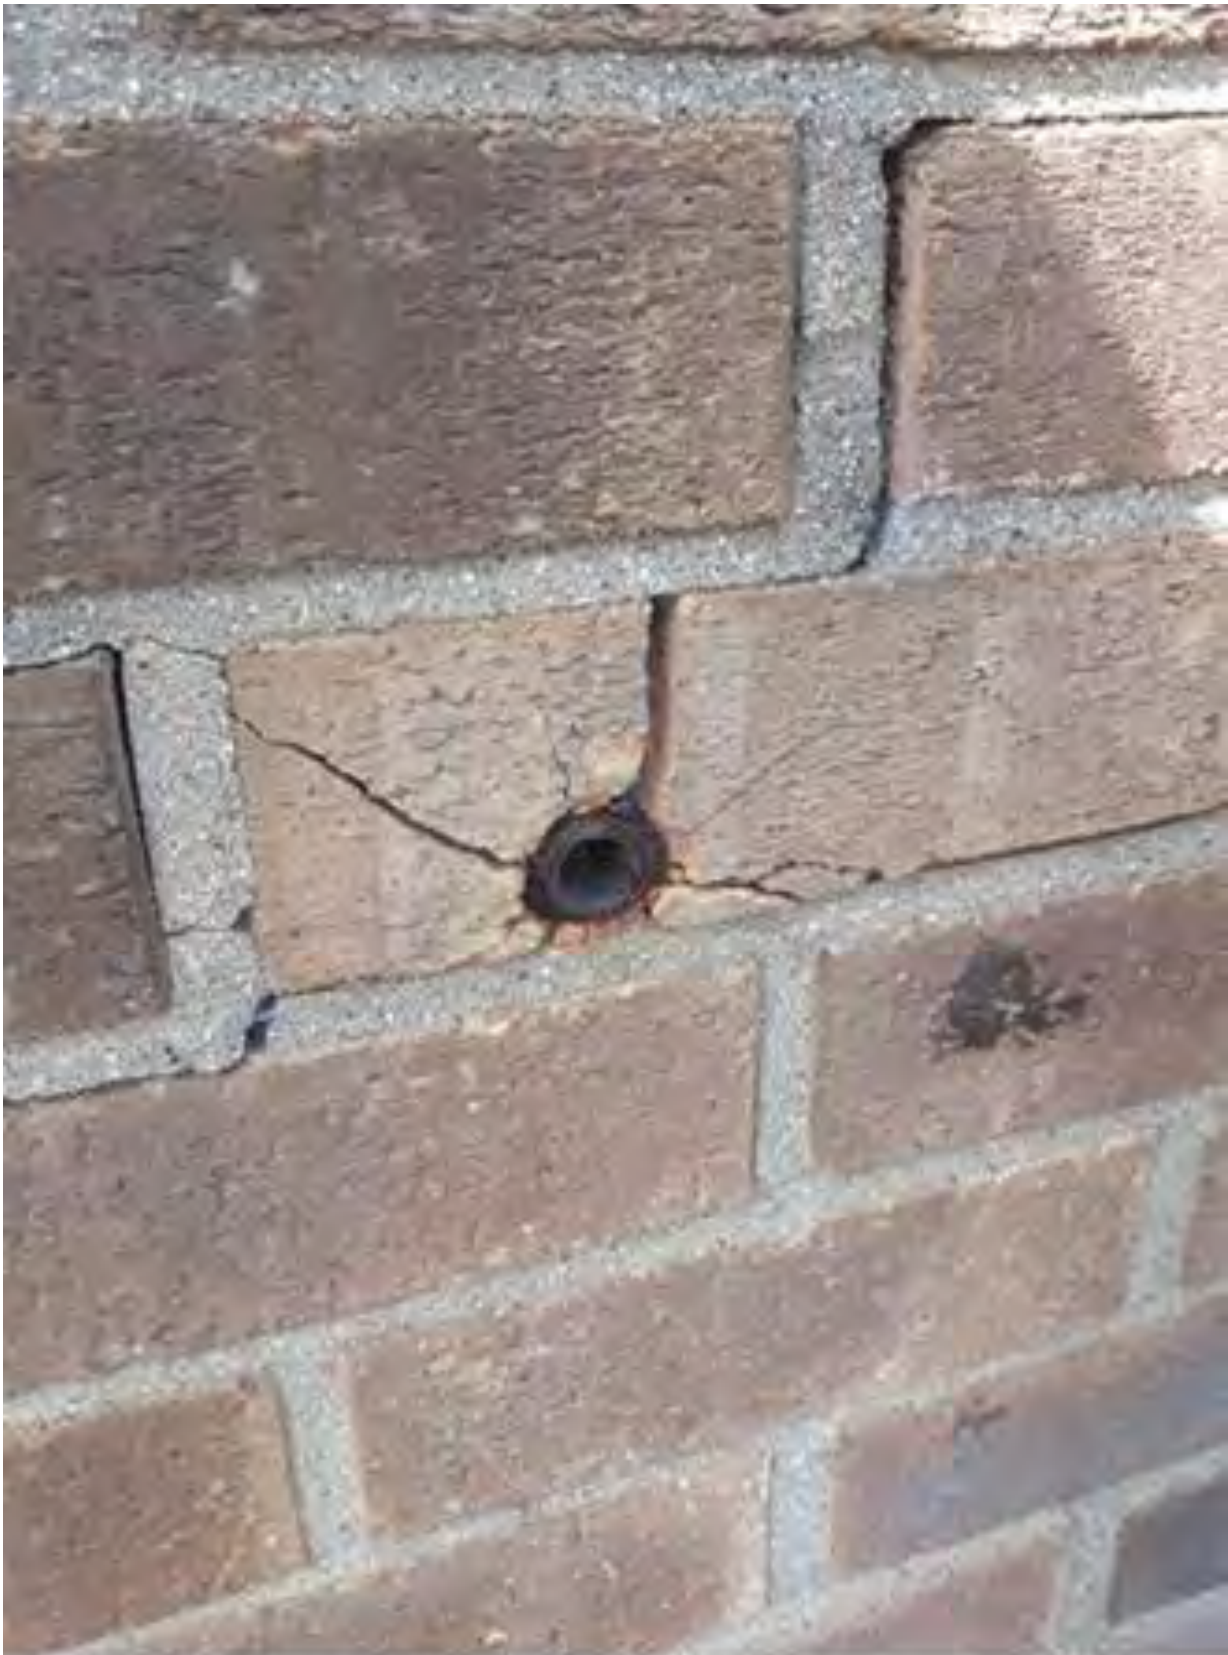
**Top of Princess Court Bin Chute Tower corroded old Scaffold Fixing bursting the brickwork at High level**
