**MLTS Limited,**  
*Structural Engineers,*  
55 Mill Road,  
Lode,  
Cambridge.,  
CB25 9EN  
Tel.: - 01223 812644  
Email: -mlts@btopenworld.com

Date: 28<sup>th</sup> February 2020

**Preliminary Report on the Apparent Cracking within the External Façade Brickwork, Concrete Façade Panels and Year 2 Urgent Remedial Works of Princess and Hanover Courts, Cambridge, CB2 1JJ and CB21 JH**

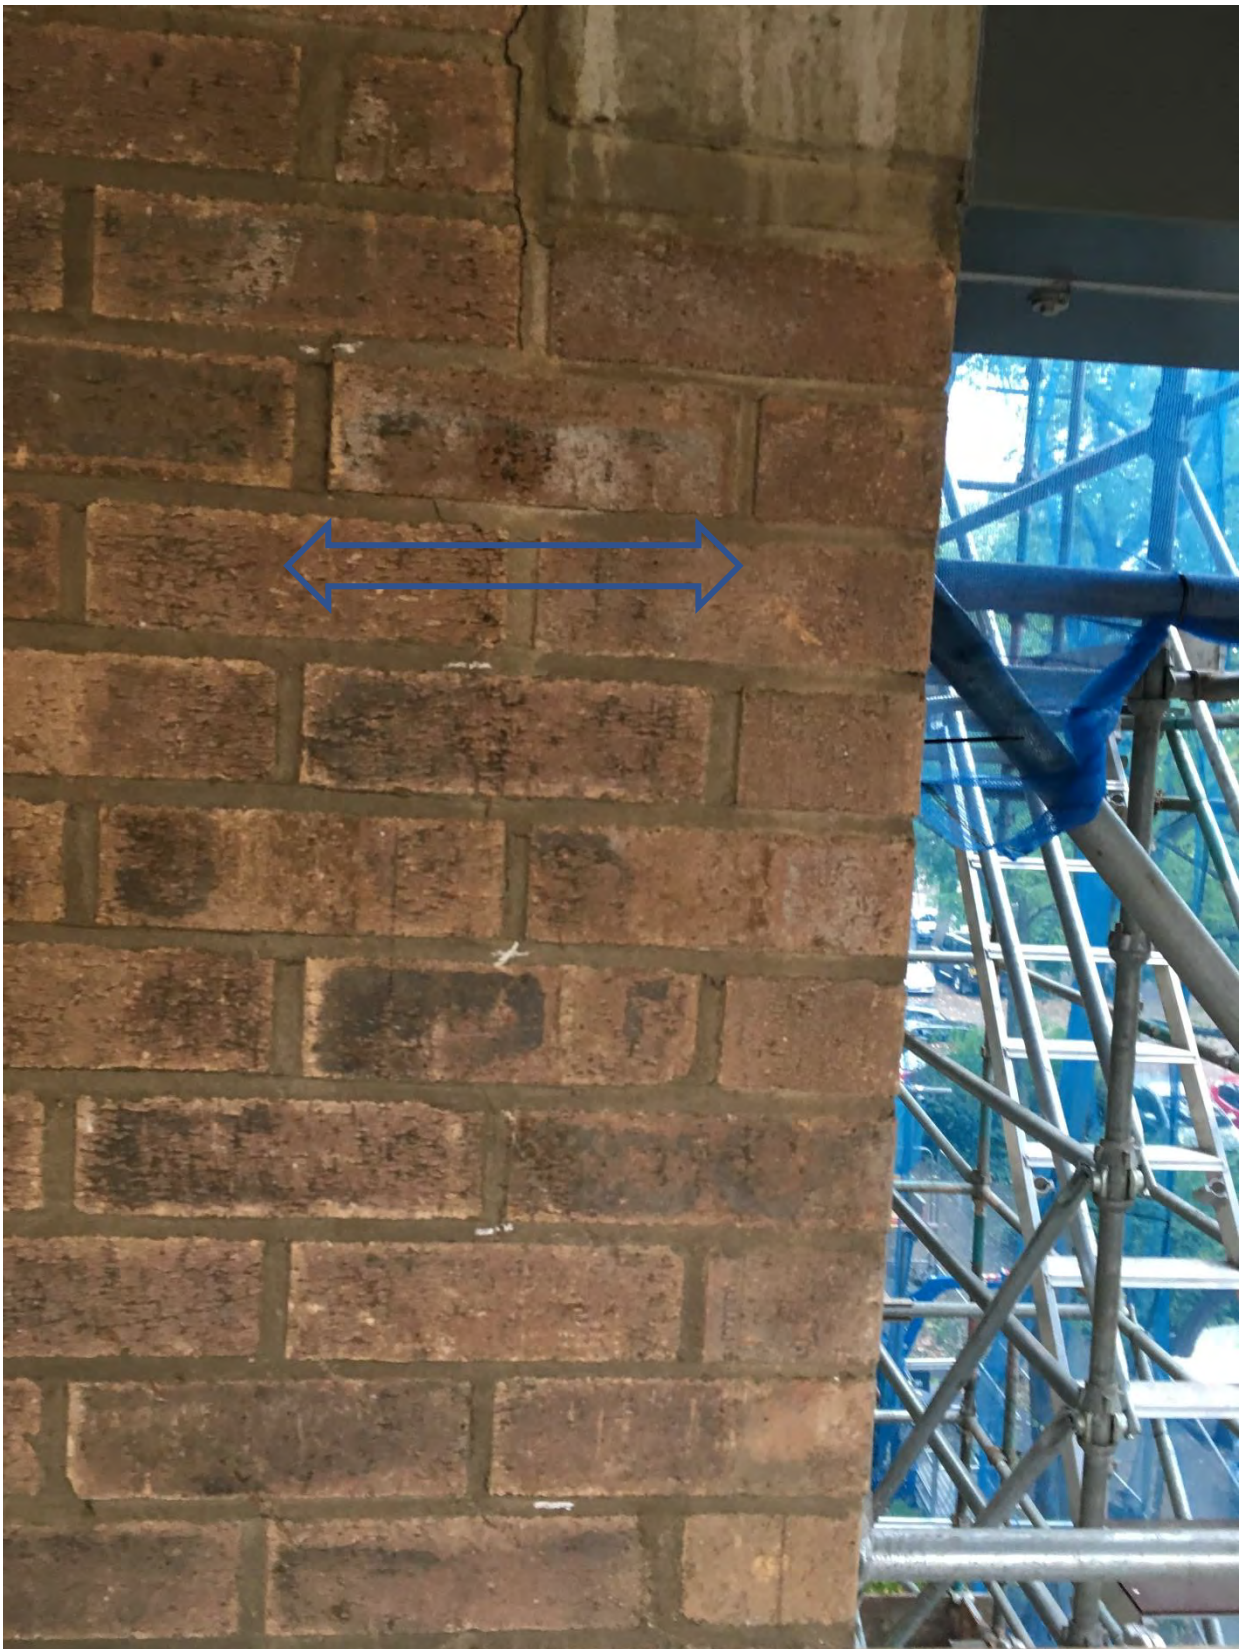
**Cracked Walkway Beam Bearing onto the Hanover Court Building – Note the tracing of the brickwork ties**

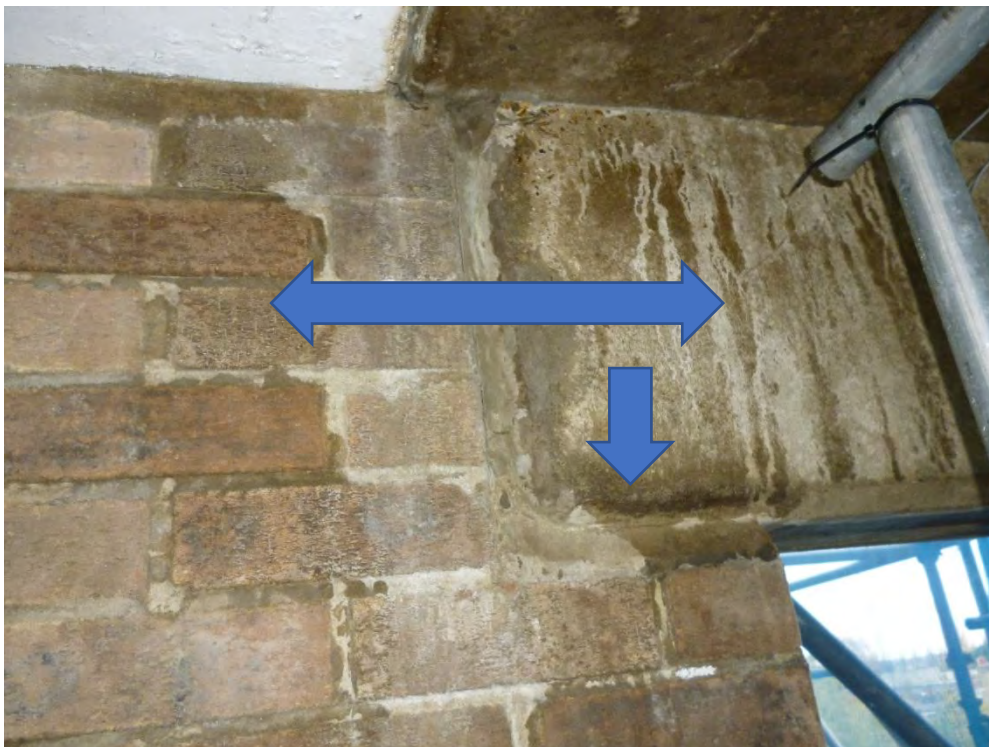
**Typical Bearing onto the brickwork in the Building note the forces pulling the walkways support beams in and out! Of the building due to sway caused by wind loading causing the cracking at the bearings.**

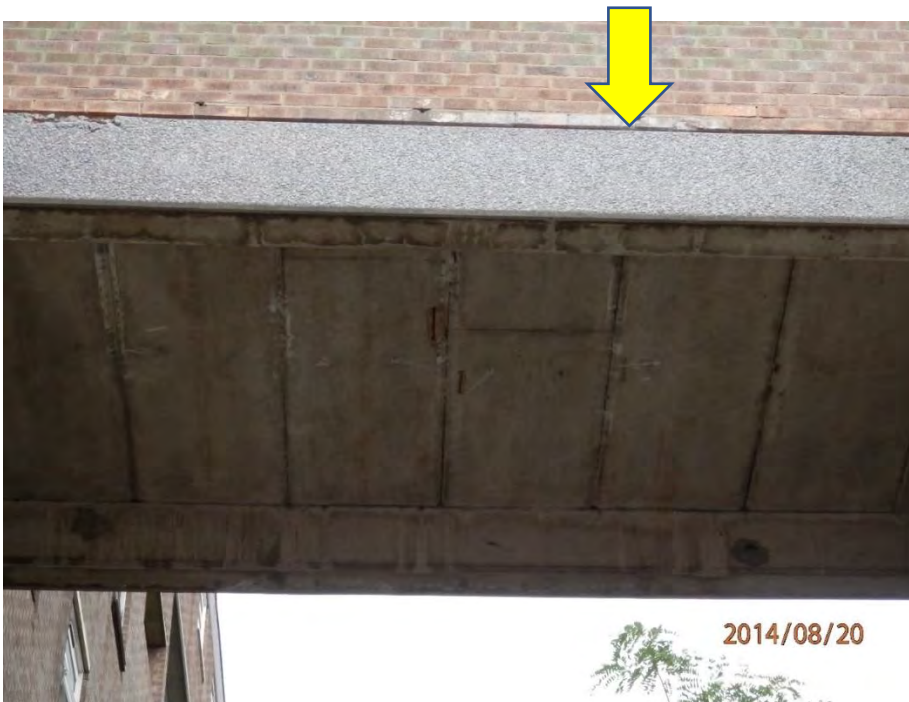
**Walkways support beams deterioration of the concrete beams and the bottom brickwork bed joints inadequately restraining these brickwork panels from overturning out of the building - prior to remedial works. Note defects to walkway flooring and walkway beam understood to be treated with SIKA 903 and 680c Anti-carbonation paint.**

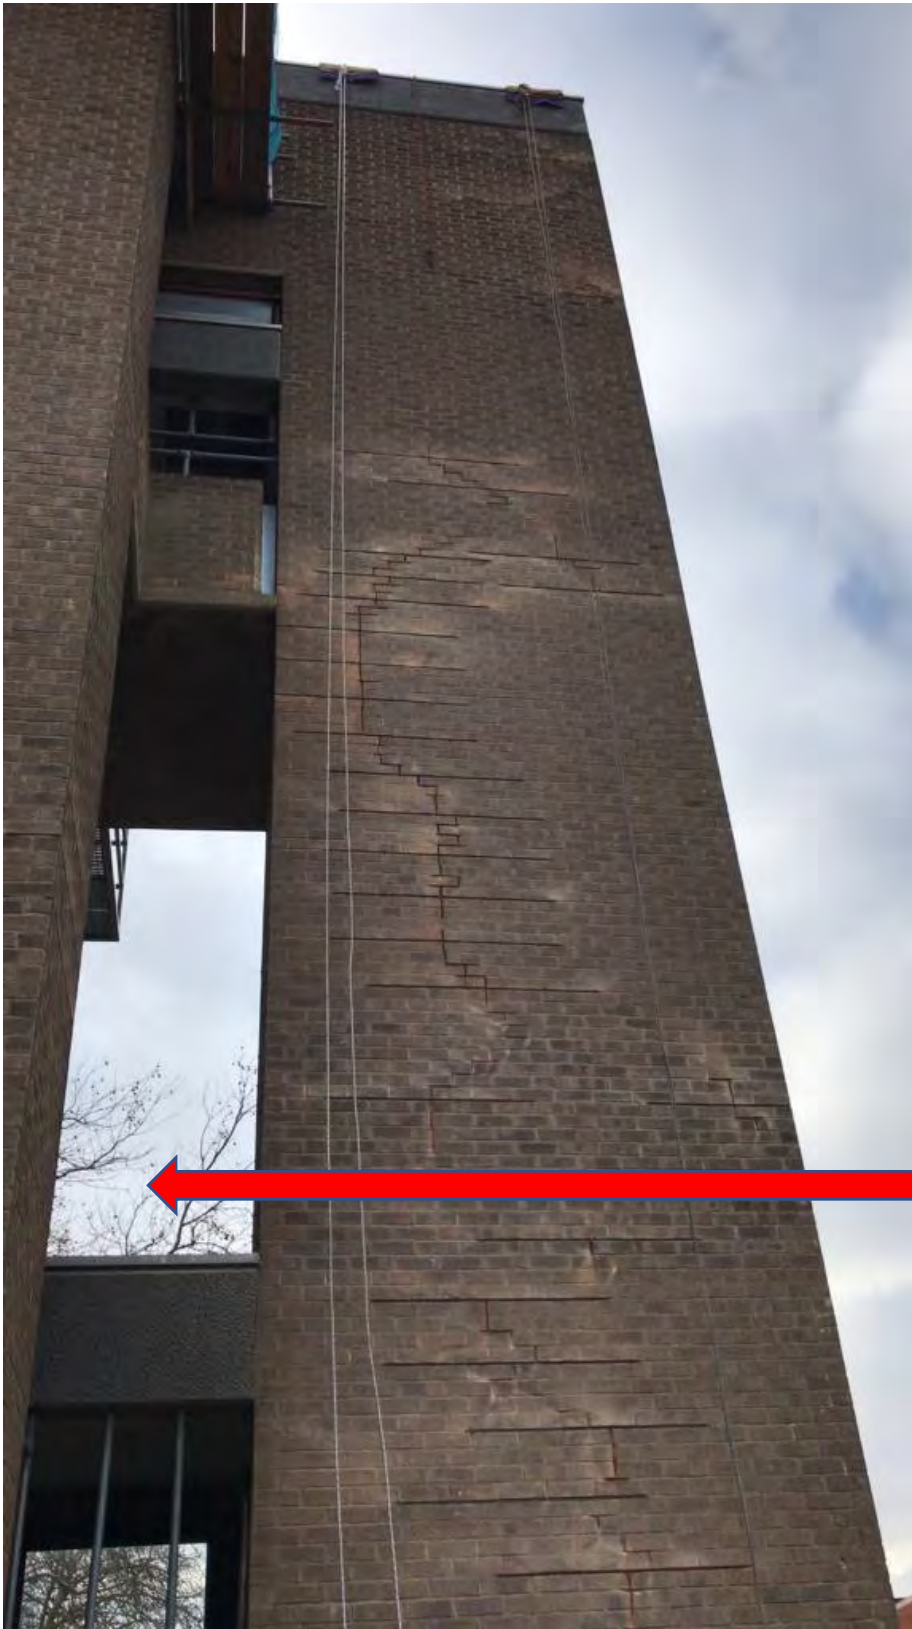
**Hanover lift shaft tower repairs chased out ready for helical bar reinforcements showing the nature of the cracking presumably caused by the lift cage expanding during hot weather and binding in the gauge of the vertical rails within the tower itself causing bursting forces. Possibly exacerbated by wind loading. Note the lift rails will wear more towards the bottom of the lift than the top as the car always returns to the ground floor no matter what floor the lift serves as required by the user. If the cracking does not abate then consideration should be given to binding the tower all around the tower with reinforcement at for example every fourth bed courses to contain the bursting forces.**
