**MLTS Limited,**

*Structural Engineers,*

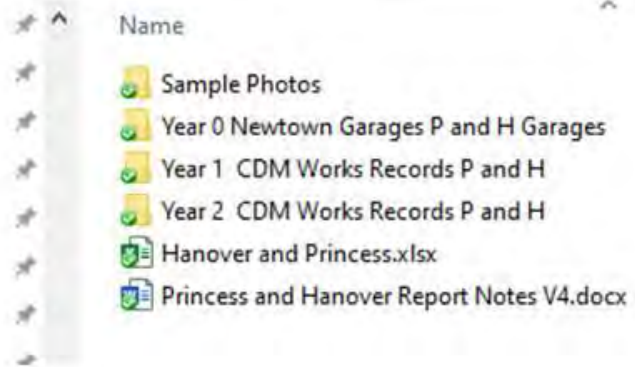
**Documents Folder for Year 1 Documents and Urgent Repairs Report.**

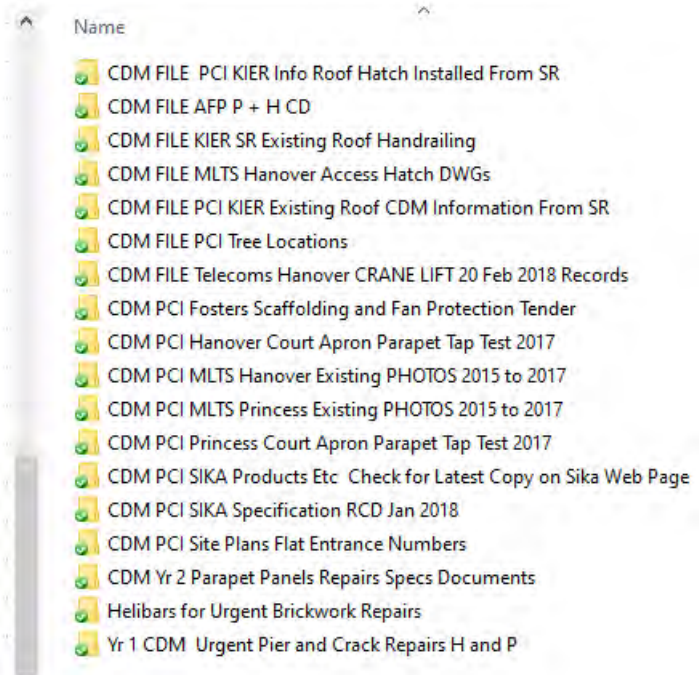
**Year 2 MLTS Ltd Record Drawings see attached and MLTS 2019 Year 2 Folder and Fosters Records Folder below and in the Dropbox link shown in blue text.**

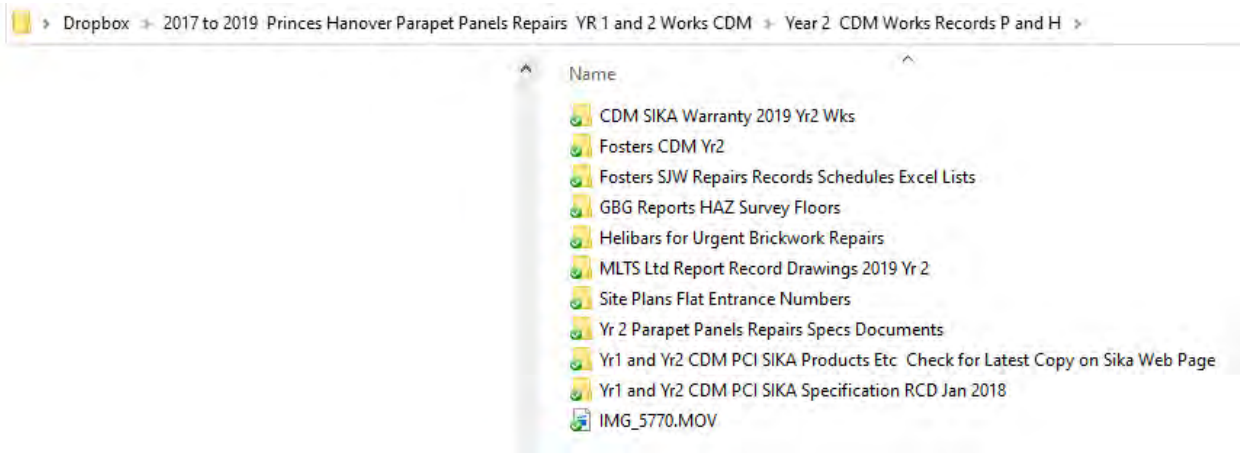
## Introduction and Scope of Our Brief:-

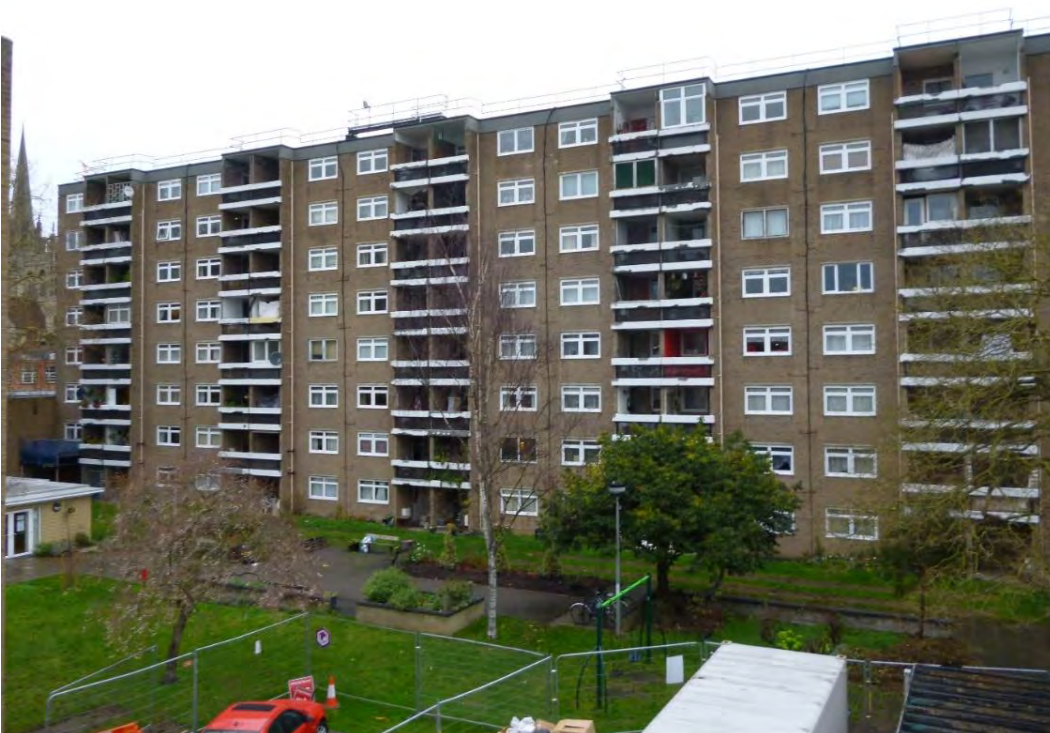
**Hanover Court Western Elevation:** - Note the grey Sika 903 and Sika 610 temporary blinded areas on the concrete balcony panels. See SJW Photographs and lists of the defects and locations and MLTS Ltd Drawings for overall view of these records.

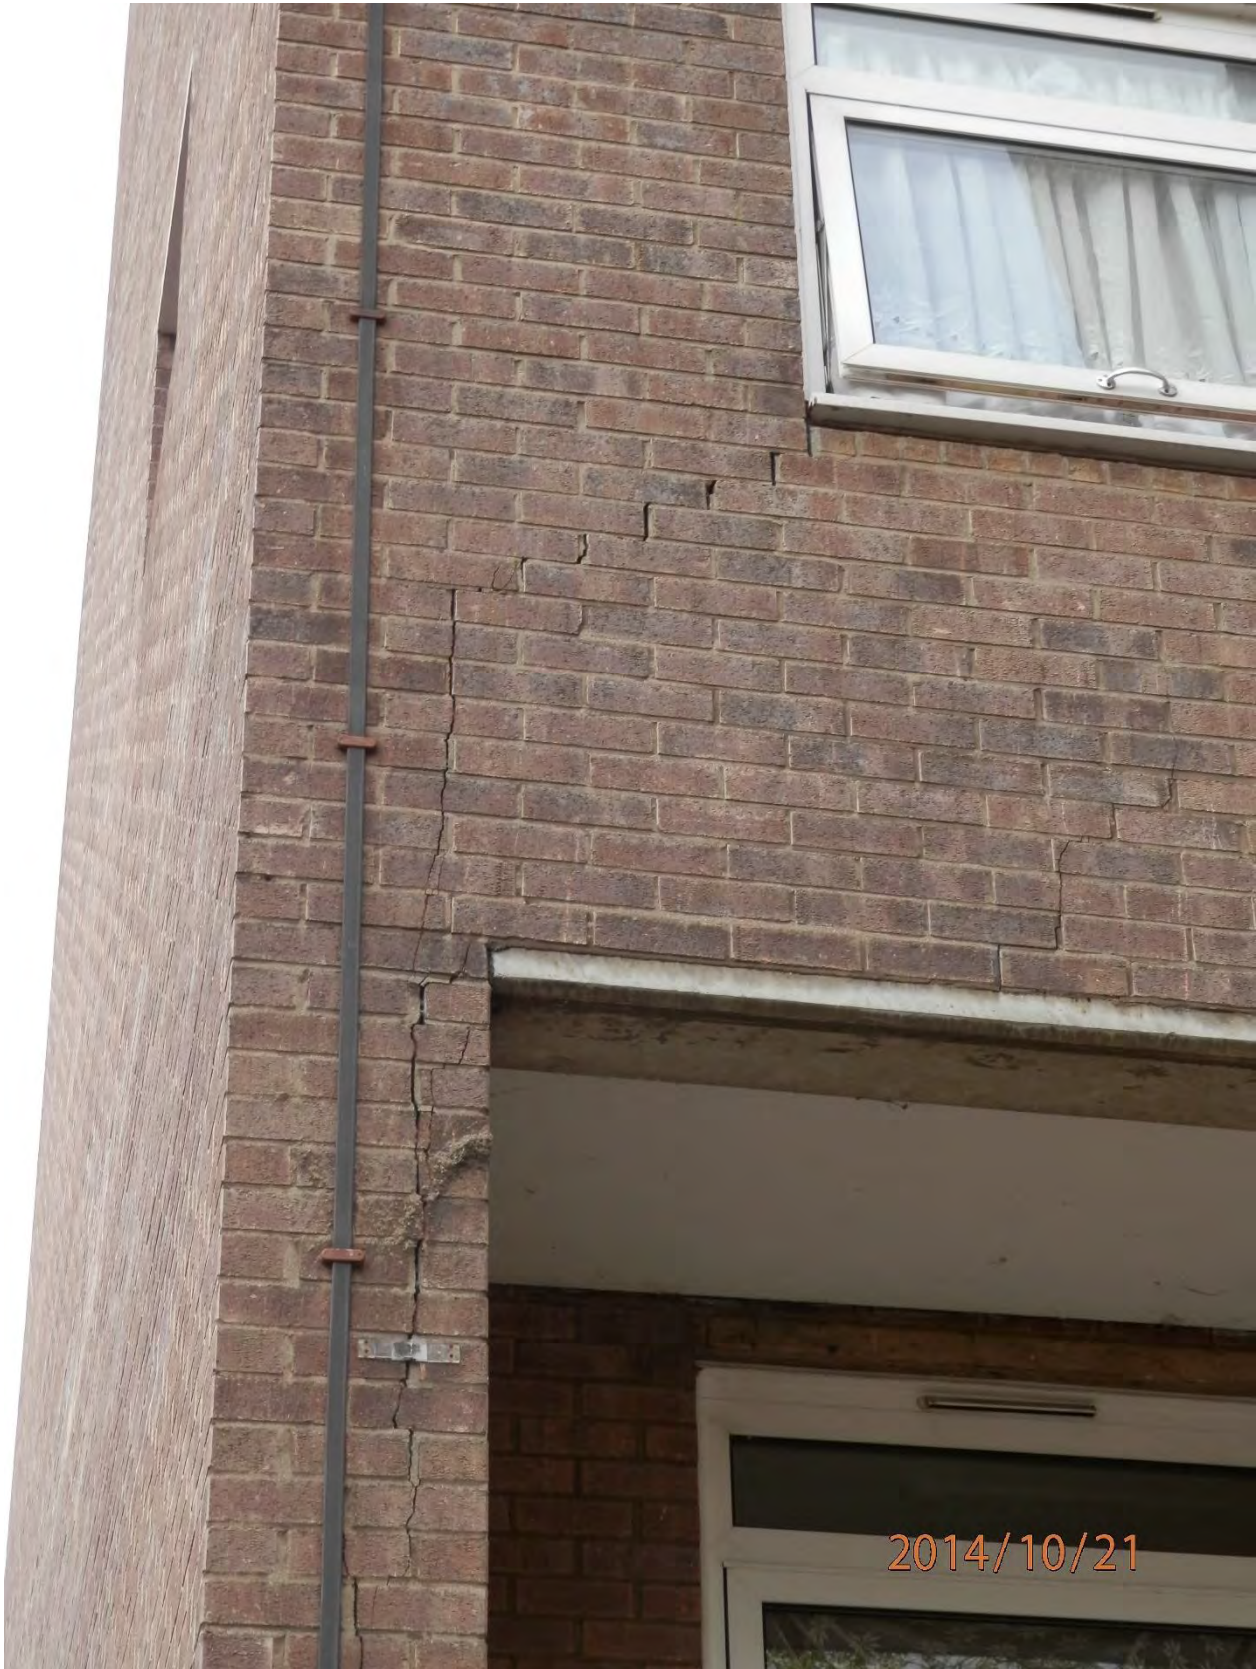
**Year 1 and 2 Emergency Repairs due to wind loading acting with dead and live loading**

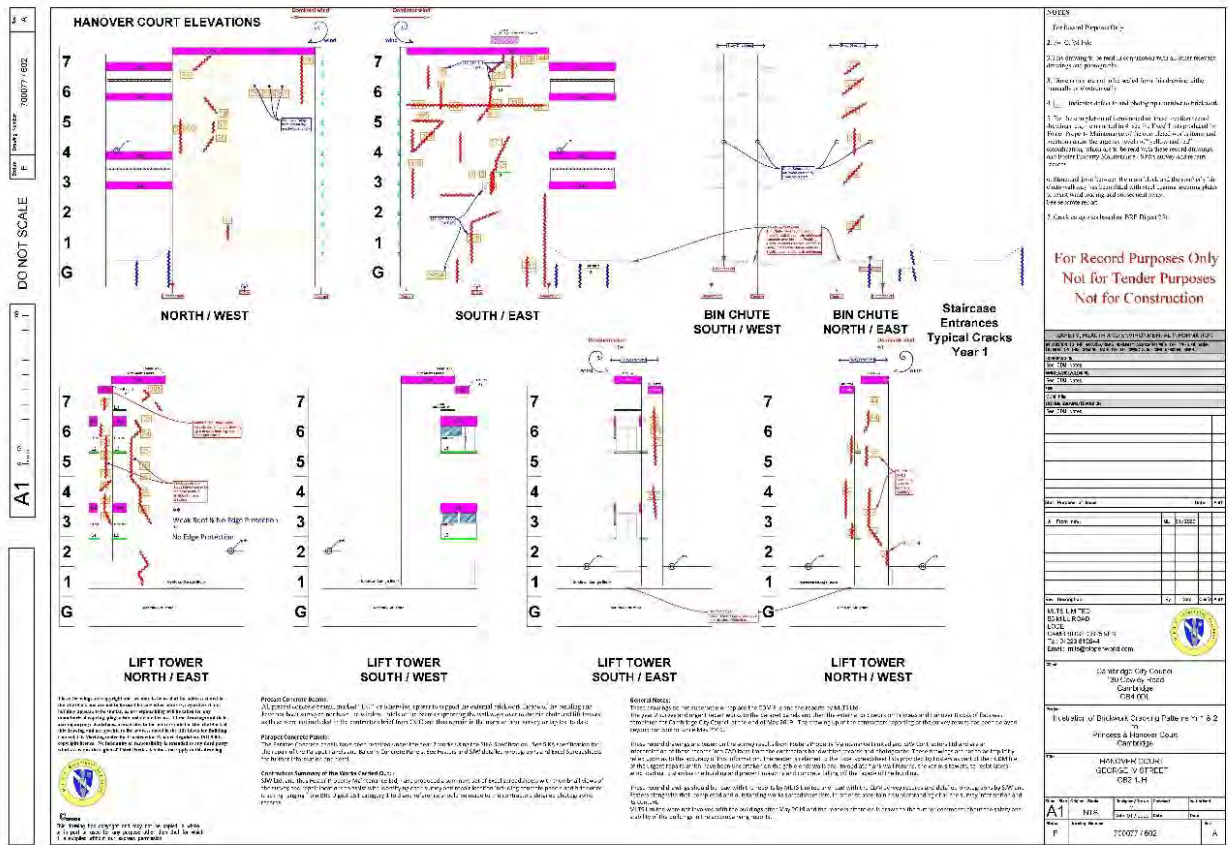
# See Crack pattern drawings by MLTS Ltd 600 Series Drawings

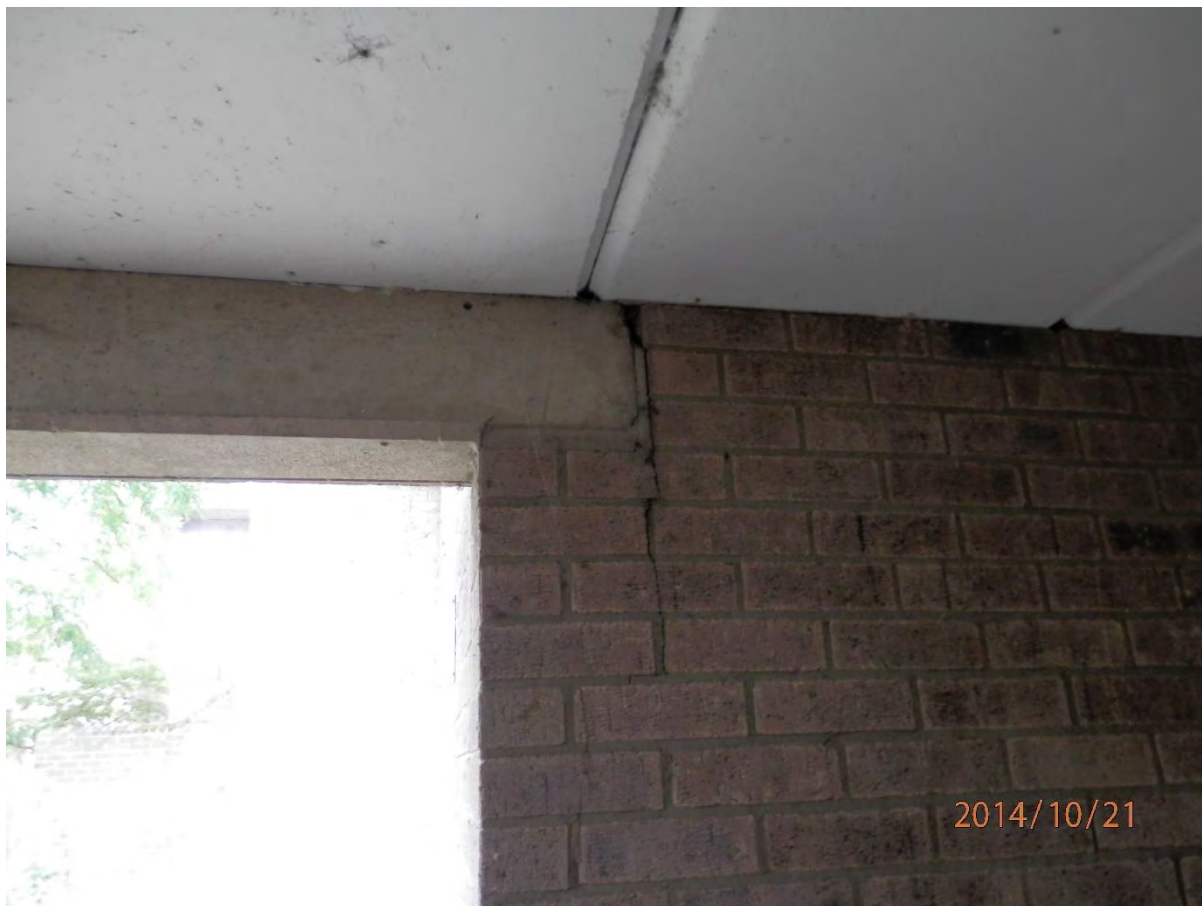
**Eastern Side of Hanover Court Typical Entrance Structure Cracking: Internal View - Repaired in Year 1 Urgent Works**

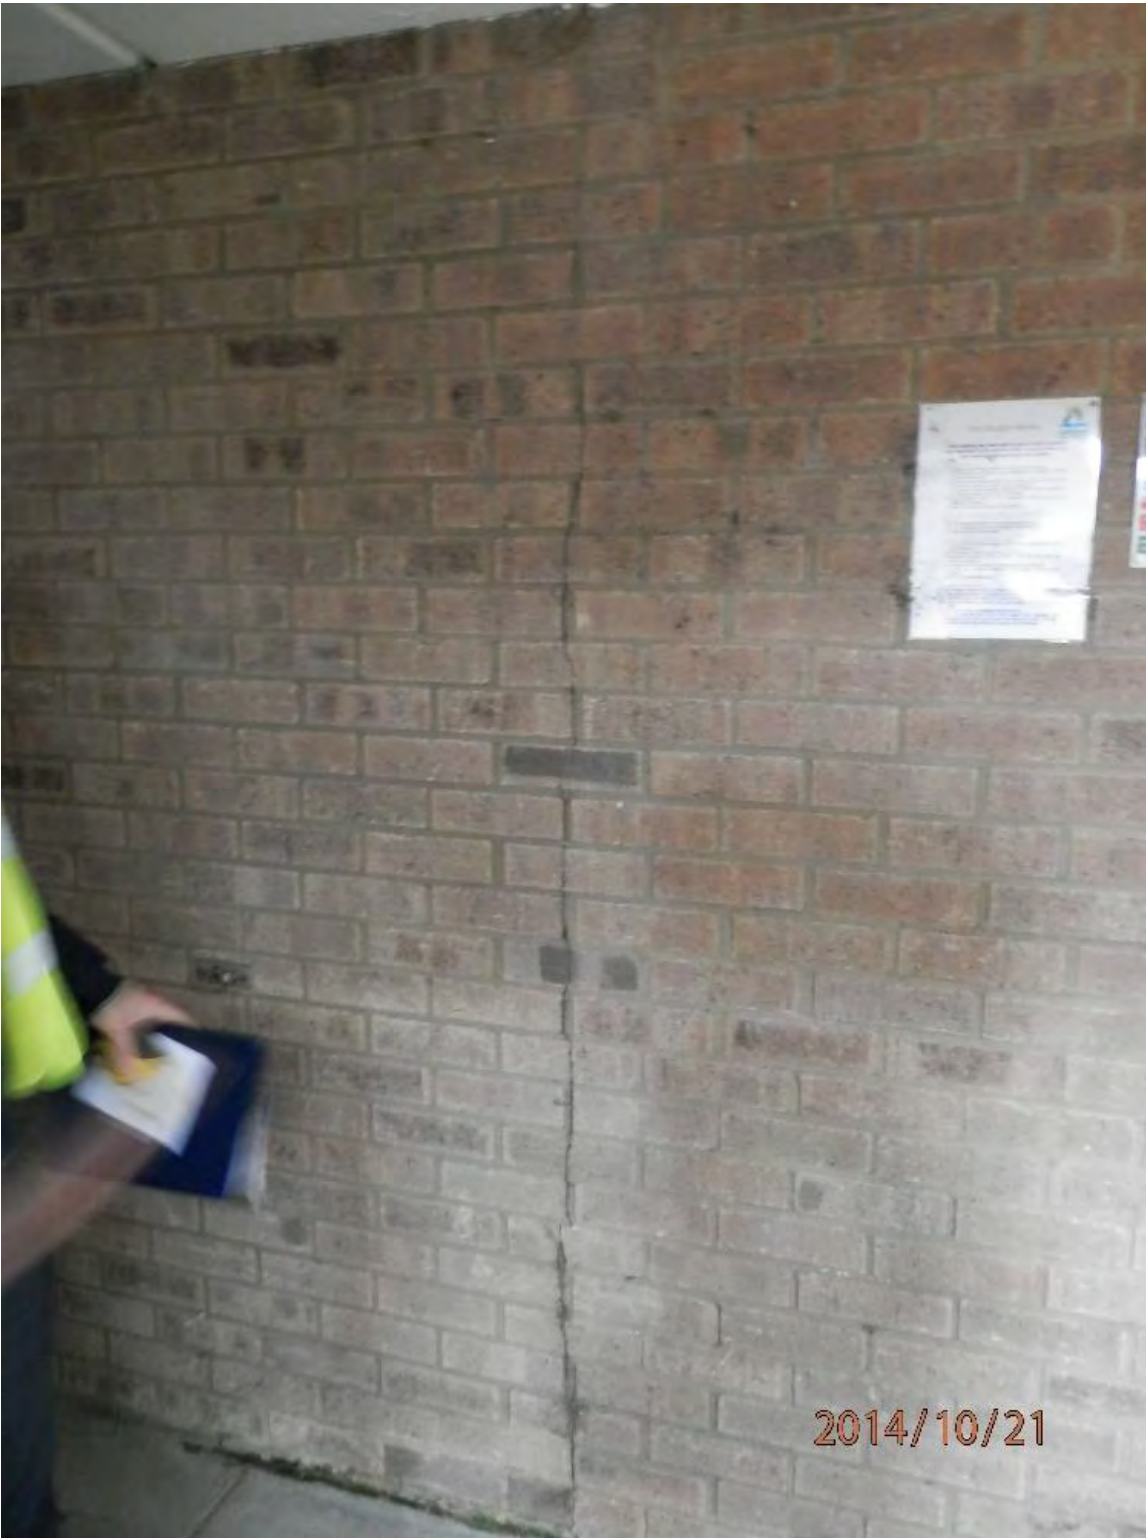
**Eastern Staircase of Hanover Court Typical Entrance Structure - Cracking Internal Northern Side:  
Repaired in Year 1 Urgent Works**

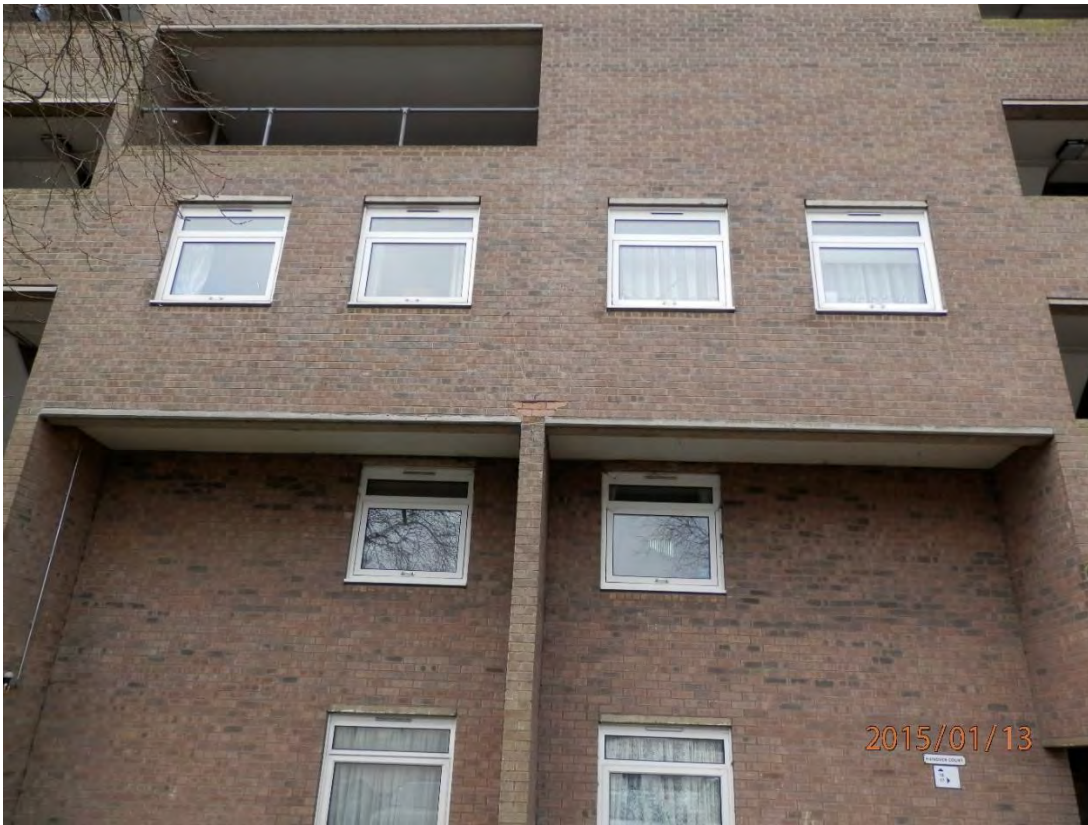
**Typical example of the Eastern Flank Wall Cracking due to vertical load overloading by the two heavily concrete lintels on both sides supporting the brickwork façade above probably exacerbated by additional vertical load due wind load on the western side and possibly exacerbated by frost attack.**

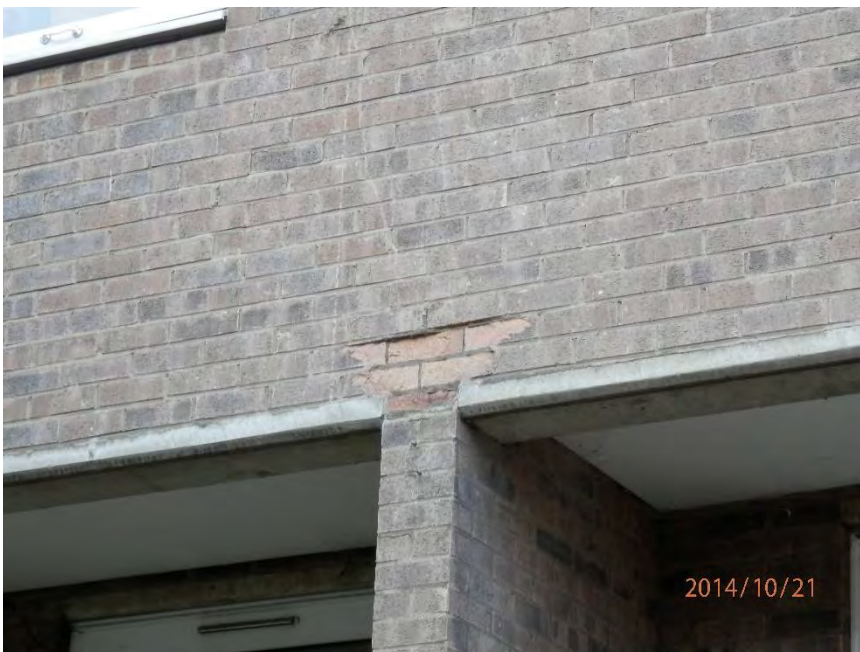
**Ditto a closer view. Repaired and Piers stiffened - Repaired in Year 1 Urgent Works**

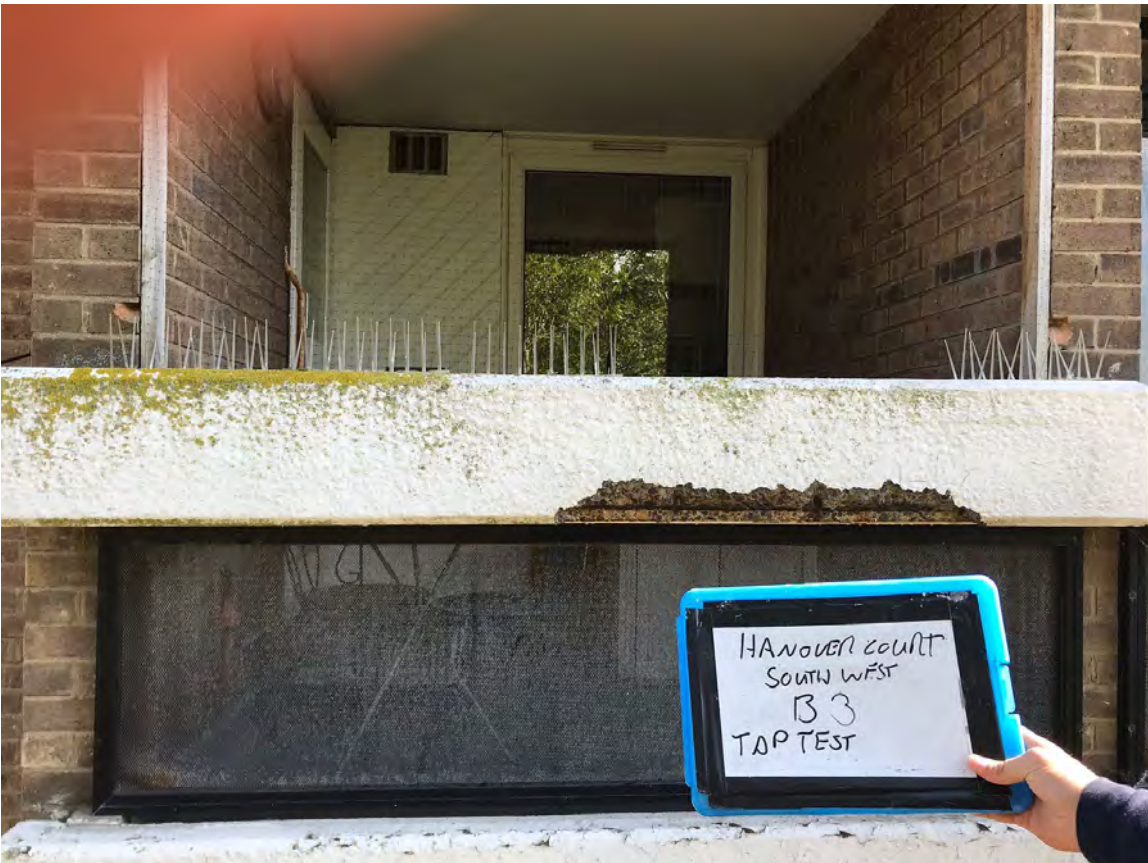
**Typical Site Record for each location** of any defect resulting in SJW / Fosters Spreadsheet

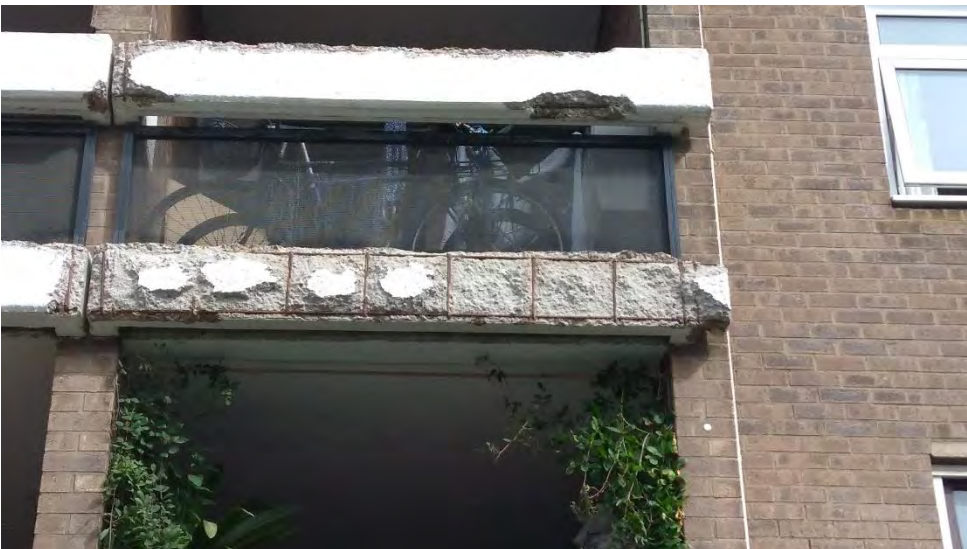
Also note the crack in the masonry party wall on the western side due to the loading including wind loading compression load due to wind acting on the eastern side of the building.

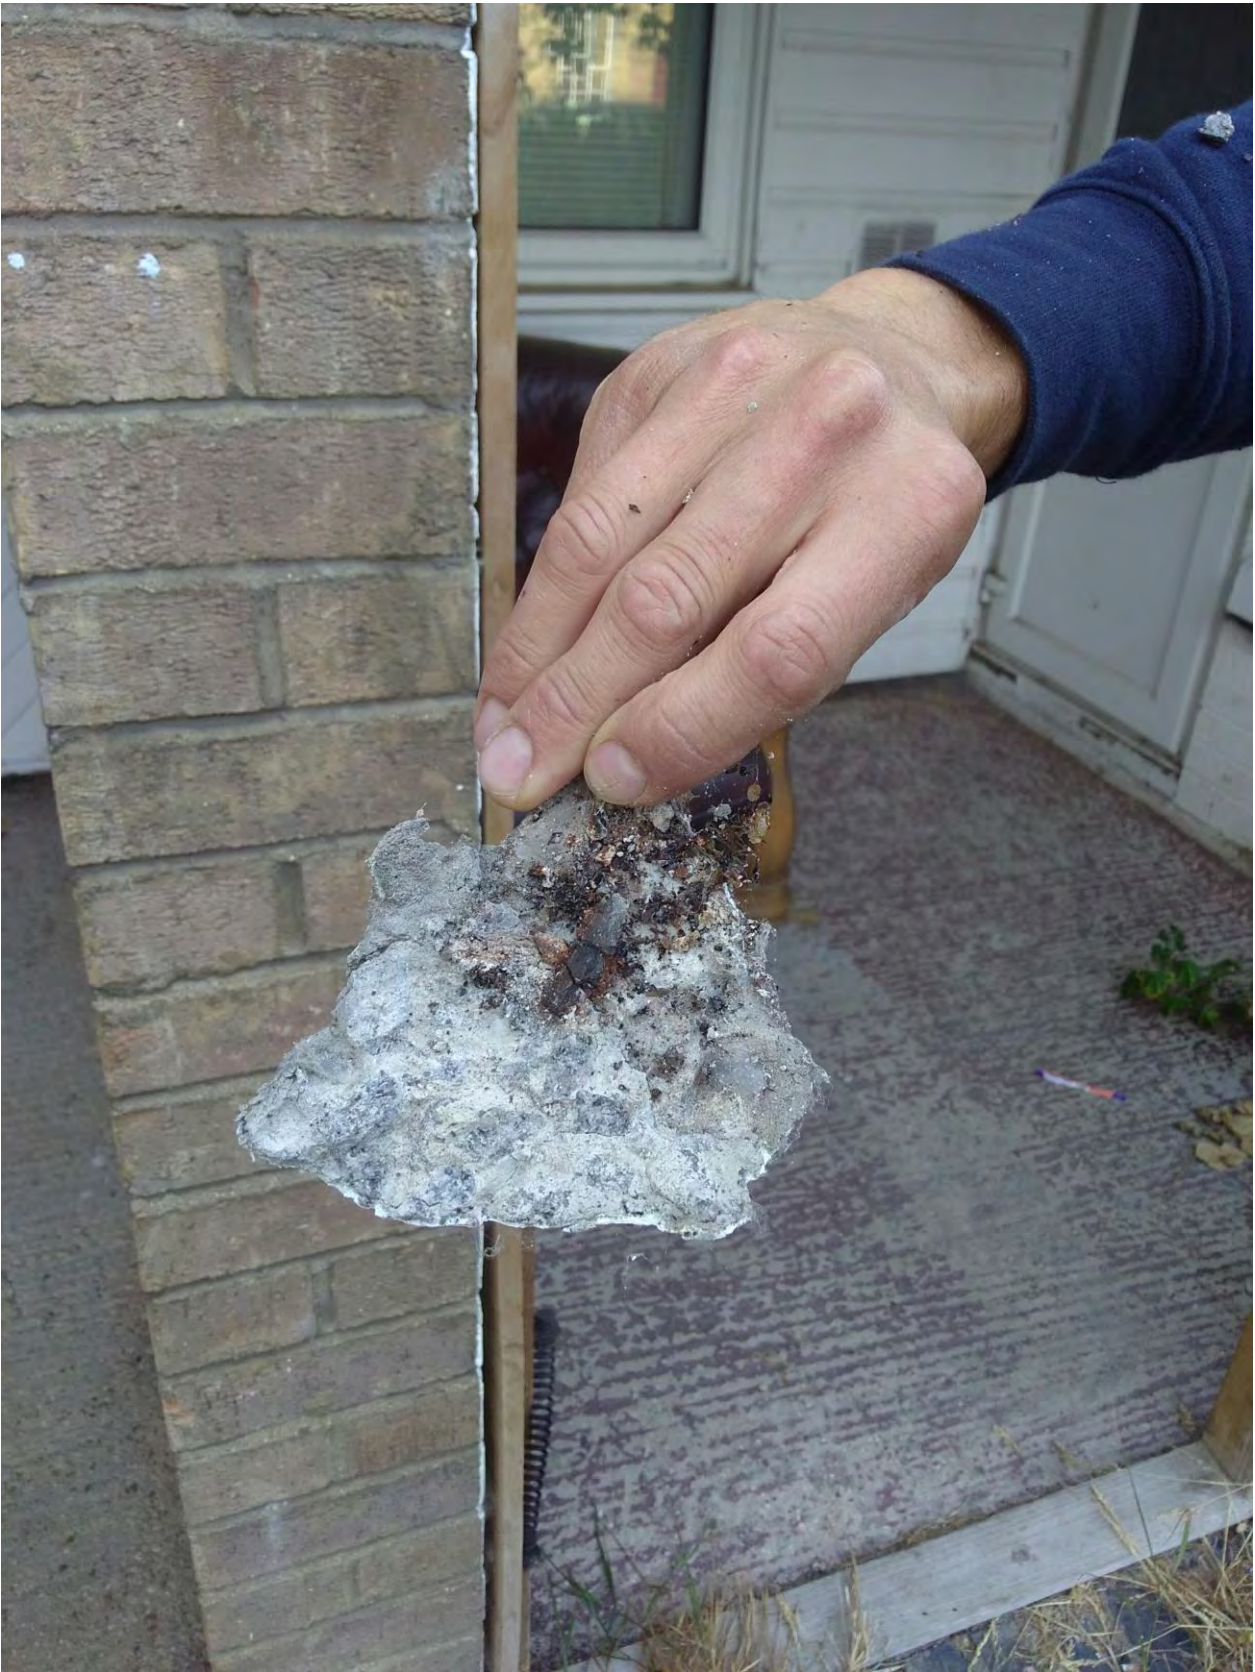
**Typical loose Balcony panel corner Removed Easily by Hand.**

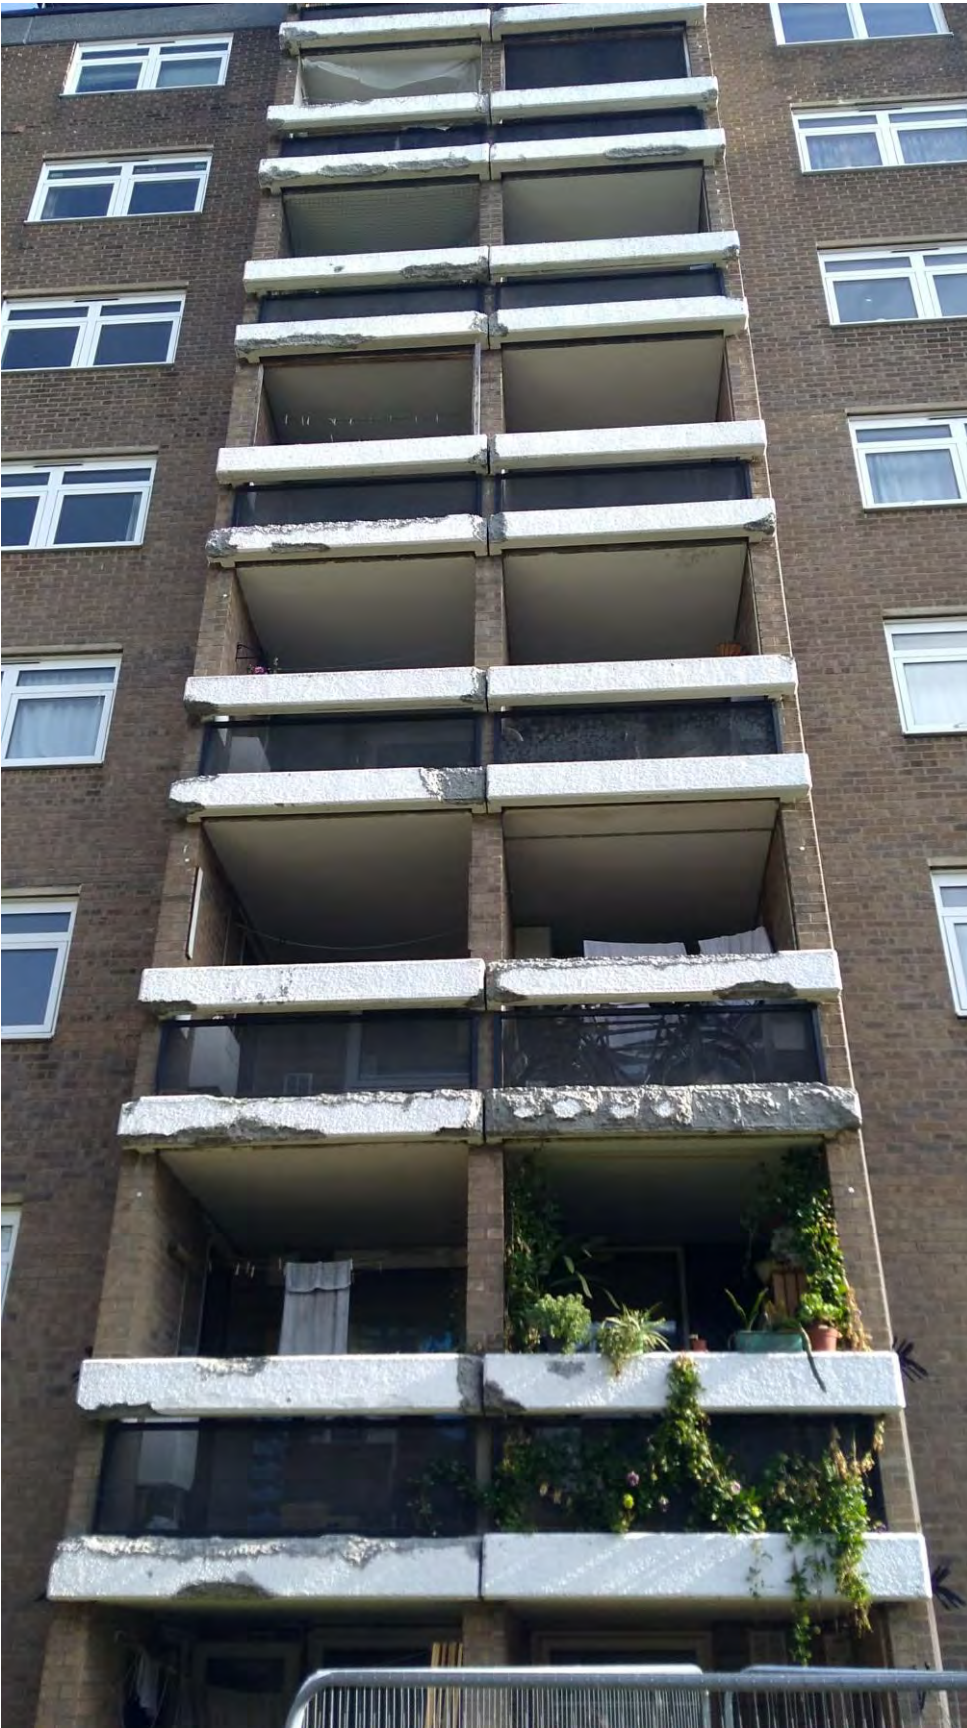
**Hanover Court Tap Tested and Primed Panels with SIKA 903 and SIKA 610 Locally – Typical Example**

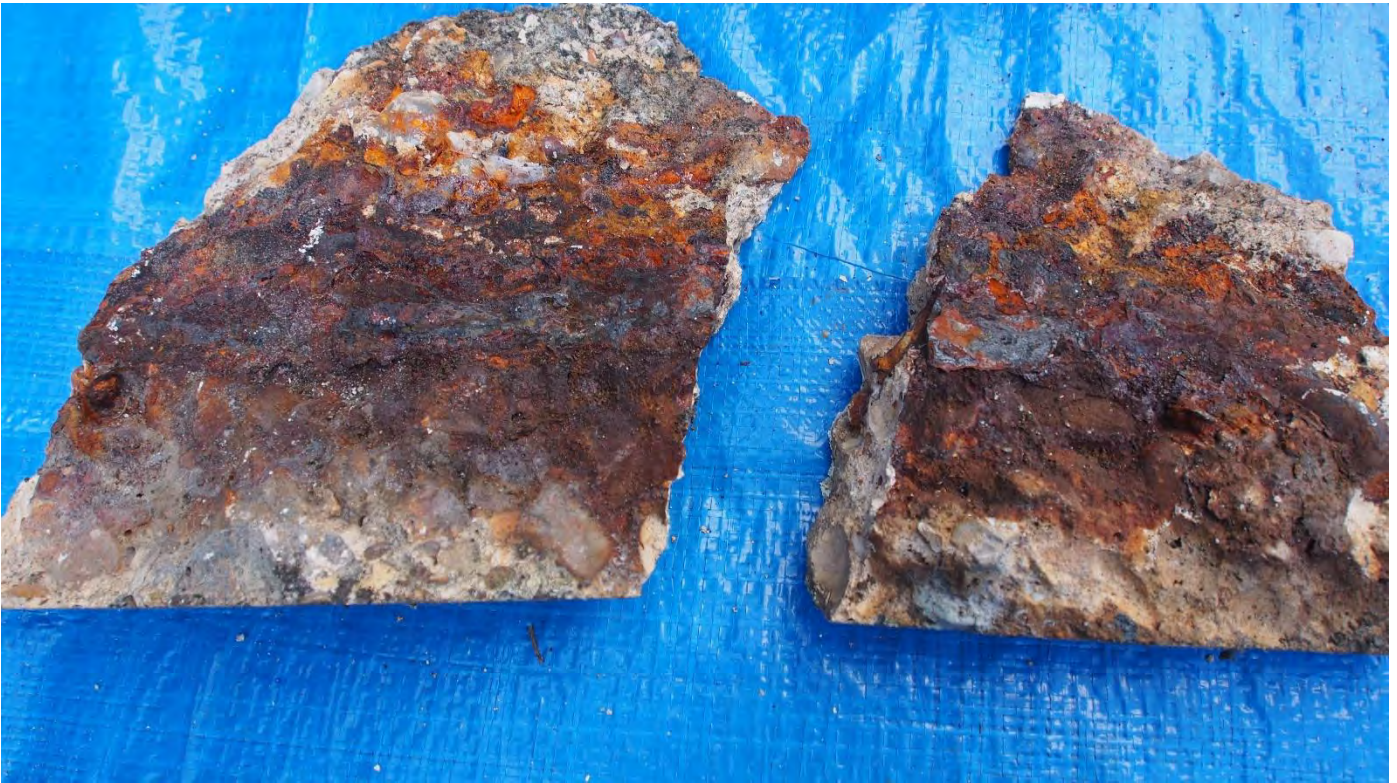
**Typical Removed Section of Balcony Panel Bottom Drip Detail found loose and painted over  
Loosened due to steel bar corrosion**

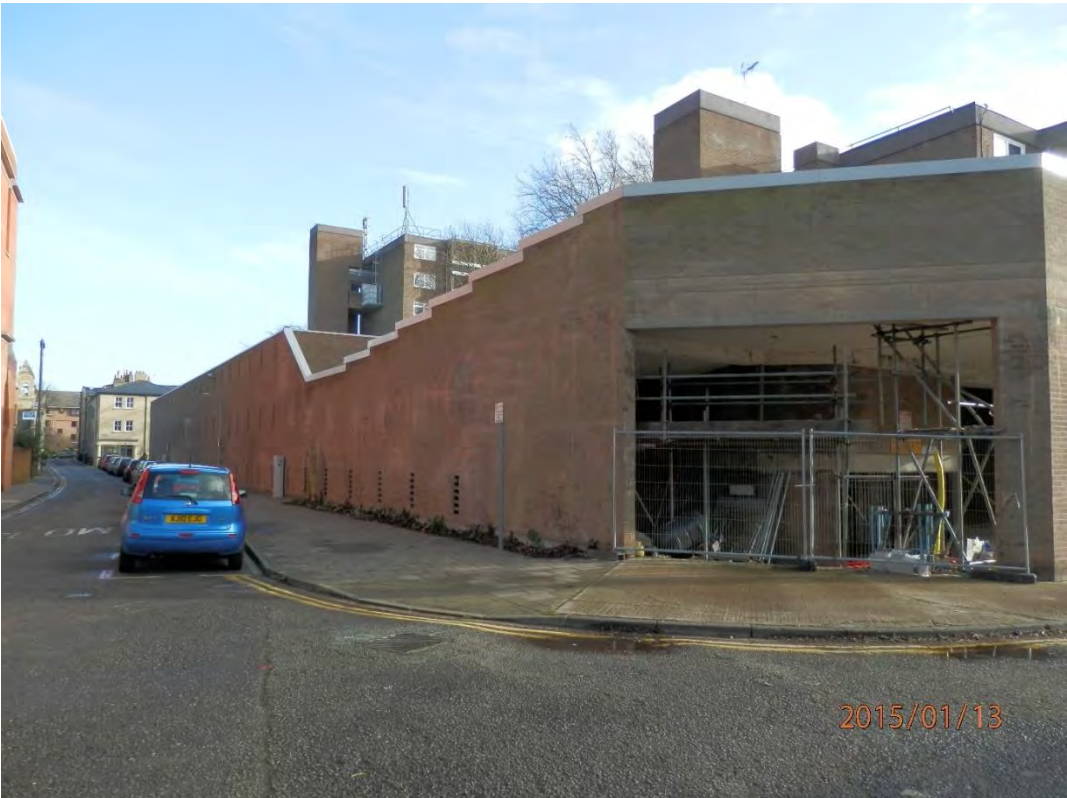
**External View - after the Year 0 Remedial works and the reduced and tied back external wall located aside the car access ramp.**

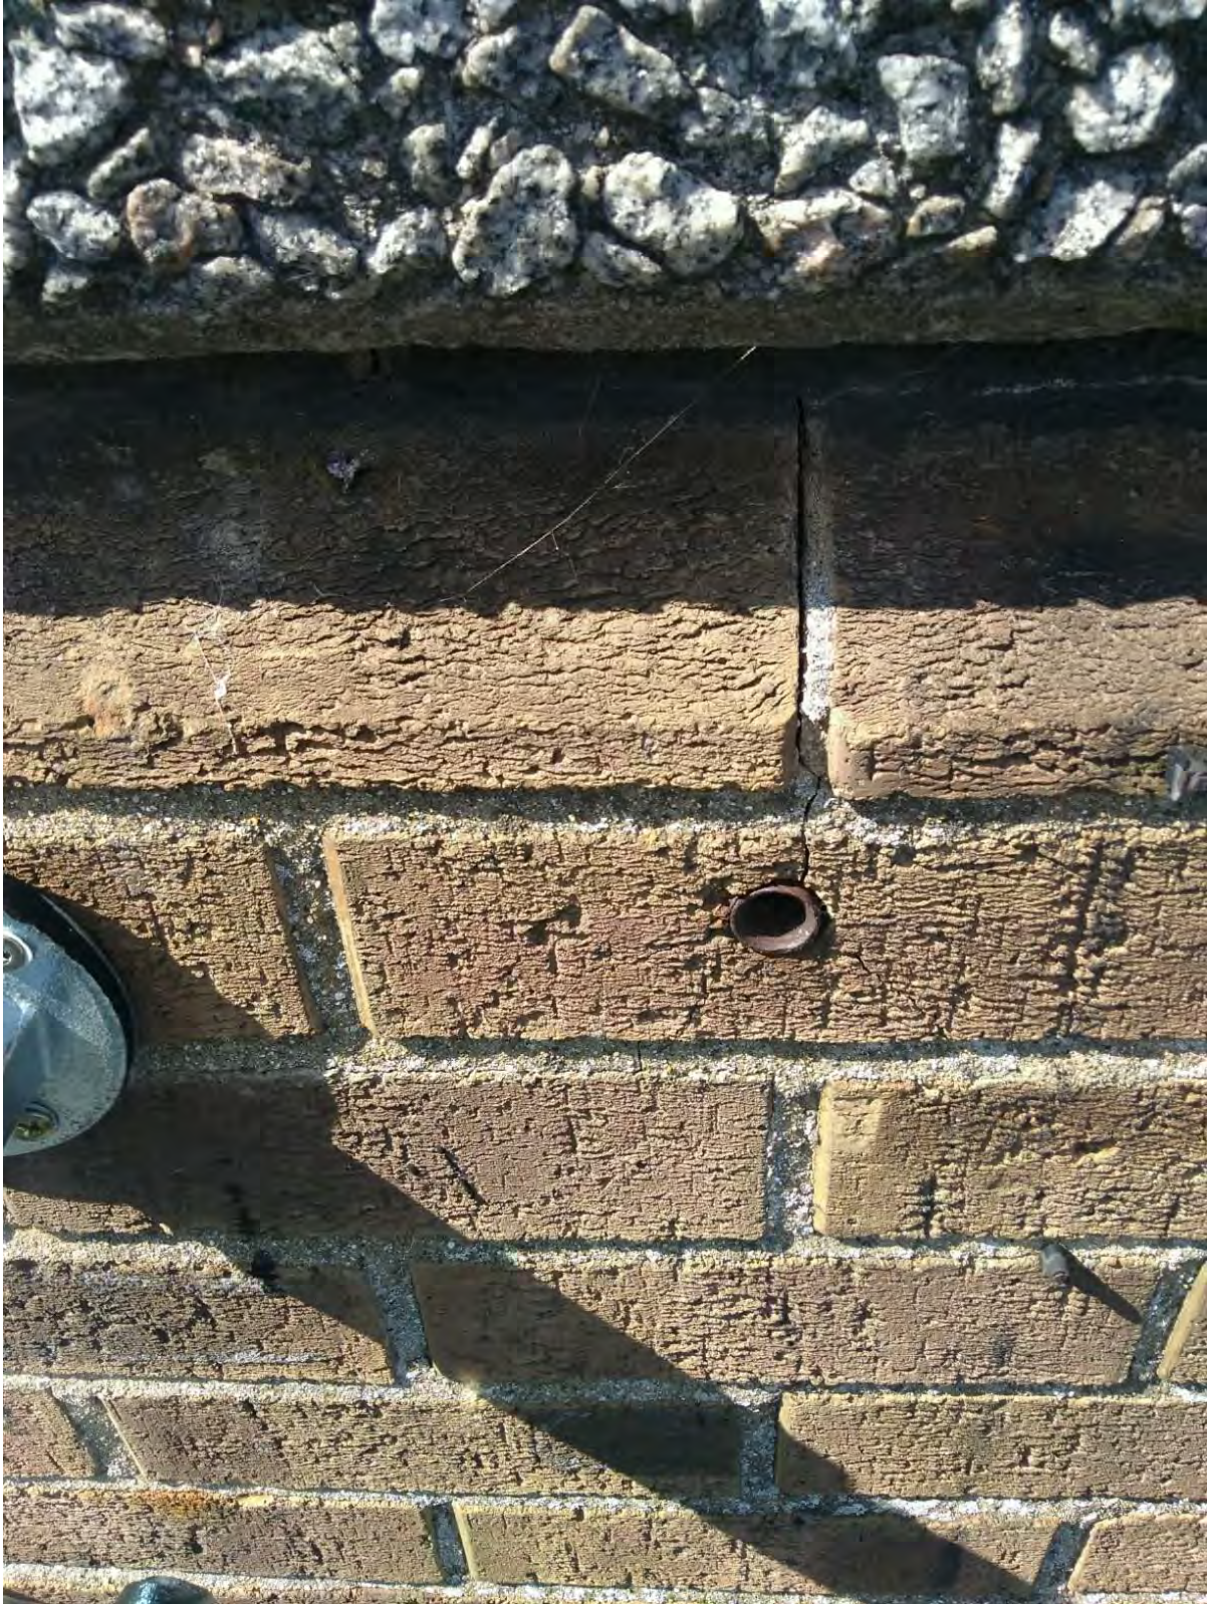
Typical Examples of Old Fixings left Rusting and Expanding within the Masonry Façade of the Buildings

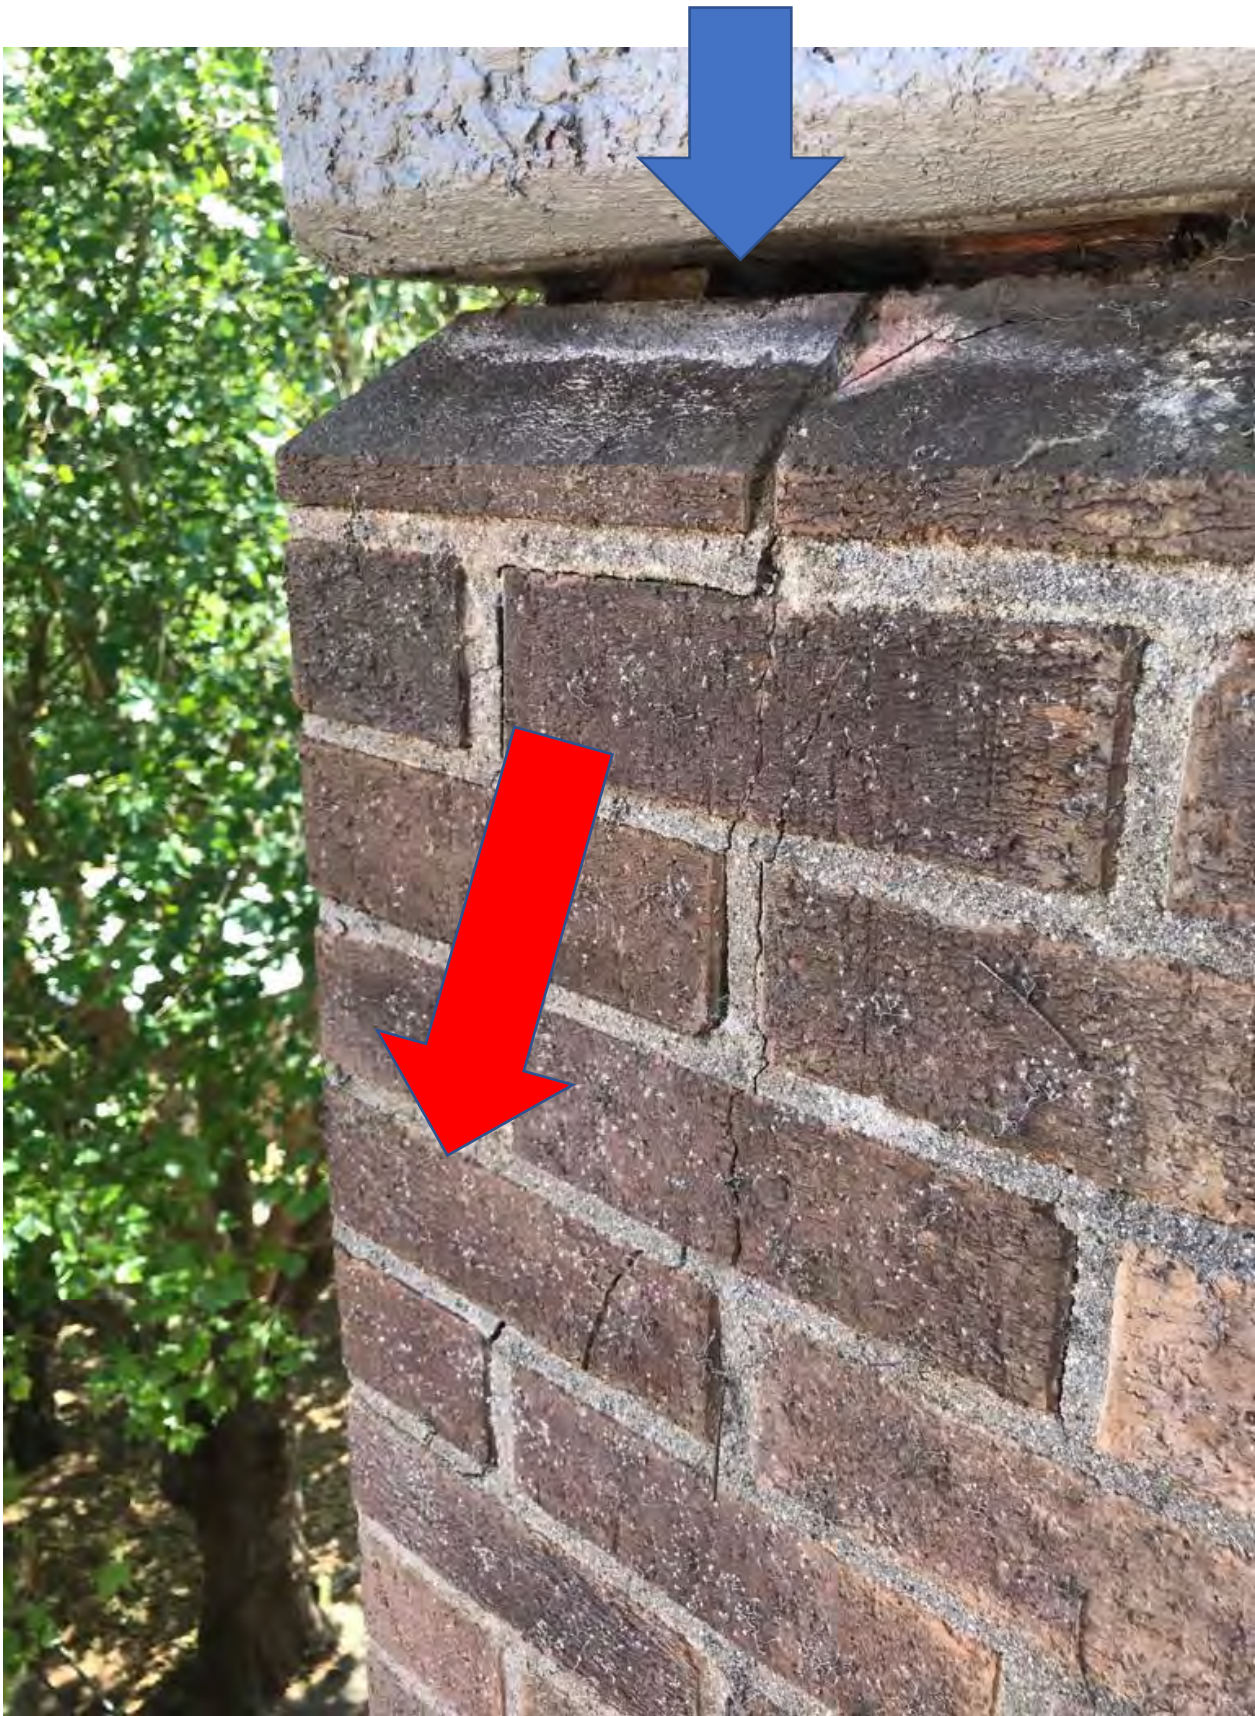
**Typical example of the brickwork splitting under the weight of the parapet panels and thermal / moisture movements at the corners** - located at the corner over a communal stairwell. Note the typical failure through the beds and perpends and the bricks under the weight of the concrete panel above exacerbated over years of cyclic freezing and thawing and thermal stress pushing out the brickwork locally at the corners. Helical Repair required at every fourth course to the brickwork back into the building – Note the height this is occurring at the very top of the buildings. Note the stress under the parapet panel Shims see Blue Arrow

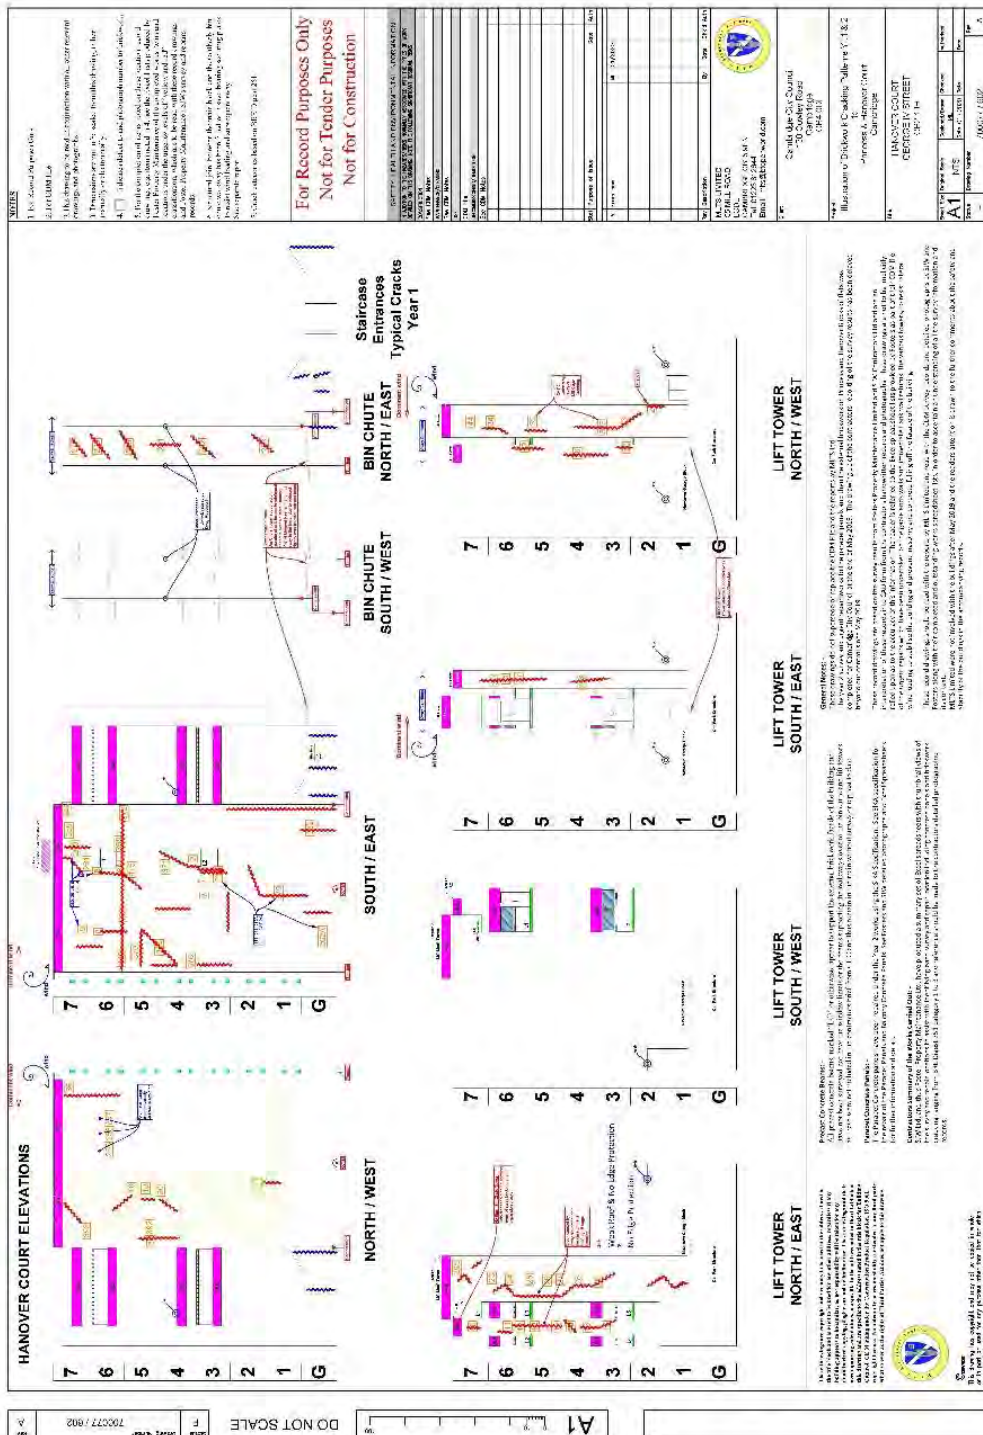
Note: - to read properly See A1 size Prints or A3 size at the minimum of the PDF files of these drawings located in the Dropbox.
