**MLTS Limited,**

*Structural Engineers,*

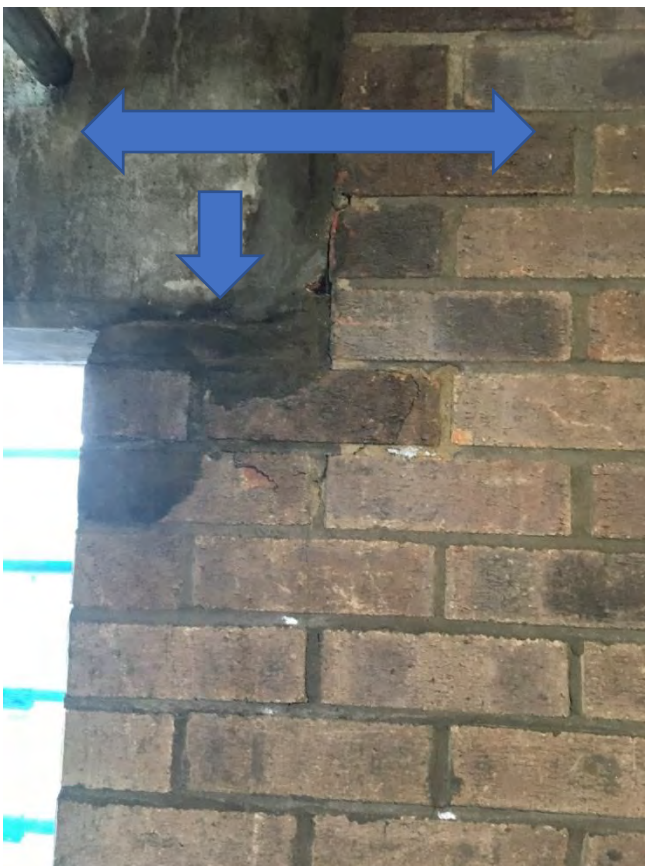
**Ditto another view**

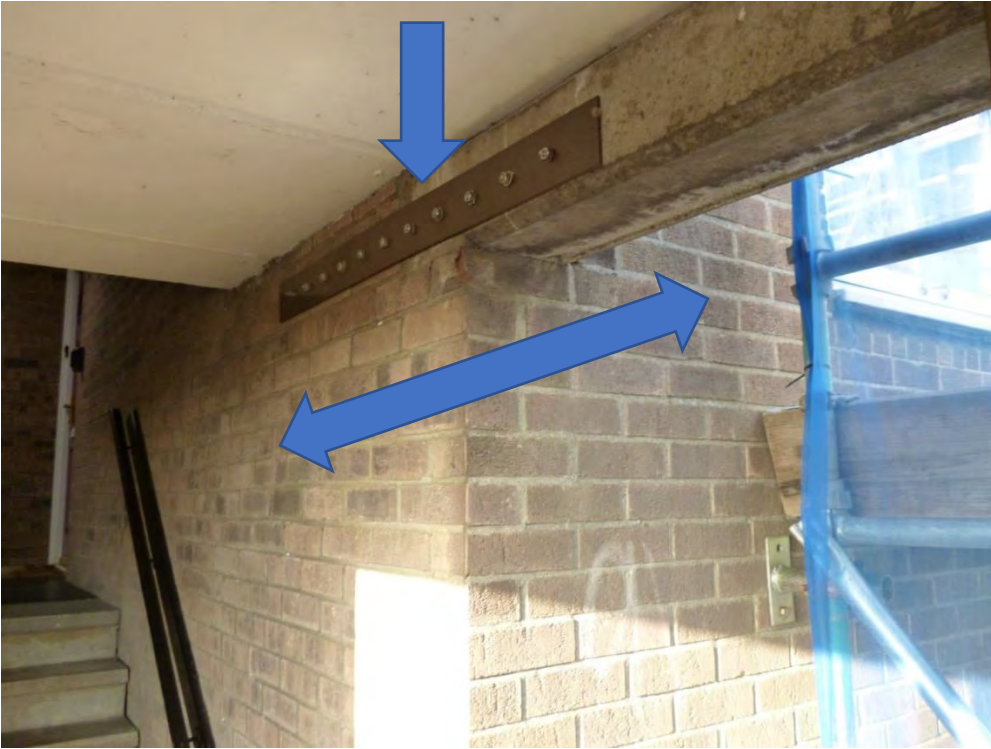
**With tie back plate to reduce the risk of the walkways and bin chute towers pulling out of and away from the building**

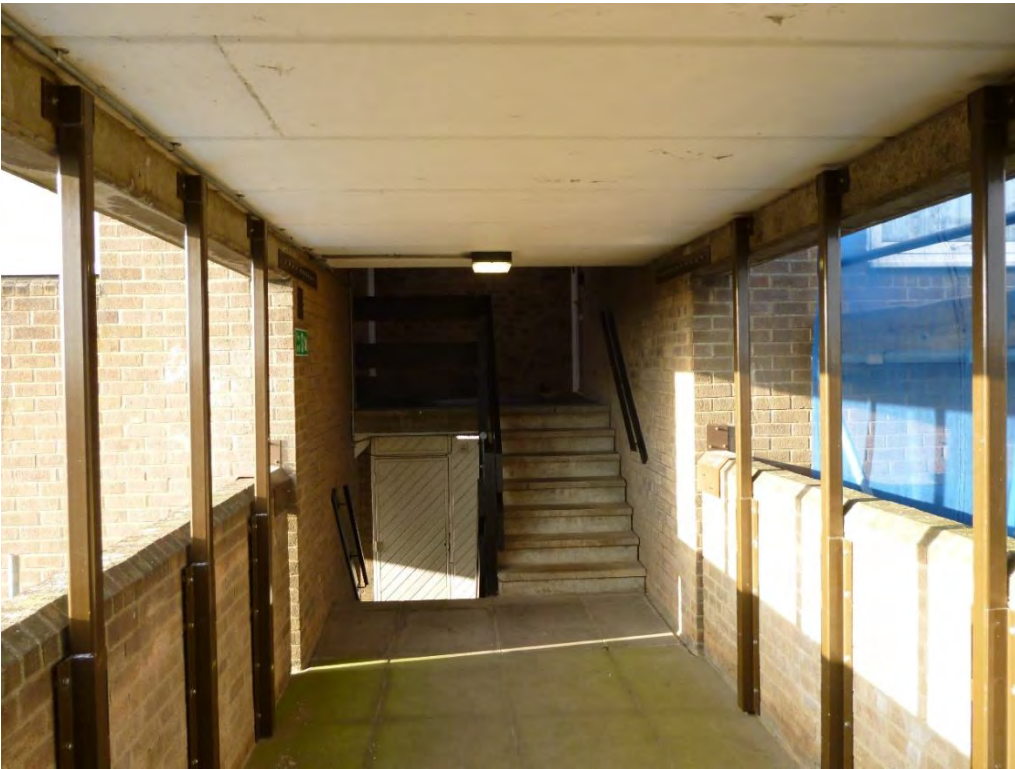
**Walkway side panels restraint posts fitted in Year 1 and Year 2 to prevent occupants pushing the unrestrained side walls with gaps at the ends removing any lateral restraint at the ends form overturning into the communal areas below.**

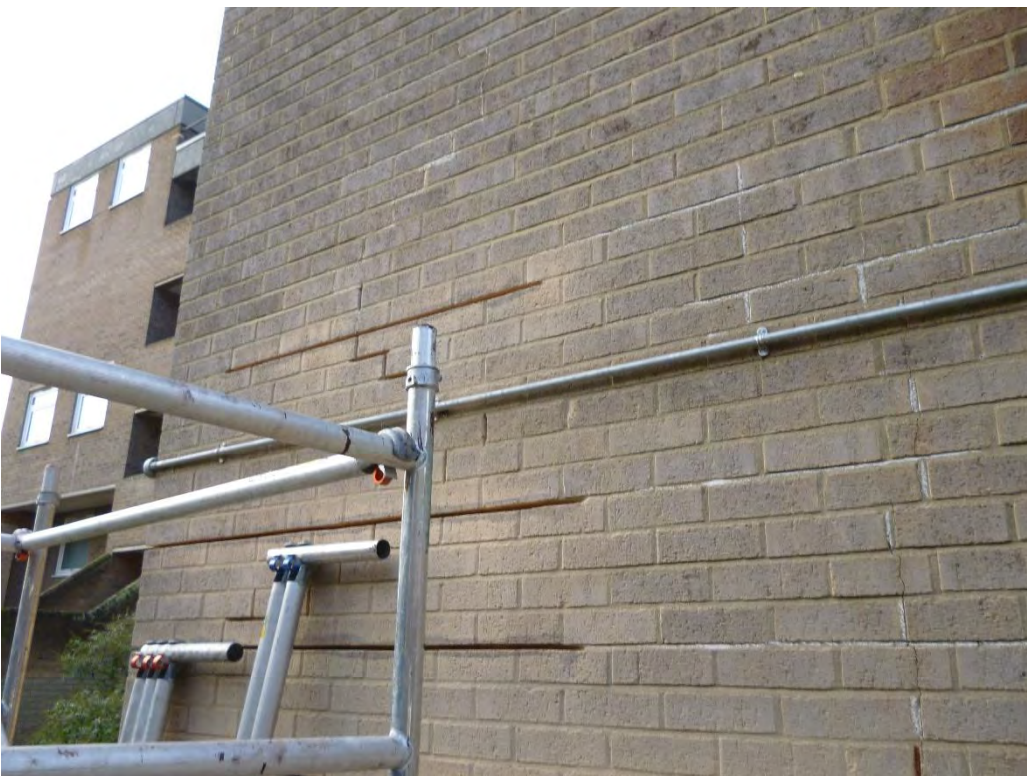
**Example Repairs on Princess Tower**

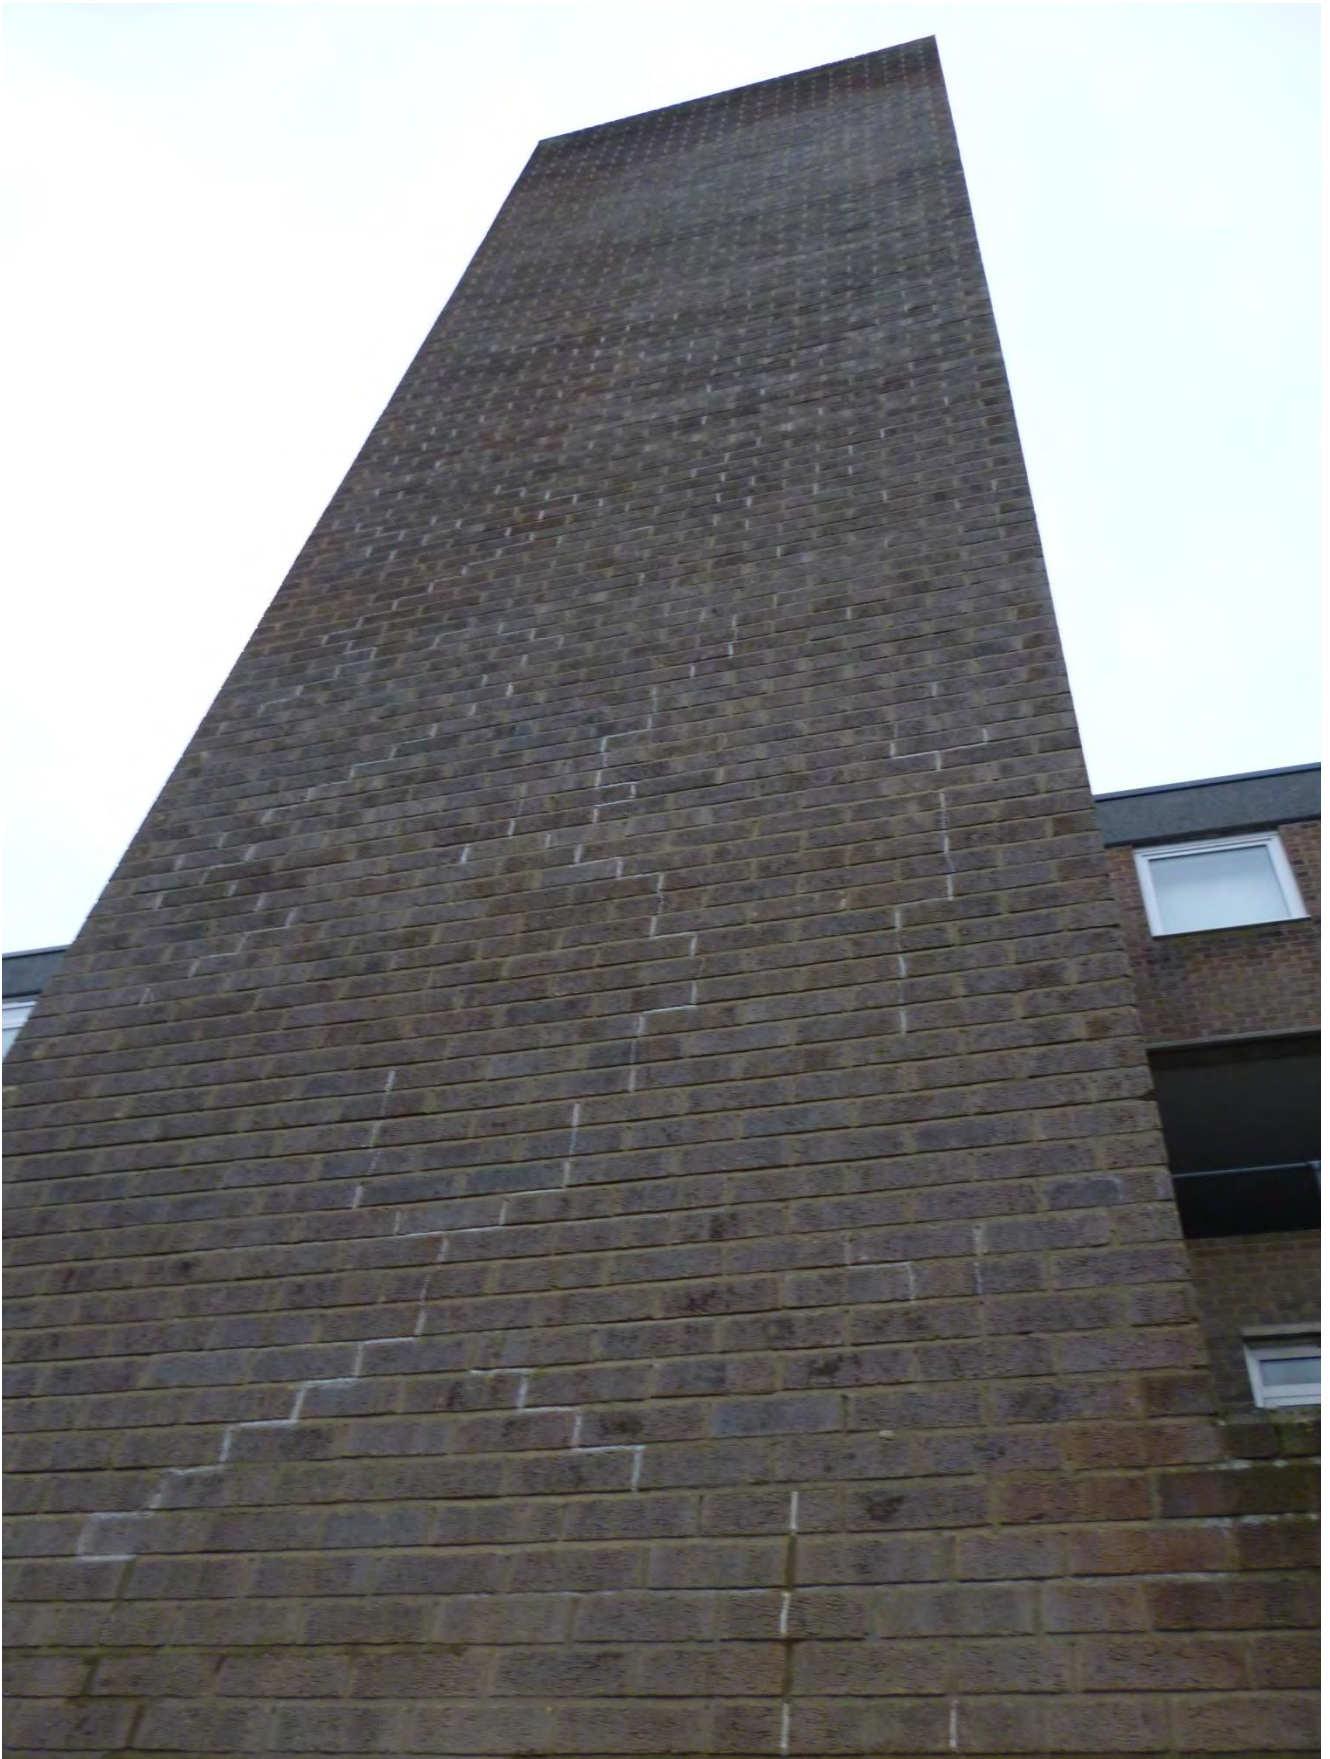
**Example of - Crack Tracing on Princess Bin Chute Tower prior to Year 2 repairs**

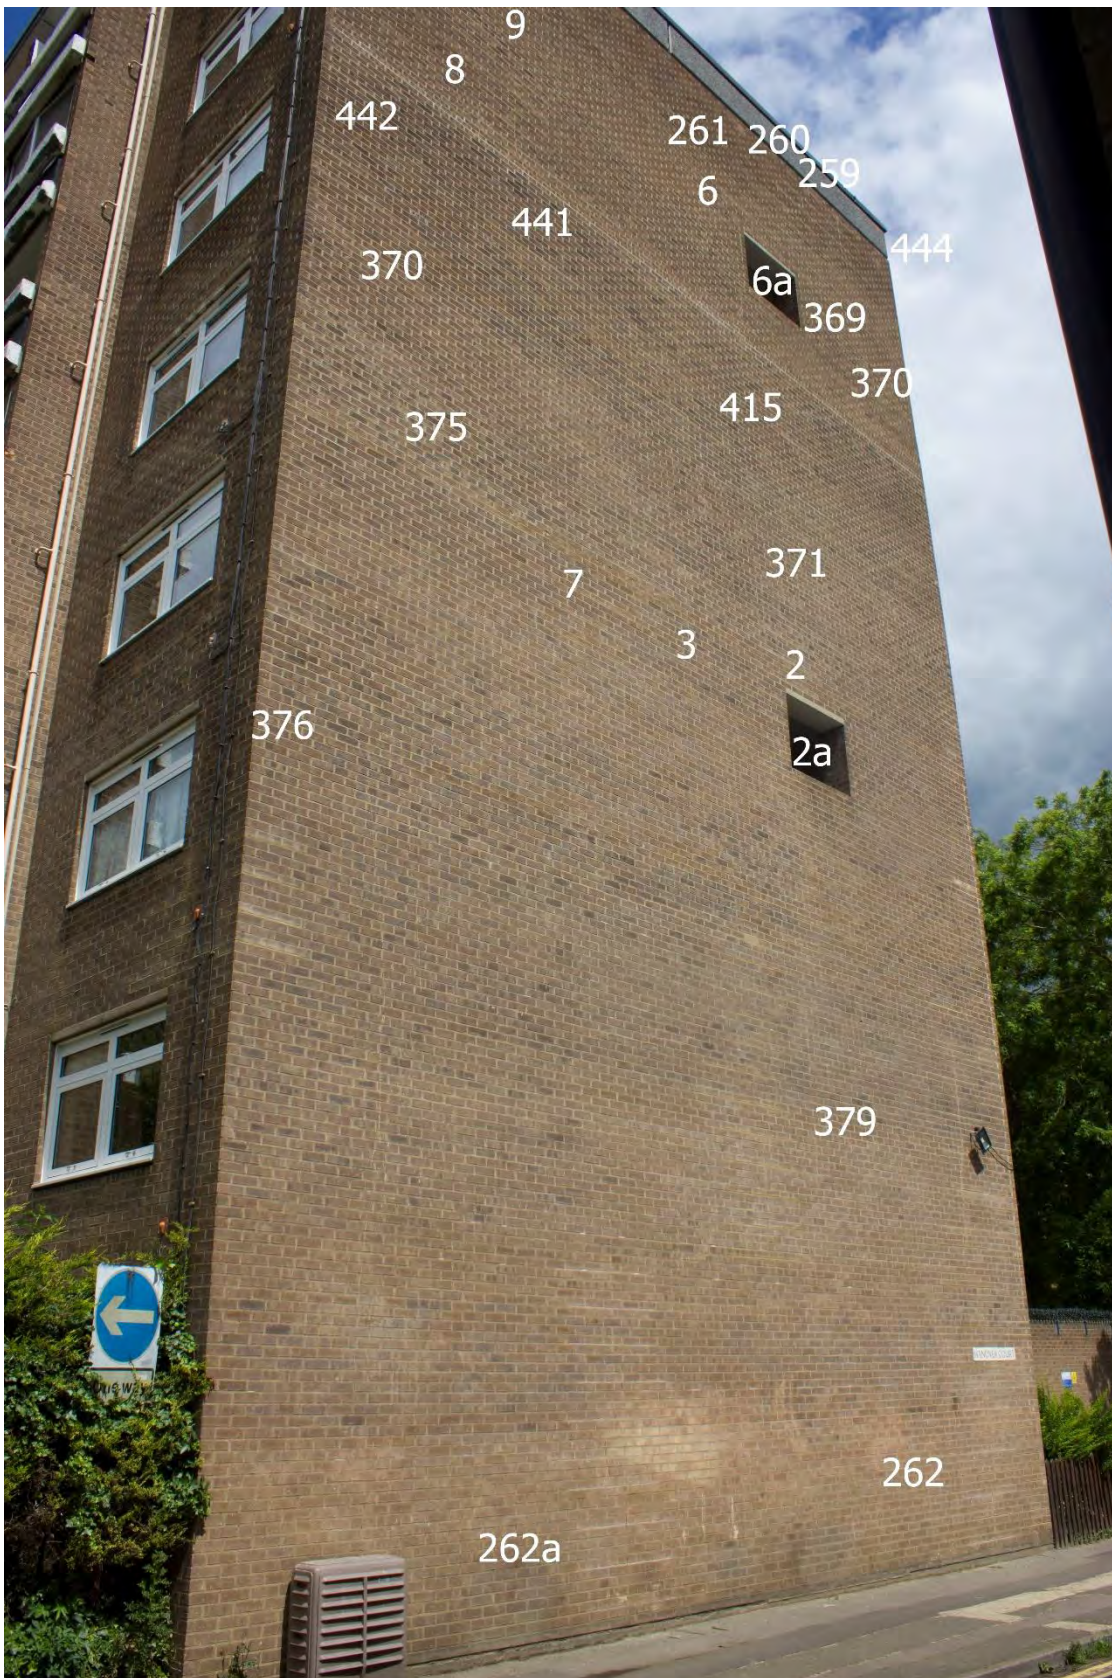
Typical Noted Elevation on Hanover court of Repair Locations Recording Defects and Repairs by Photograph Number using a whit wipe board
