Corn Exchange Street

General Overview

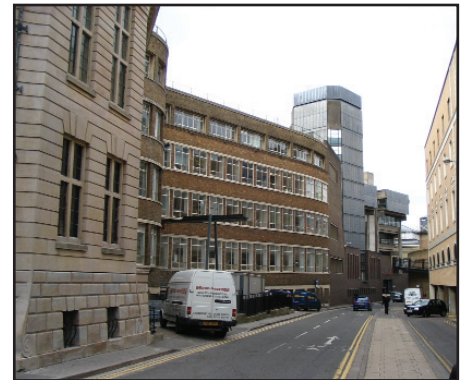
View north along Corn Exchange Street
