Round Church Street

A row of diverse building types including the C11 Round Church.

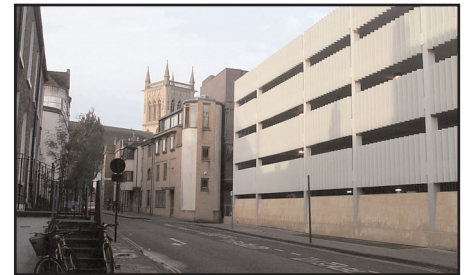
View south west along Round Church Street

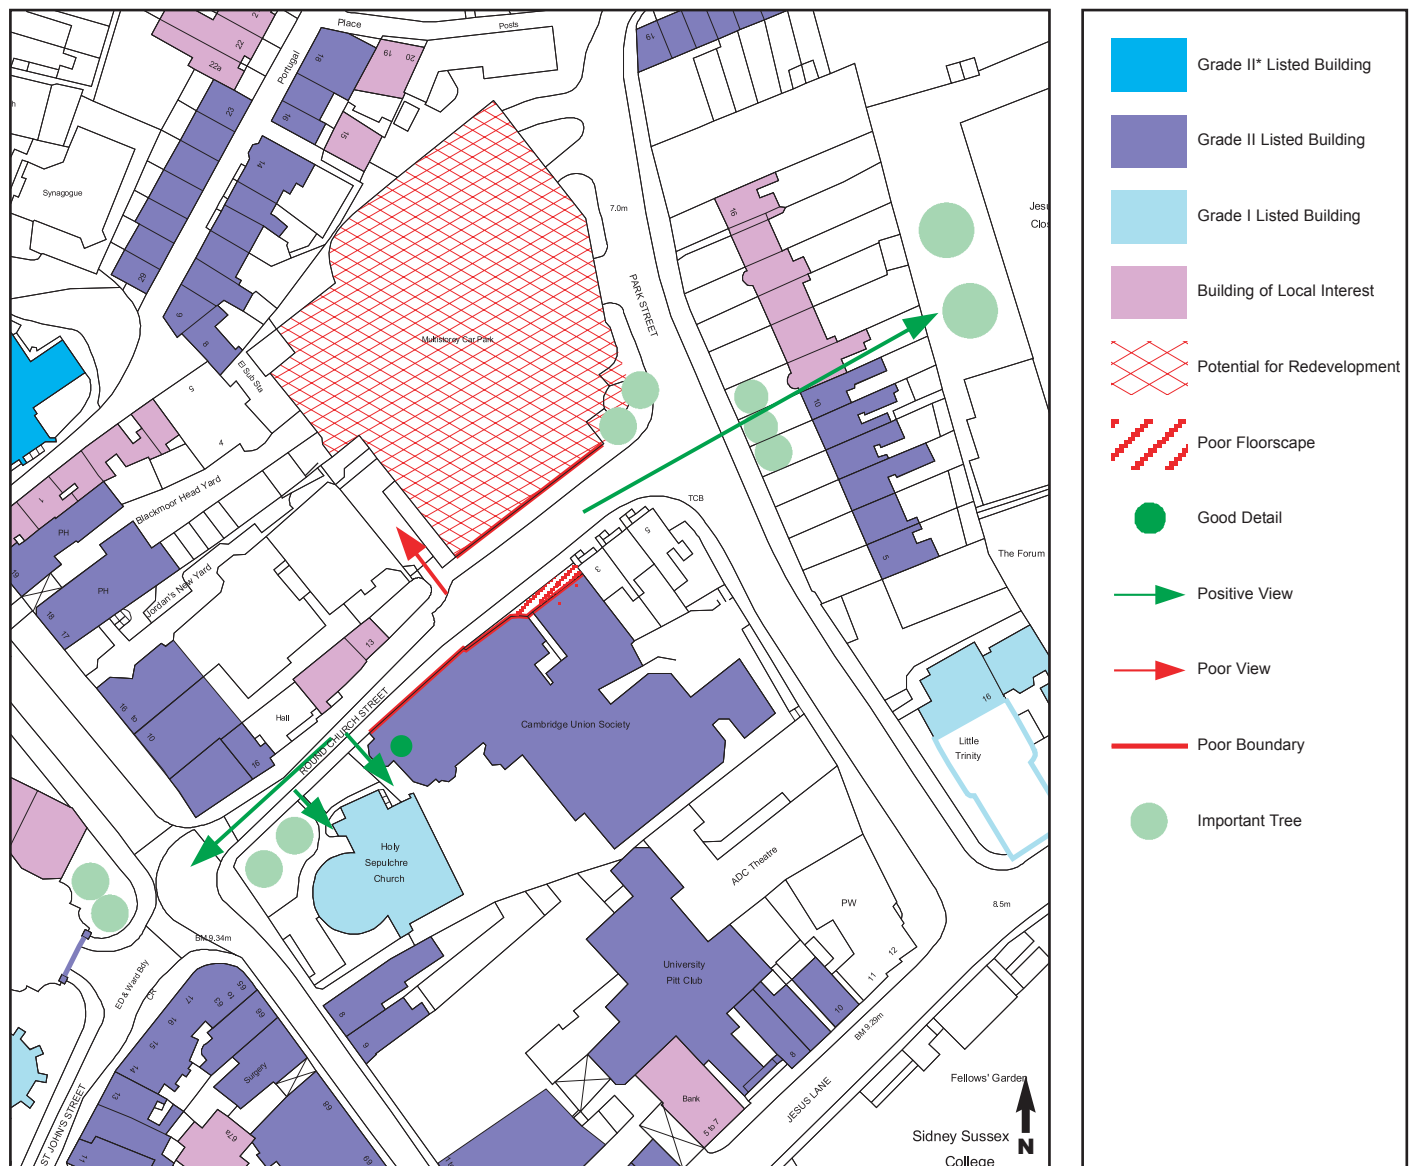
1 : 1,250

- > Building line mostly to back of footway.
- > Views to north east closed by Park Street terrace and to the south west by one of most imposing views of St John's Chapel.
- > Glimpsed views into Round Church yard and Union Society Garden.
- > Excellent skyline features to the old part of the Union Society.
- > No significant landscaping except for churchyard shrubs and trees.
- > Trees in front of car park partially screen the buildings.
- > Timber-framed buildings turn the corner opposite the churchyard.

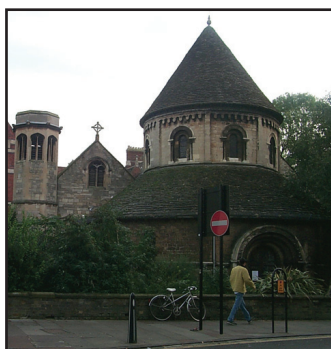
Holy Sepulchre Church

Numerous finds of Roman material have been made in the area, with very dense deposits noted, but not investigated, under the University Union around 1890, and large pits of the 2nd and 3rd century AD excavated during investigations at Jordan's Yard in the 1970s. The Round Church itself was built on the site of a much earlier church, St. George's, which was probably pre-Norman Conquest in origin.

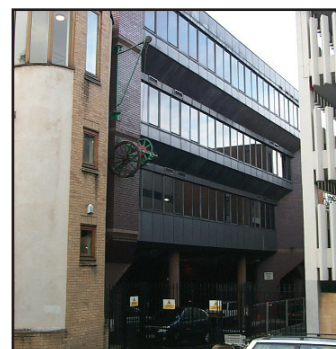
Bridge House / Park Street car park

- > Car park
Should private car usage reduce, the redevelopment of the car park could bring about significant improvements to the townscape.
- > Bridge House
The office block behind nos 10-16 is similarly bulky and incongruous.
- > Cambridge Union Society
The sculpture studio and extension (1930s refronting in render and steel windows) to the Union could be significantly enhanced.
