**Arboricultural Method Statement & Tree Protection Plan – In  
Accordance with BS 5837:2012**

| Project No:<br><b>12318</b> | <b>Hanover &amp; Princess Court, Bentinck Street, Cambridge, CB2 1HG</b> | | |
| Client: | | Cambridge Investment Partnership | |
| Date of Report: | 29/04/2026 | Revision: | A |

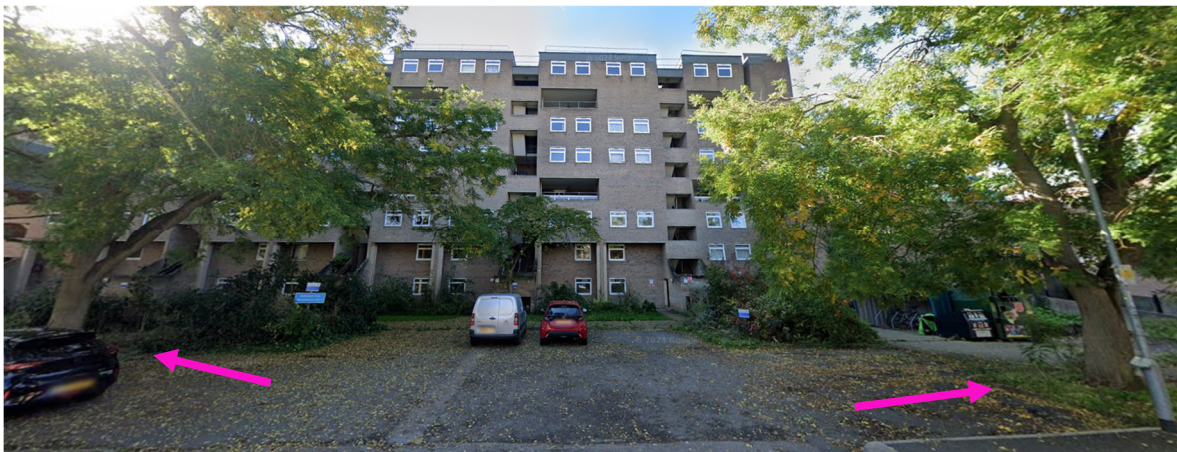
**Image 1** – The existing car park to be used for the Demolition Site Office and parking. T003 is on the left side of the image and G003 is on the right side of the image. Temporary protective fencing to be installed at the kerb edges (annotated with pink arrows).

- 3.2.4 The location of the Demolition Site Offices and Contractor Parking coincides with an existing car park which will be retained to act as ground protection at this stage, as detailed on the supplied 'Hill Demolition Only Traffic Management Plan' Ref T20008. The Demolition Site Offices will be supplemented by temporary protective fencing to create an exclusion zone around the soft earth surrounding G003, T003 and T004. The site cabins will be orientated to be single storey where they are to be sited below the crown of G003, and double storey where they are outside of the crown of G003, and can be rolled into position from Union Road, thus avoiding conflict with the crown of G003. The lowest point of the crown of G003 is 4m above ground level, providing adequate clearance above a single-stack arrangement. Other than the installation of temporary fencing (Appendix F3-F5) to segregate each of the site office and welfare facilities from physical access to retained trees, no specialised tree protection systems will be required. The site will be inspected by the project Arboricultural Consultant to check and confirm the location of the temporary protective fencing, as detailed in the appended Statement of Supervision (Appendix H).

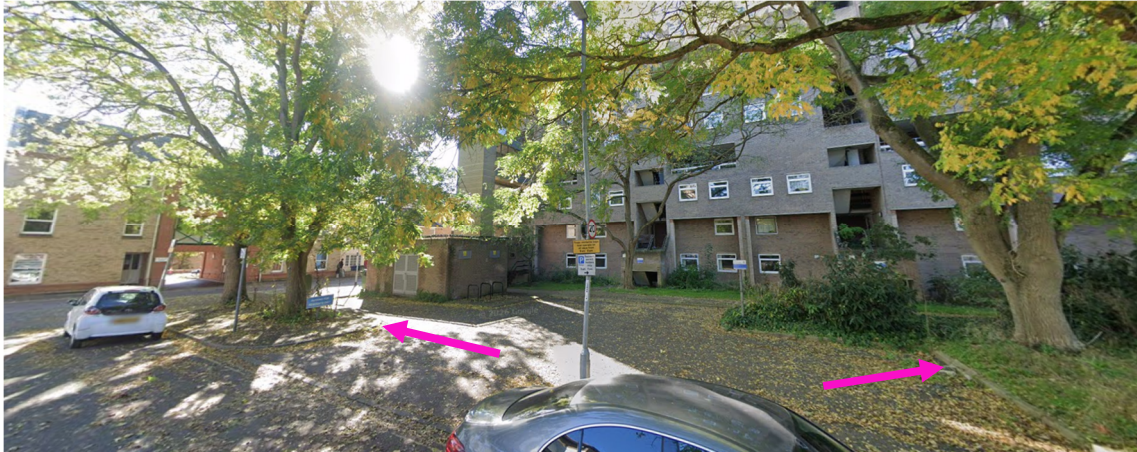
**Image 2** – The existing car park to be used for the Demolition access. G002 is on the left side of the image and T003 is on the right side of the image. Temporary protective fencing to be installed at the kerb edges.

- 3.2.5 The existing car park adjacent G002 will also be used for Demolition access, with the hard surfacing retained as ground protection, and temporary protective fencing forming an exclusion zone around the soft earth surrounding G002.

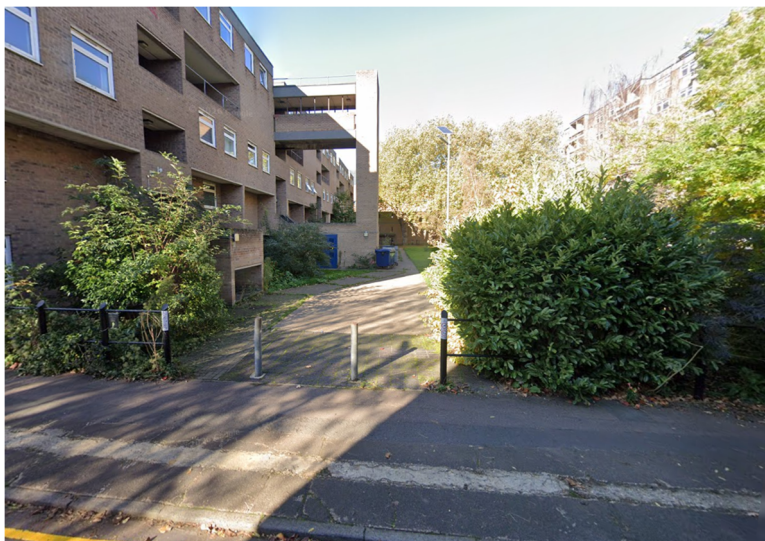
**Image 3** – The demolition phase point of access off Coronation Street.

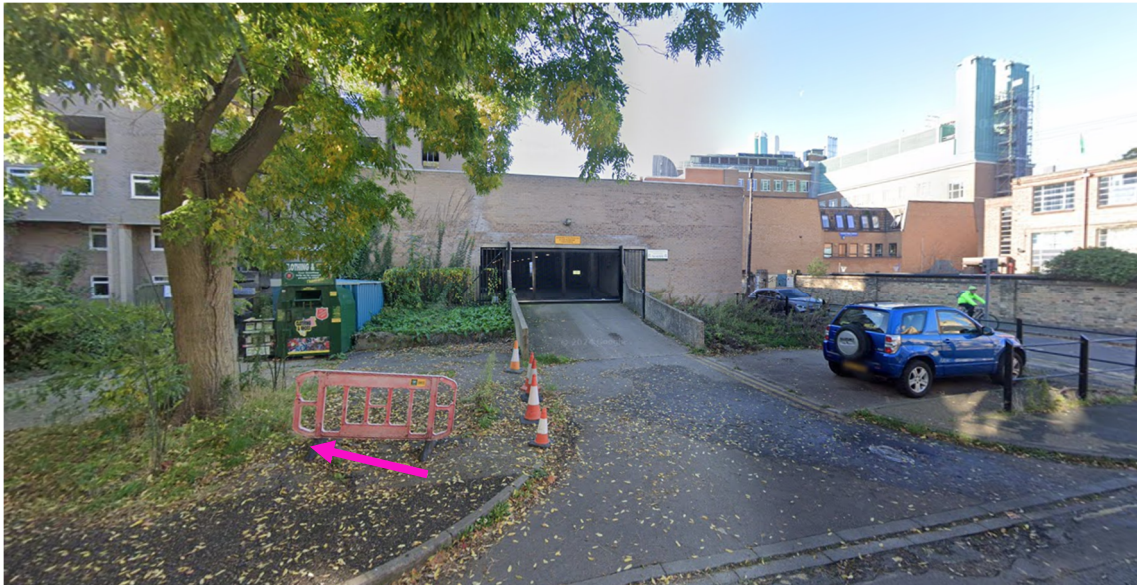
**Image 4** – The existing hard surfacing will be used for the Construction Site Offices and Pedestrian Turnstile. G003 is on the left side of the image. Temporary protective fencing to be installed at the kerb edges.

- 3.5.1 The location of the Construction Site Offices coincides with an existing vehicle access and small car park which will be retained to act as ground protection at this stage, as detailed on the supplied 'Hill Demolition Only Traffic Management Plan' Ref T20008. The Construction Site Offices will be supplemented by temporary protective fencing to create an exclusion zone around the soft earth surrounding G003. Other than the installation of temporary fencing (Appendix F3-F5) to segregate each of the site office and welfare facilities from physical access to retained trees, no specialised tree protection systems will be required. The site will be inspected by the project Arboricultural Consultant to check and confirm the location of the temporary protective fencing, as detailed in the appended Statement of Supervision (Appendix H).

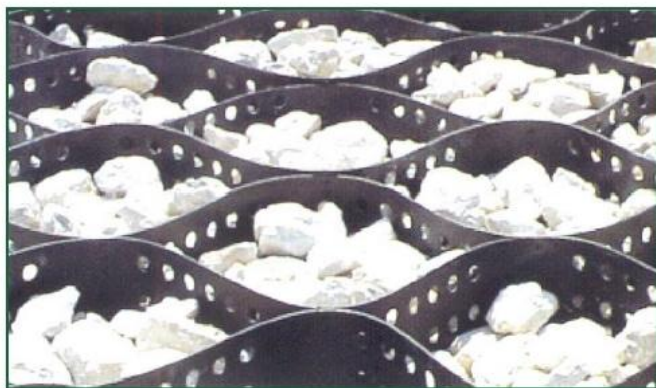
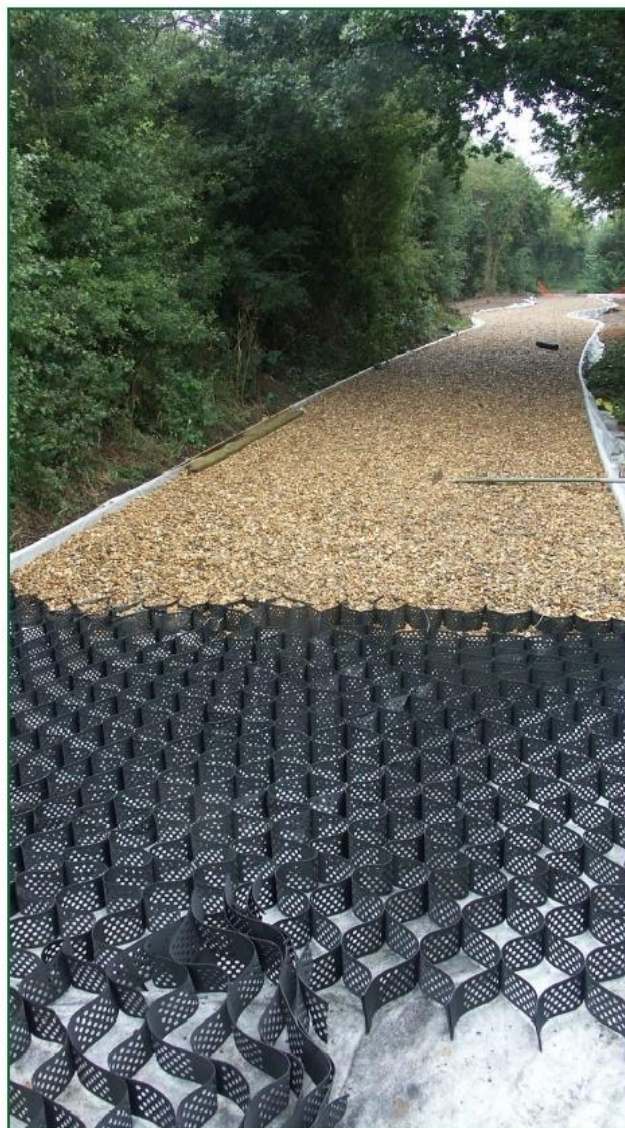
'No Dig' system during construction (right)

"Geocell" Cellular Confinement System (100mm deep) with gravel chippings (below)

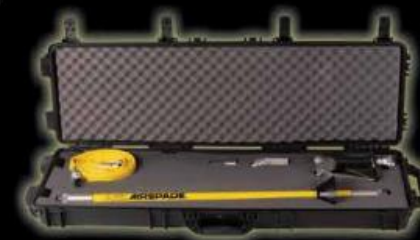
AirSpade 2000 Arbor/Landscape Kit shown above.
