(CCC) Trumpington Pump Track

Safety Inspection Report

Post-installation Inspection

King George V Playing Field

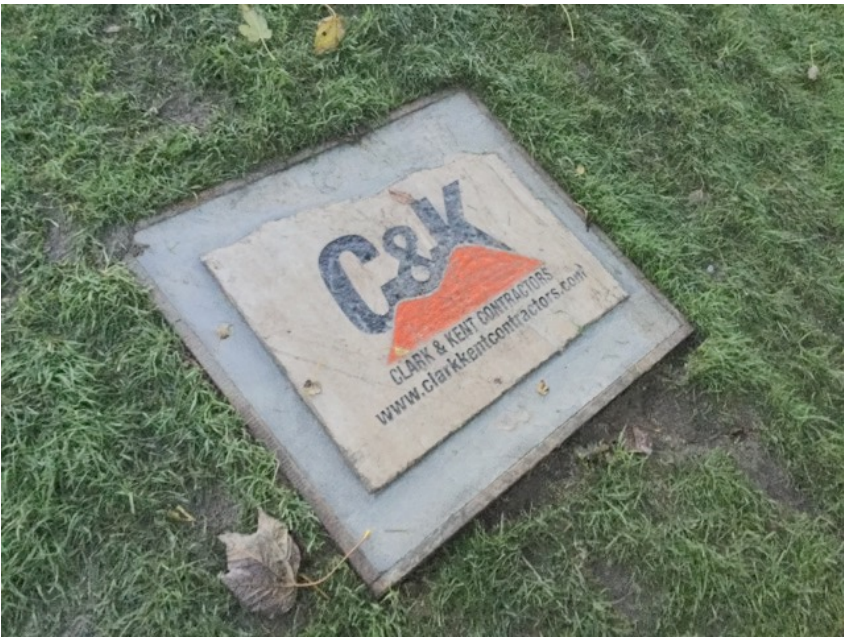
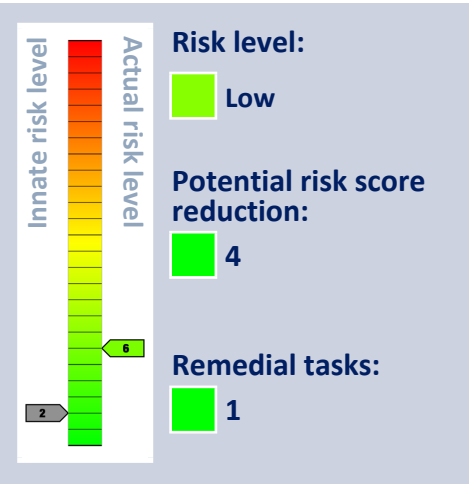
Signage

Install suitable temporary signage before site is opened. Ensure suitable content of permanent signage.

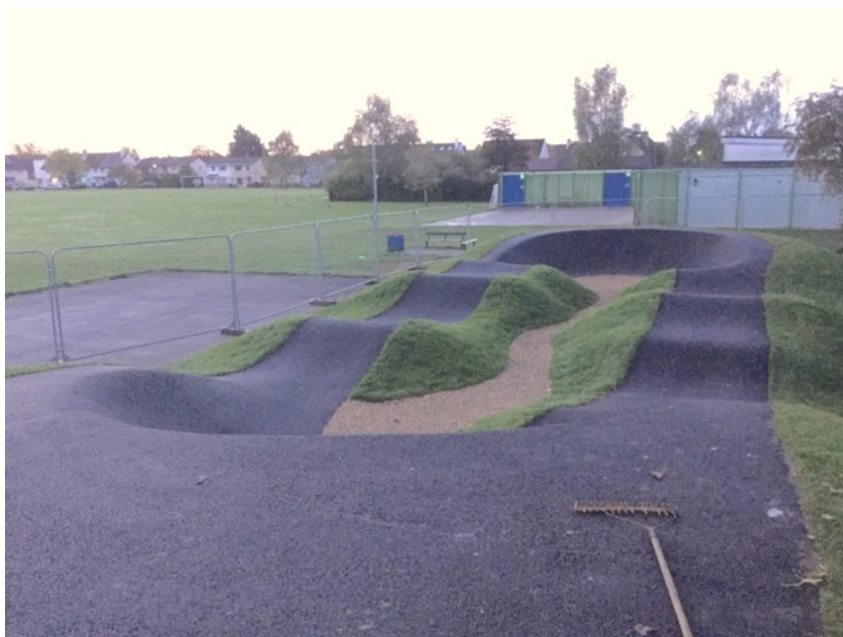
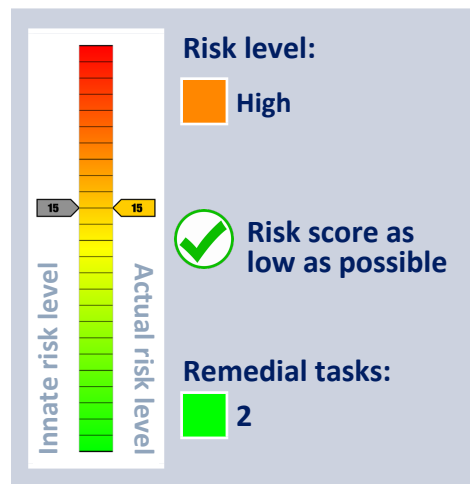
Wheeled Sport - BMX Track - Beginner

None, BMX Track Guidance

The item and its surfacing (where applicable) meet with the requirements of the relevant standards.

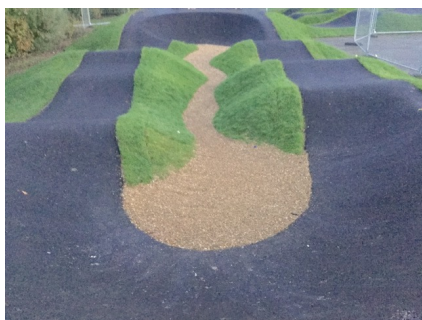
Install suitable markings depicting the intended route as discussed.

Medium

8

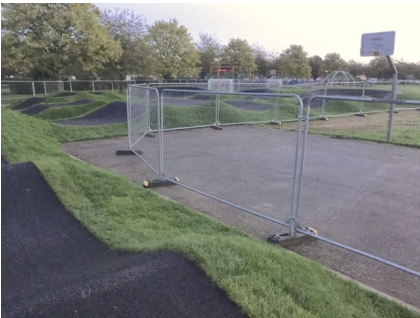
Inspector has minor concerns regarding the proximity of the basketball court and the potential for collisions - monitor.

Low

6

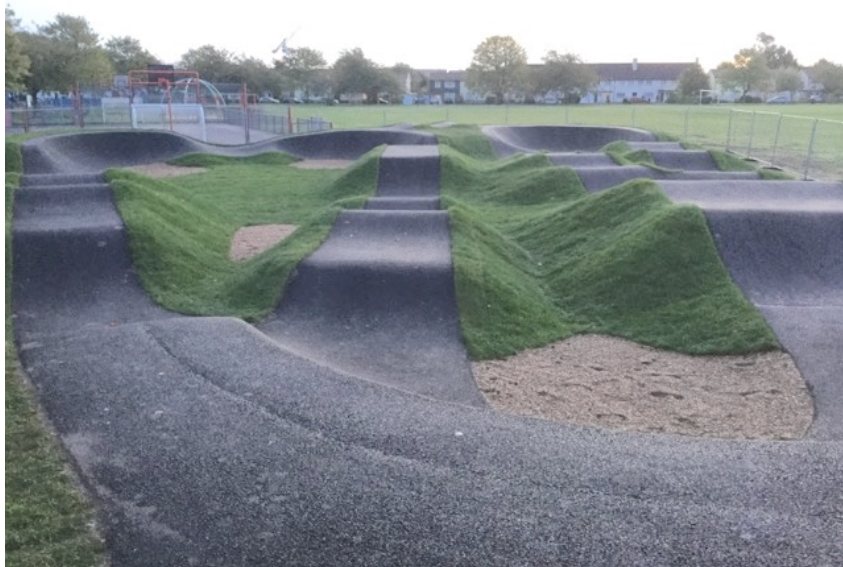
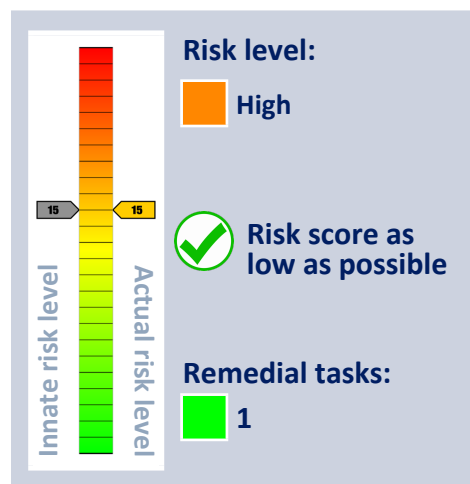
Wheeled Sport - BMX Track - Advanced

None, BMX Track Guidance

The item and its surfacing (where applicable) meet with the requirements of the relevant standards.

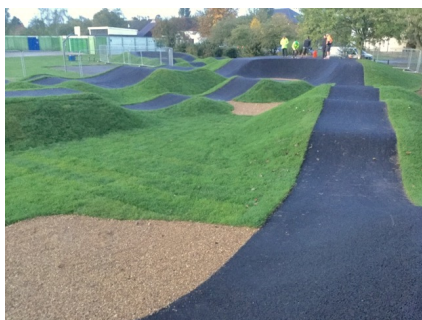
Install suitable markings depicting the intended route as discussed.

Medium

8
