Fire Risk Assessment

CAMBRIDGE
CITY COUNCIL

Assessed Area: Hanover Court, Coronation Street, Cambridge

Date of Inspection: Jul 17, 2020

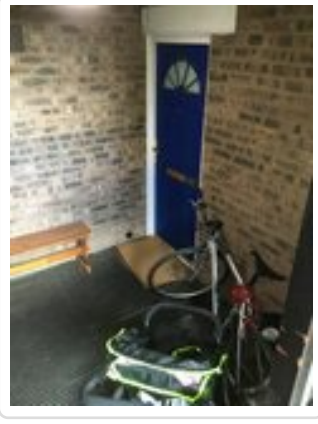
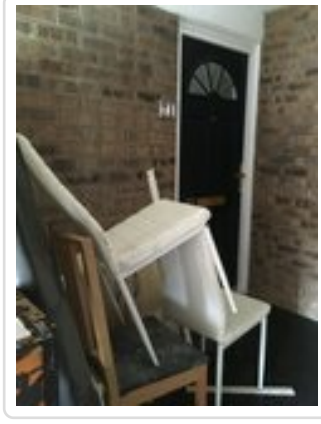
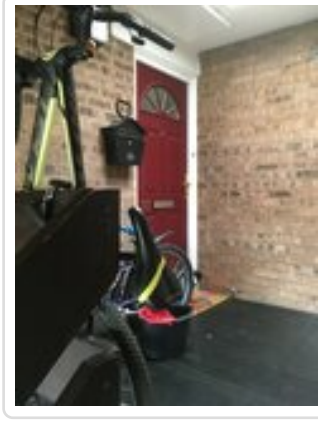
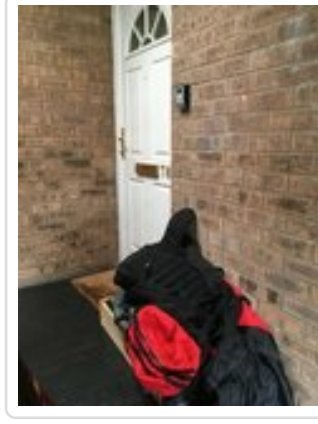
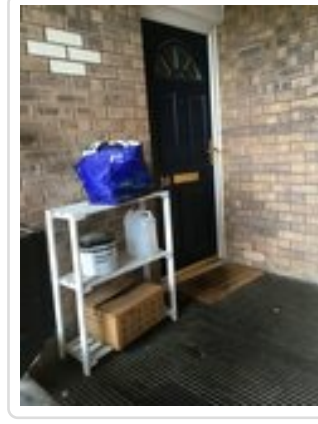
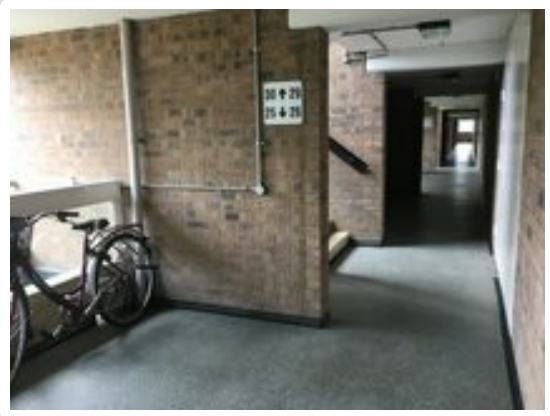
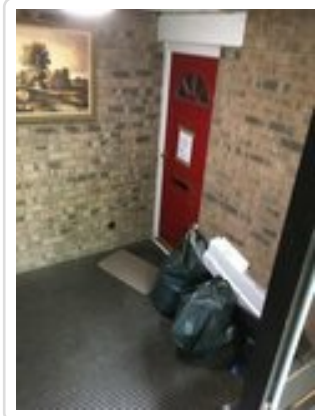
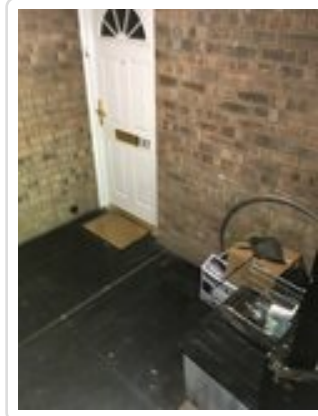
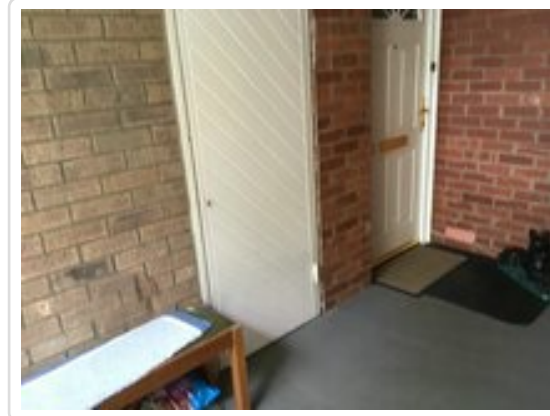
Images **9**

Housekeeping to the premises was poor in the following areas due to storage of bicycles/items outside flats causing an obstruction and trip hazard.

The picture outside flat 31 is not a particular fire hazard but should be discouraged so as not to set precedent for other residents.

As can be seen from the attached images there are either bikes or items of storage outside some flat entrance doors. Application of the Council's zero tolerance policy as per other flats is recommended although acknowledged as difficult to implement in some instances.

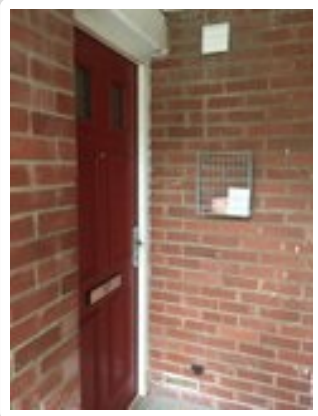
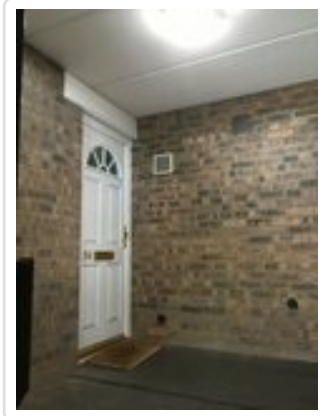
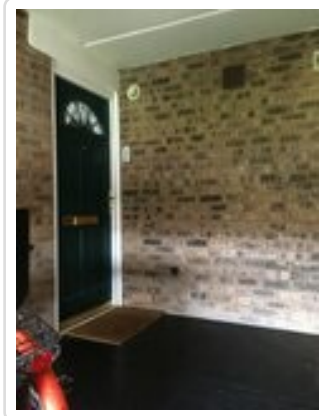
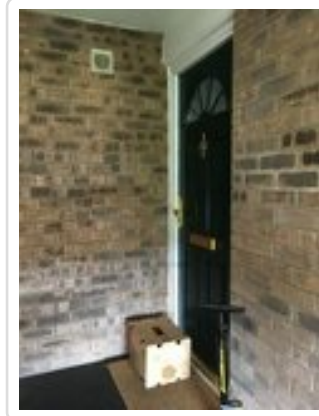
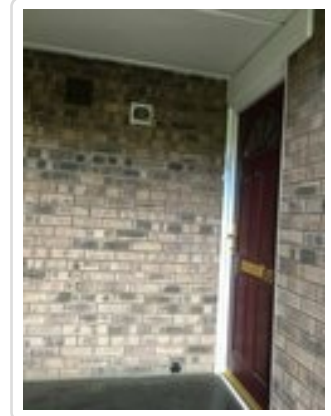
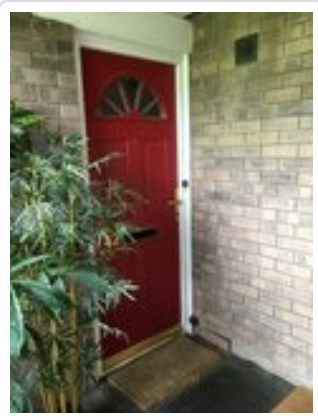
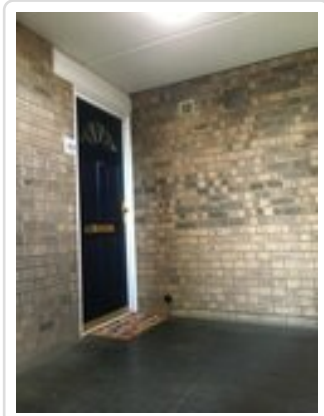
Images 7

All CCC tenant doors in a recent survey have been identified as HIGH priority as they are non fire rated flat entry doors and need to be replaced with an FD30S standard door

All leasehold doors in a recent survey have been identified as HIGH priority as they are non fire rated flat entry doors and need to be replaced with an FD30S standard door.

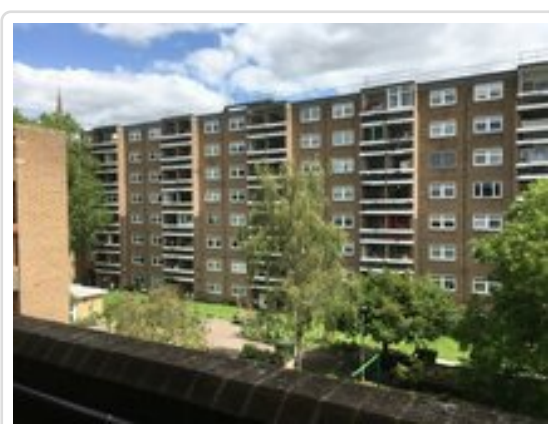
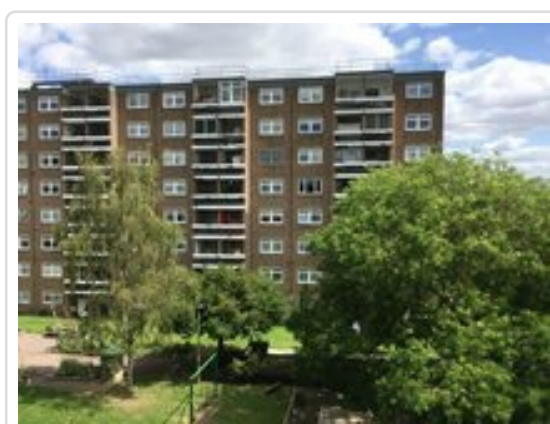
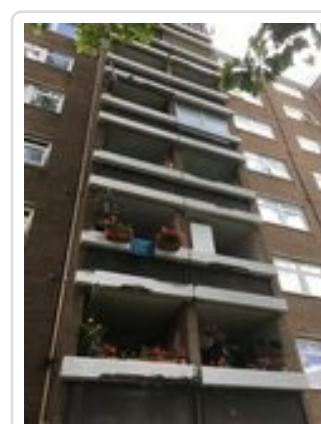
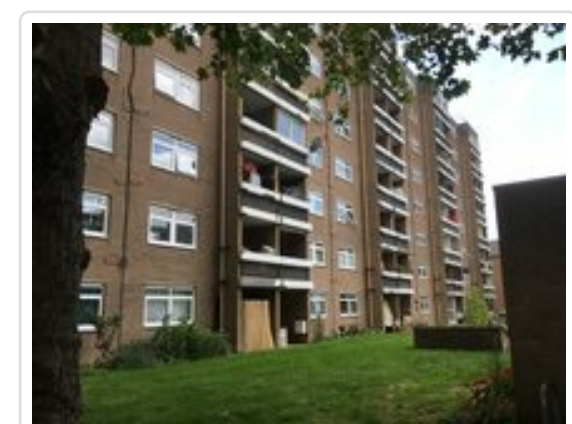
🖼 Images 4

It was not possible for the assessor to externally check by observation the use of all the resident balcony spaces given the height of the building. In discussing this with the caretaker there are some balconies of concern (flats 15 and 20) that may present additional fire hazards. With the support of the housing management team these should be investigated and information provided to residents more generally about the usage of balconies.

A flat fire in Hanover Court early in 2020 and in block 4 at Kingsway flats in May 2020 resulted in either smoke and/or fire spread through the service riser. The outcomes of a subsequent specific FRA (see 'Evidence') included a review of the stay put policy, installation of linked early warning of fire and further surveys of service risers in all blocks at Kingsway flats and Hanover/Princess Courts (as the buildings are from the same era and very similar in design) to provide solutions to the lack of fire resistance/compartmentation.
