HANOVER & PRINCESS COURT

MORIBUND REPORT

This report demonstrates how Hanover and Princess Court can be considered 'moribund housing' for the purpose of Homes England Grant Funding

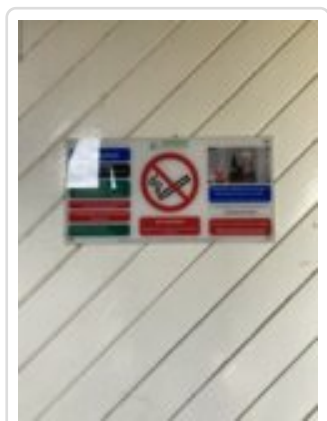
IMG_2345

A no smoking policy is applied to the communal areas in accordance with The Health Act 2006 and signage displayed accordingly.

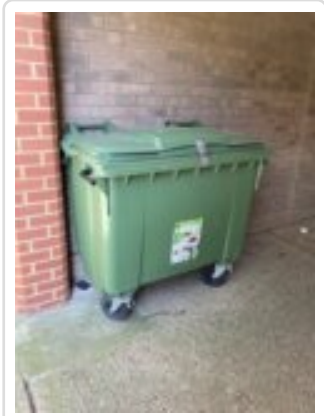
IMG_2409

There was a large wheeled bin located under the archway that could be prone to an arson attack and should ideally be located away from the building, however, it was noted as being locked shut.

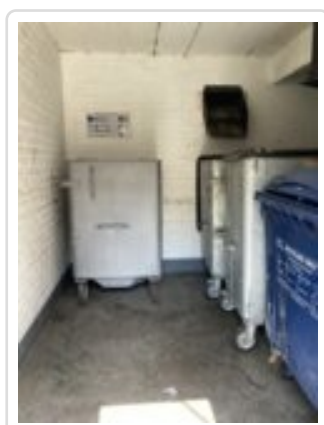
IMG_2364

See action above. Bin stores were in good housekeeping condition.

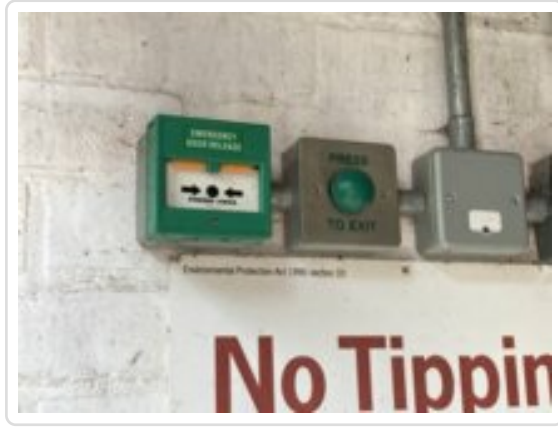
IMG_2371

Manual over ride devices activated.

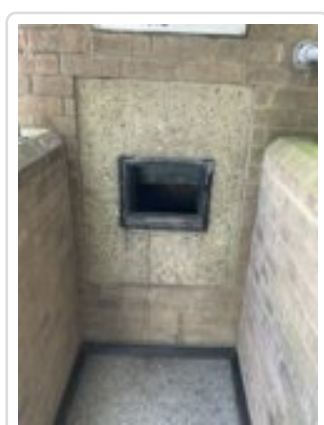
Refuse chute cover missing

The refuse chute cover near the lift on the 3rd floor walkway is missing and should be replaced.

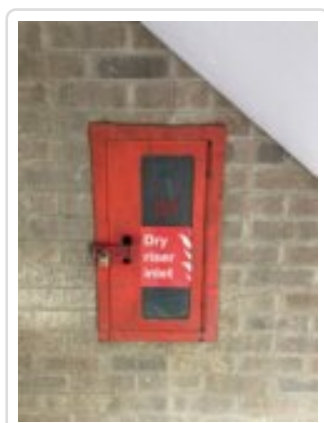
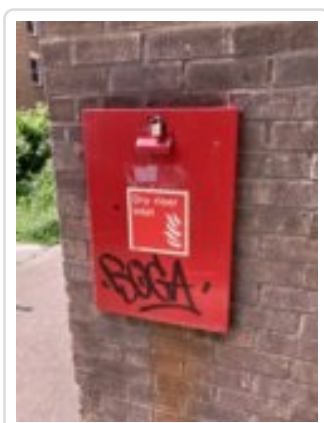
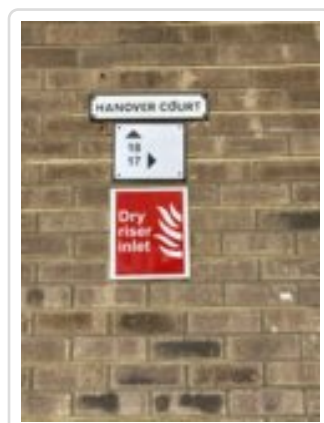
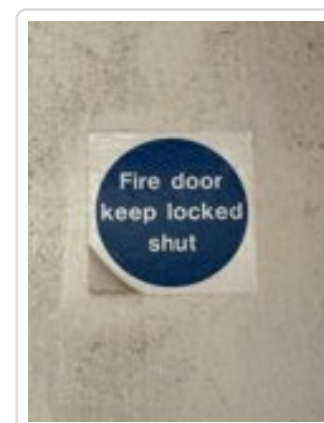
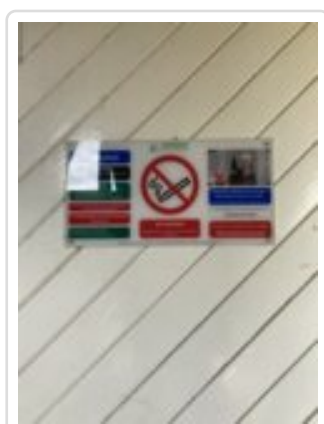
Where appropriate fire safety signage and notices are provided including fire action notices, fire exit directional signage, some store/electrical cupboards and dry riser inlets.

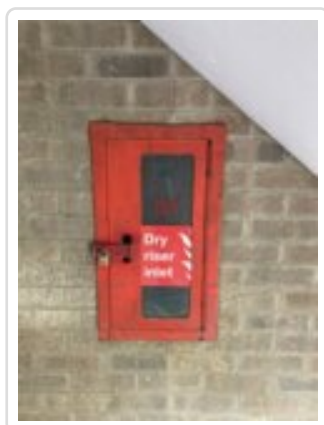
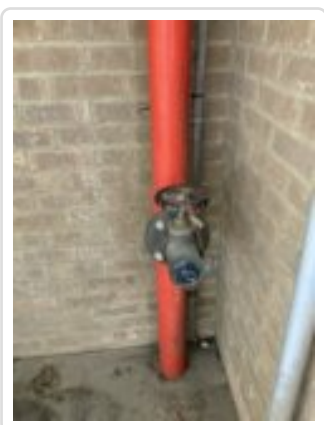
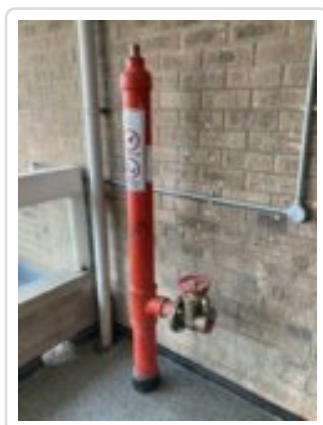
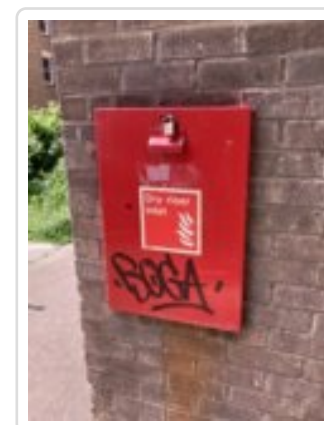
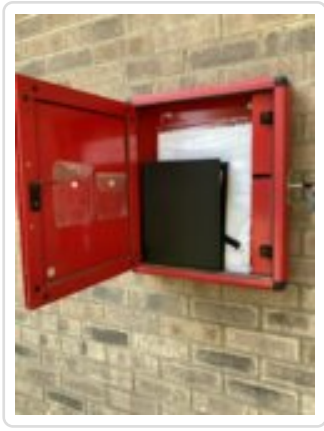
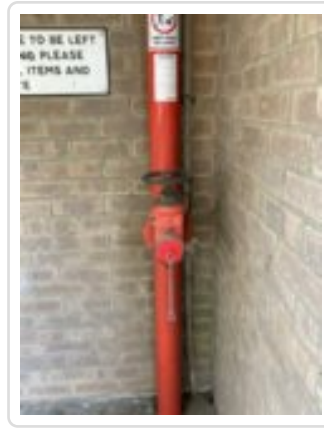
The DR outlets are not enclosed in a box for protection but were secured with a strap and lock.

It is recommended that the fire service are invited to use the DR's as part of a training/familiarisation exercise.

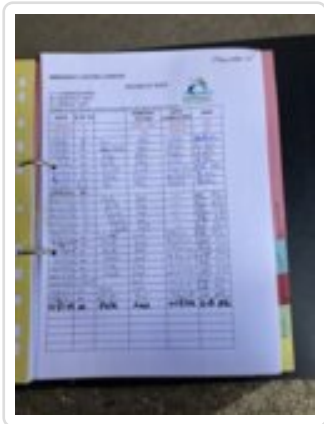
IMG_2367

The record shows continual failures - this has been fed back to TSG by the assessor.

Annual test carried out 11.05.2023 by ATL.

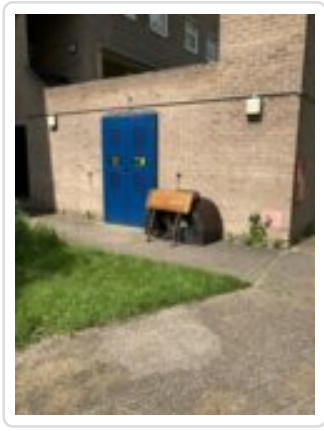
IMG_2405

A couple of items were noted dumped outside bin room 2 which should be collected. They are away from the building and did not pose a significant risk.

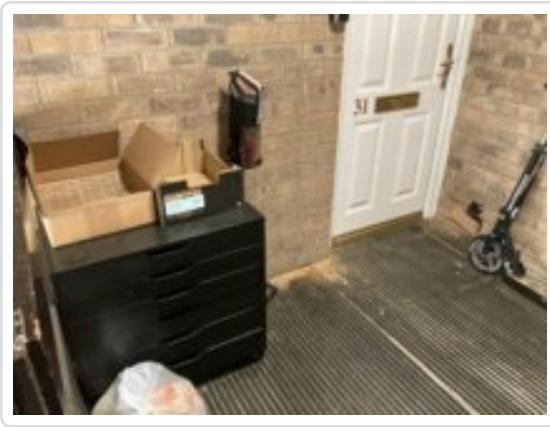
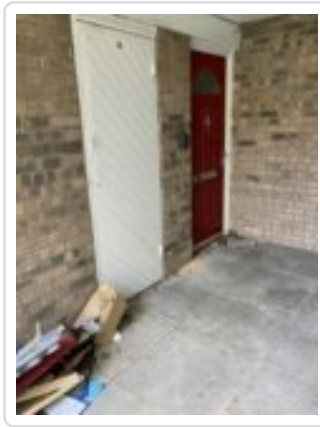
IMG_2379

Items located in escape routes. These can be an obstruction to the means of escape, a trip hazard for fighters and add to fire loading in an area that should be managed as a sterile space.

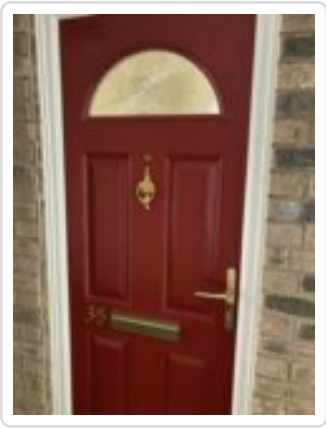
Damage to flat entrance door

The fire resisting glazing to flat 35 FED has been damaged. This should be replaced.

✓ Damage to flat entrance door - repair/replace

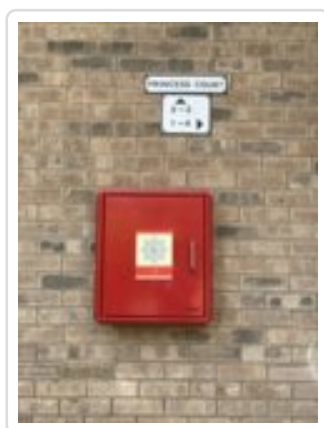
One of the DR inlet boxes has been defaced with stickers - the box is still identifiable to the FRS but it is recommended these are removed.

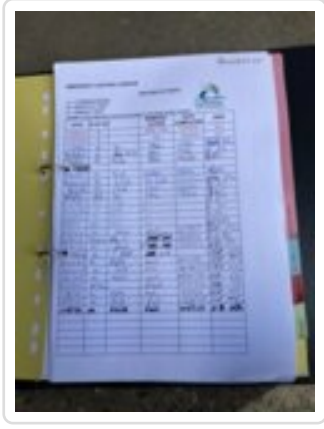
Testing carried out by ATL - more failures as per 2022 FRA - fed back to TSG.

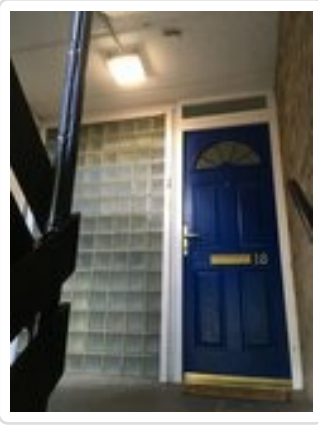
IMG_4521

A programme is in place (2020-21: delayed by Covid-19) to replace all tenant flat entrance doors and to address leasehold doors. There are no other openings onto the escape routes which also helps to reduce the likelihood of them being affected by a fire. It is also proposed to replace store cupboard doors with FD30 standard doors which will also reduce the opportunity for arson.

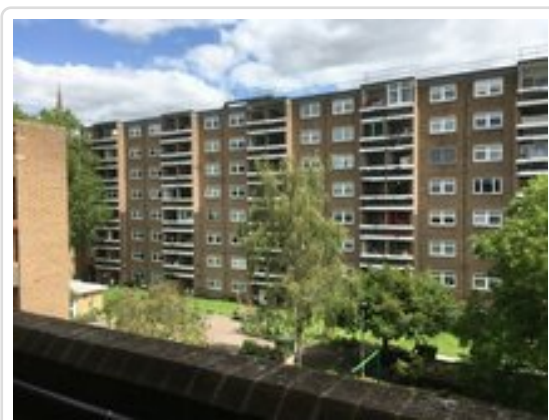
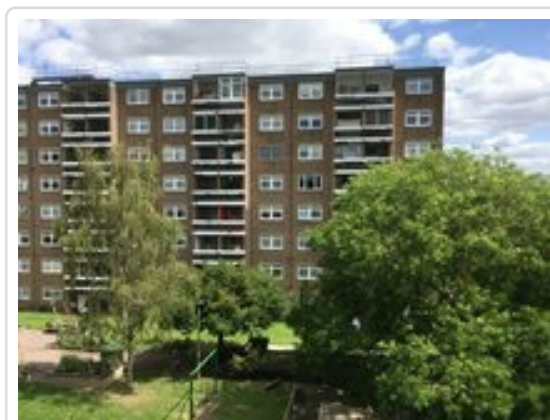
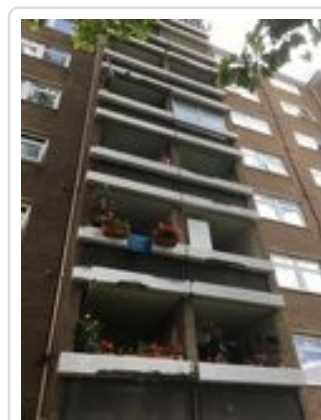
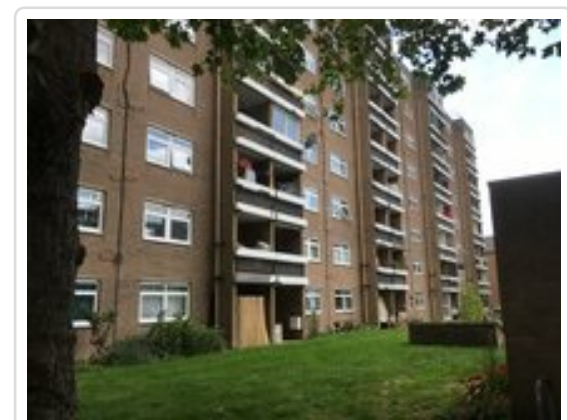
It was not possible for the assessor to externally check by observation the use of all the resident balcony spaces given the height of the building. In discussing this with the caretaker there are some balconies of concern (flats 15 and 20) that may present additional fire hazards. With the support of the housing management team these should be investigated and information provided to residents more generally about the usage of balconies.

Resident balconies are not constructed of combustible materials although some are enclosed - see recommendation above.

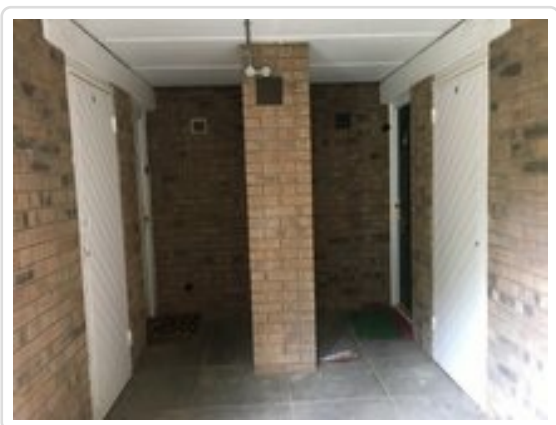
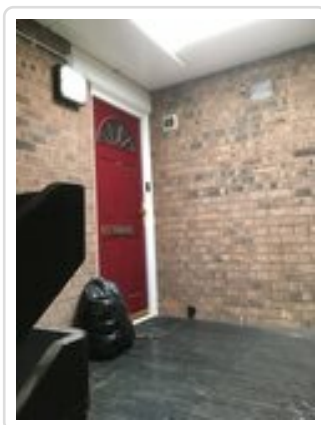
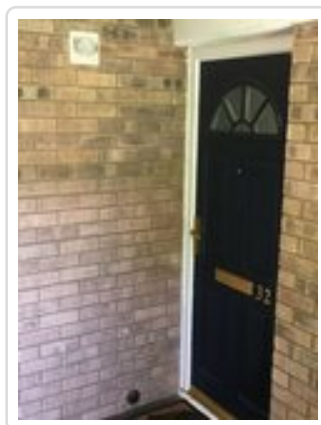
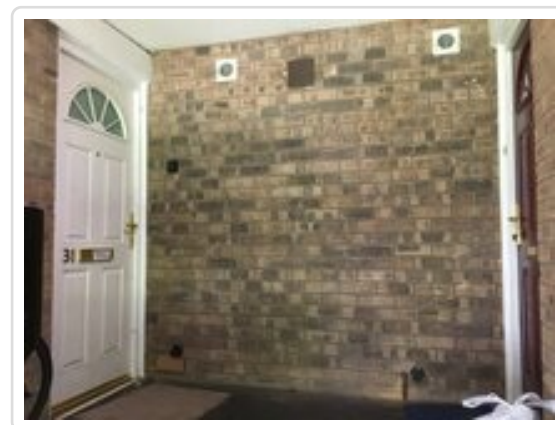
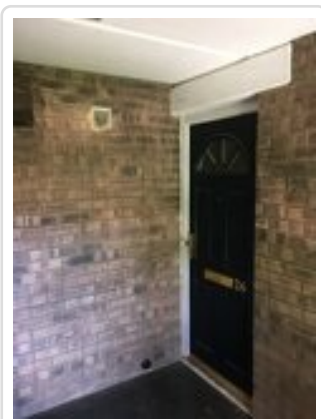
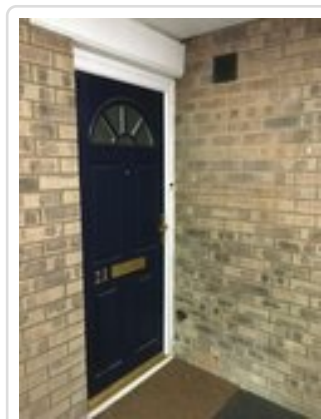
The escape for most of the flats above ground floor is via generally semi-open routes which provides venting for smoke, however, also see comment above re 'escape routes' regarding impact of a fire on these routes. This includes the staircases from ground to first floor flats and those serving 2nd/4th flats off the walkways at 3rd floor.

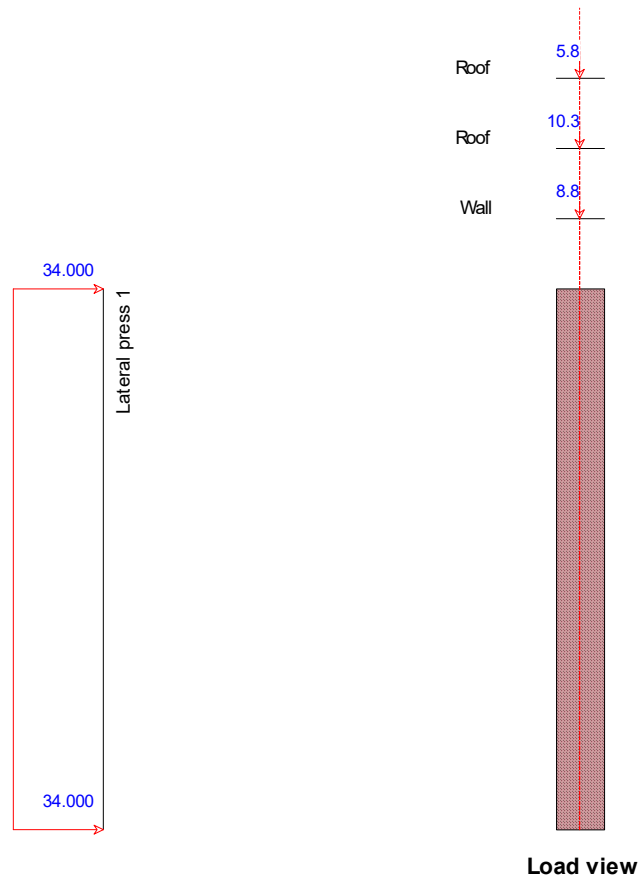
Internal Wall - Roof	Job No	MA11229
		Job Ref	
		Designed By	
		Checked By	
		Date	24/ 5/2021
		Revision No	
		Calc No	
		Page No	2

Description	Wall	Status	Units	Description	Near	Status	Units
Lateral load capacity	2.109		kN/m ²	Max. slenderness ratio	27		
Design uniform load	47.600		kN/m ²	Actual	8.656		
Utilisation	22.565	Fail		Utilisation	0.321	Pass	
Load combination	0.90D+1.40Lp1						
Limiting dimension / area							
Allowable	11000		mm				
Actual	2539		mm				
Utilisation	0.231	Pass

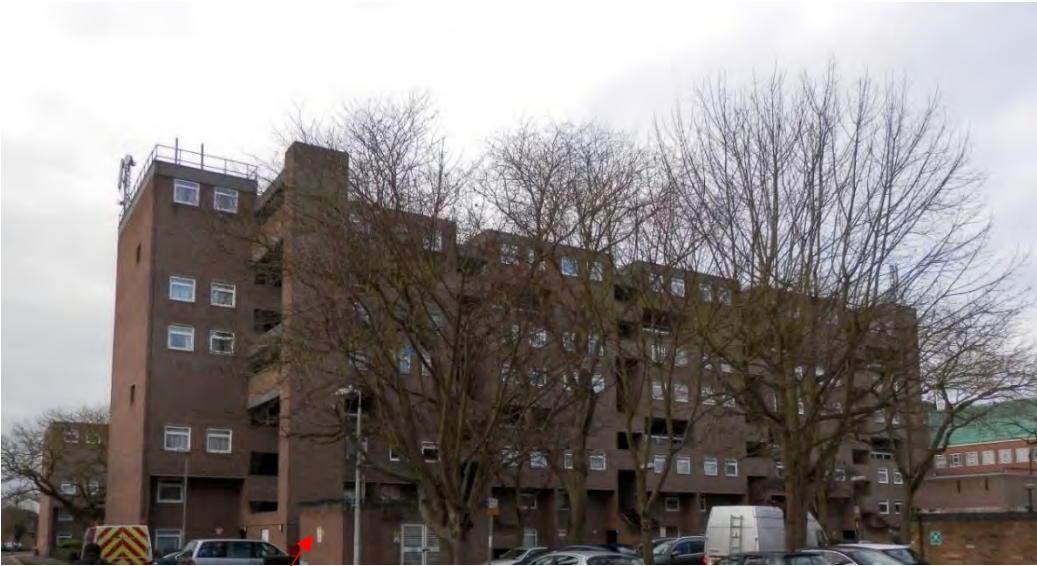
General View of the Tallest Block Hanover Court Eight Storey High – Eastern Elevation

Note: - The slender Bin Chute Tower located towards the left (south) of this view.

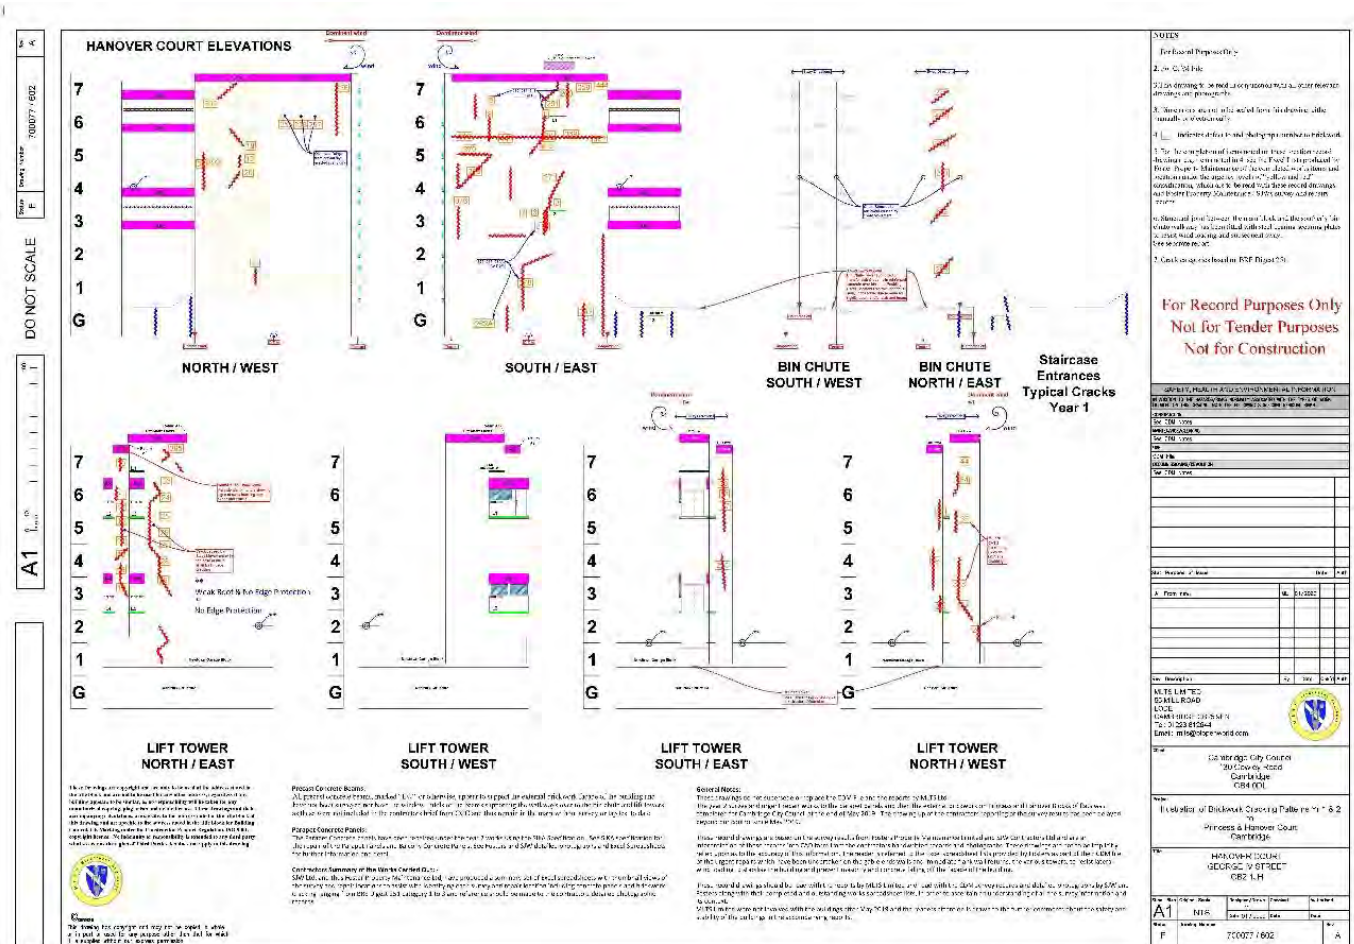
The cracking patterns within the tower structures suggests damage principally due to wind loading acting on these structures due to their tall slender walls resisting lateral sway resisting wind loading.

Towers: - These tall slender towers appear to act independently due their relatively slender nature, particularly the Bin Chute Towers.

These towers are not rectangular in plan consistently right down their entire height particularly and critically at the bottom of the towers adding to their flexure of the towers in strong winds.

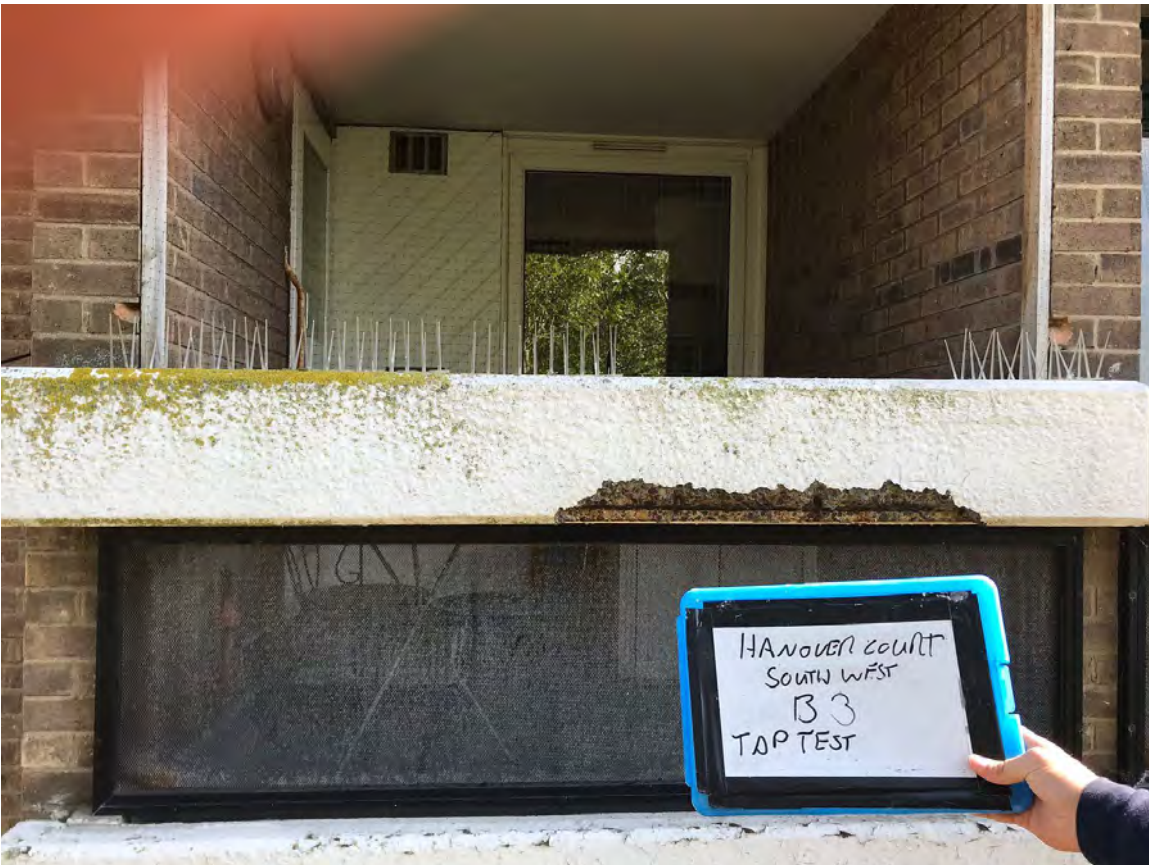
Typical Site Record for each location of any defect resulting in SJW / Fosters Spreadsheet

Balcony Beam Typical Loose Concrete Removal: - Note the rusty square twist reinforcing bars buried within the precast concrete balcony panels.

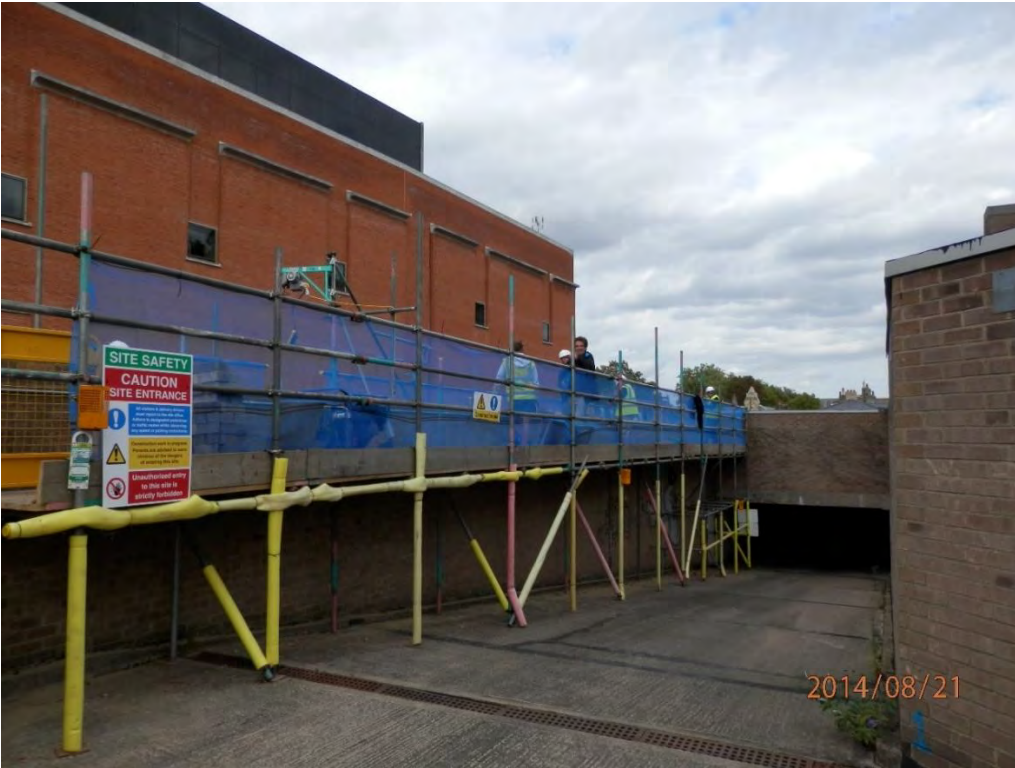
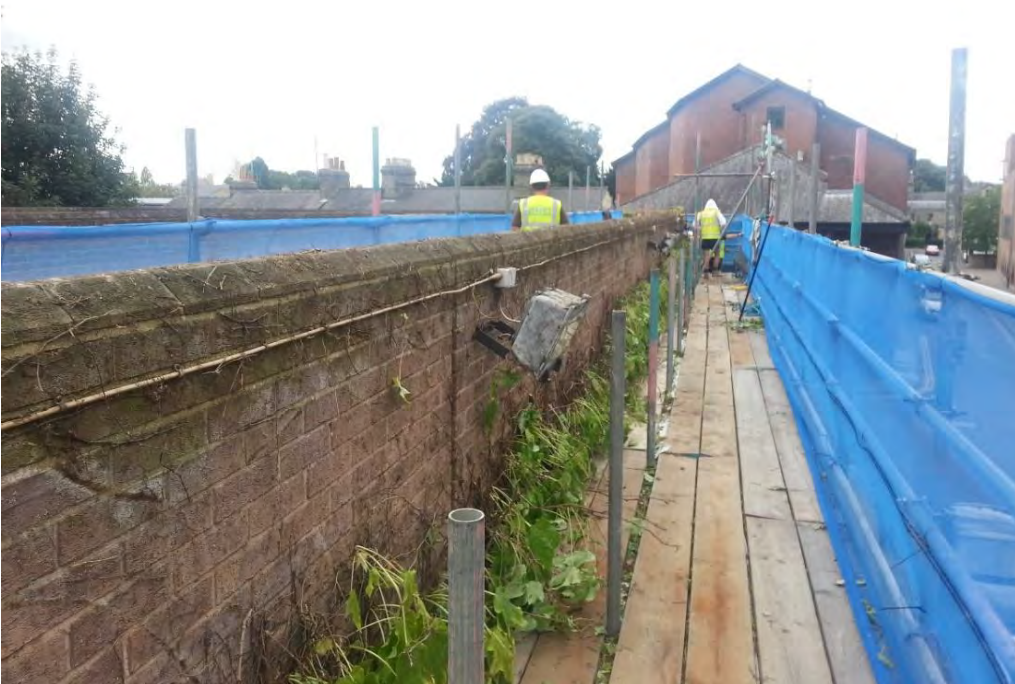
General Views of the unstable access ramp wall

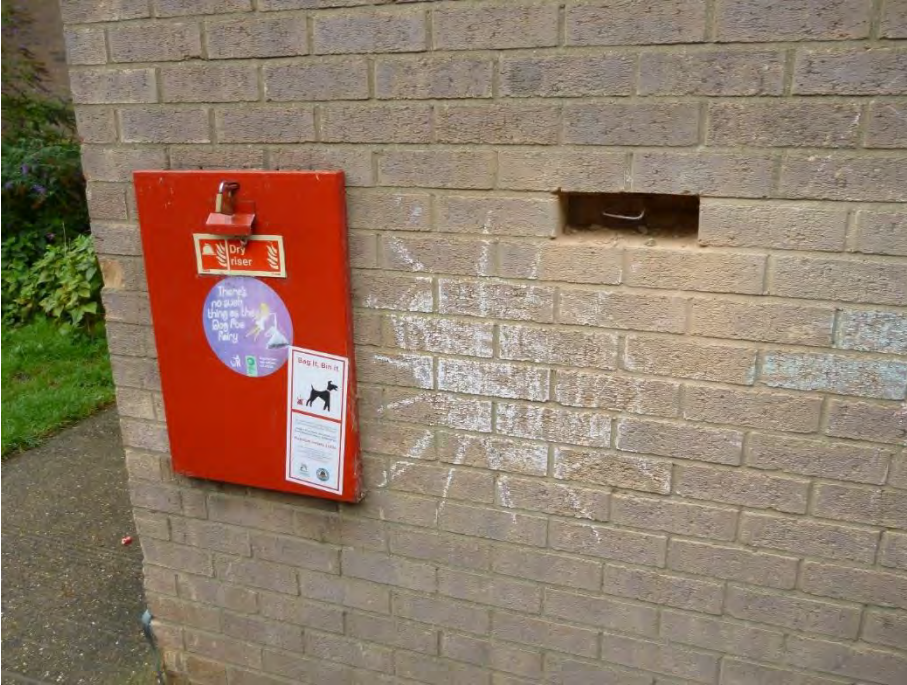
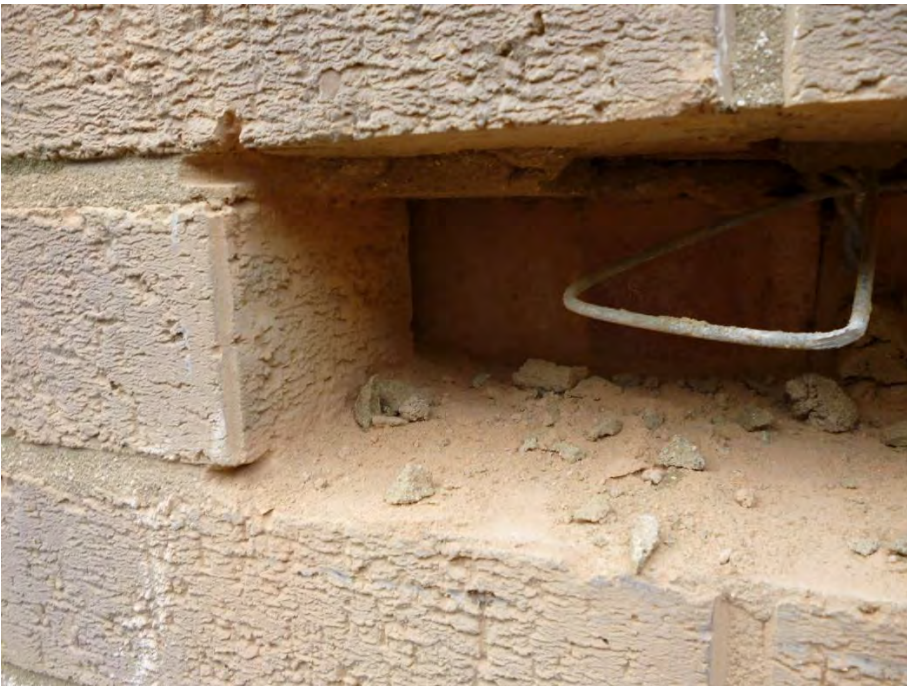
No Cavity just a 10mm to 12mm wide vertical open joint between the two layers of Brickwork.

Note: - the hole for the Dry Riser effectively weakening the tower near its base against both vertical and lateral loading.

Brickwork: - Only appears to be an overall with both layers of brickwork to be in the order of 225mm thick.

Note the butterfly ties are not sufficient to transfer shear between the layers of brickwork for composite action to occur they merely tie the brickwork together thus reducing the effective lateral stiffness of Brickwork to two layers acting alone rather than cross bonding the brickwork together to form one solid and much stiffer wall forming the bin chute tower structures.

Note: - the galvanising on the butterfly ties appears to still be sound possibly due to the density of the mortar and the facing bricks?

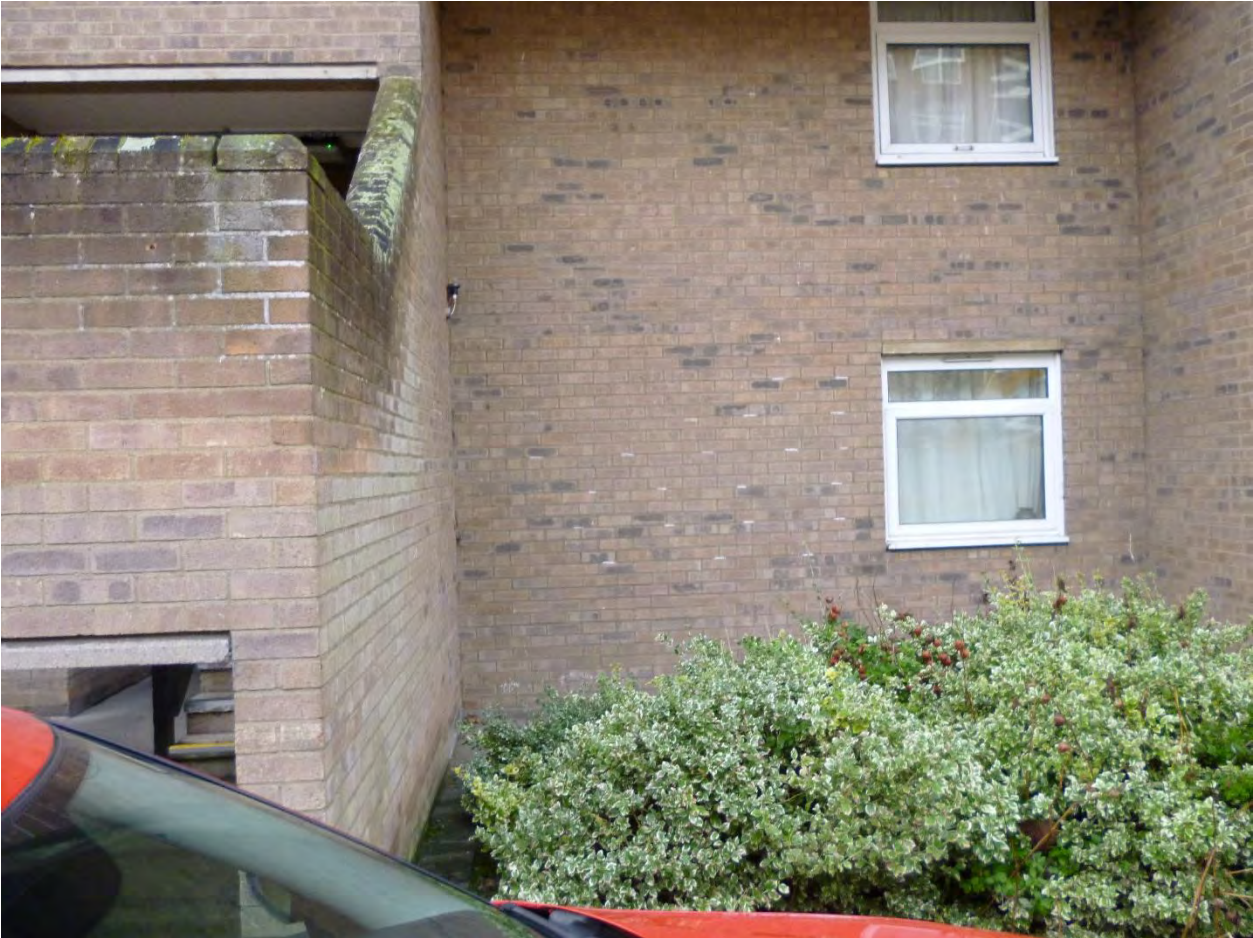
Princess Court Sample Panel – Tracing Brickwork Ties with metal detectors

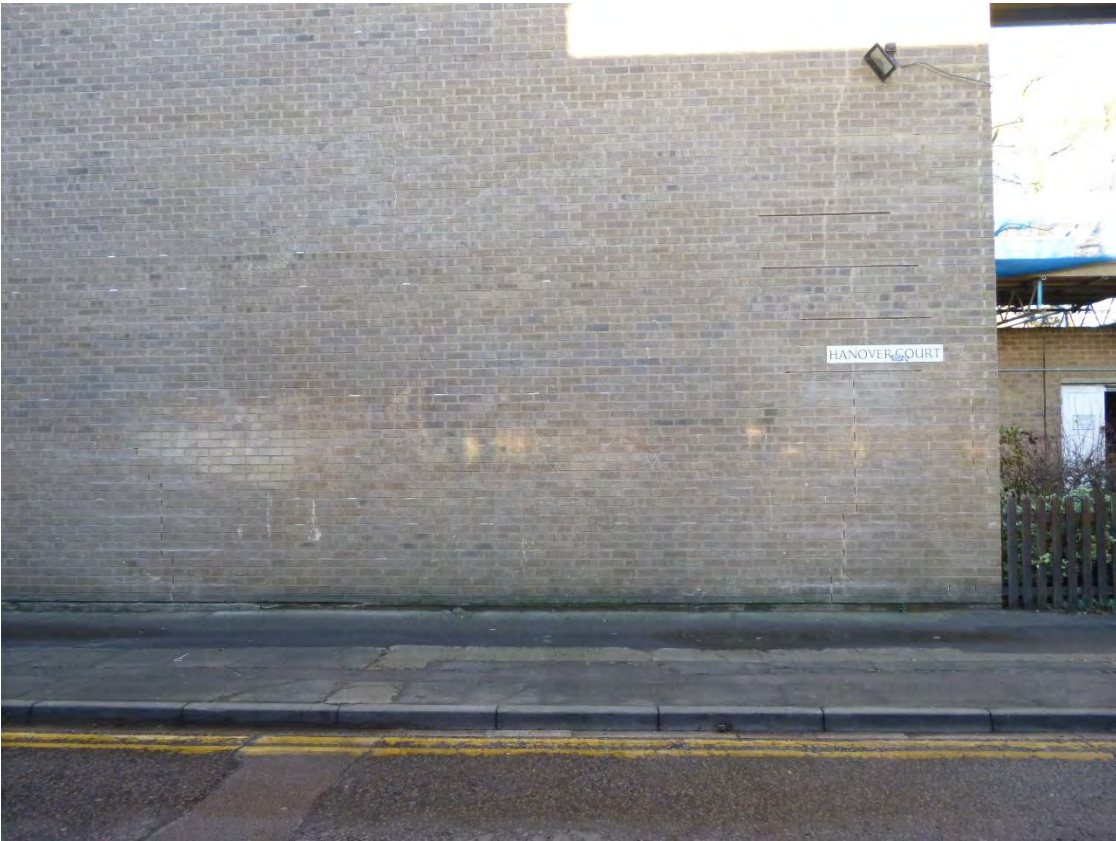
Hanover Court Sample Gable End Panel Tracing Brickwork Ties – Note the unusual pattern

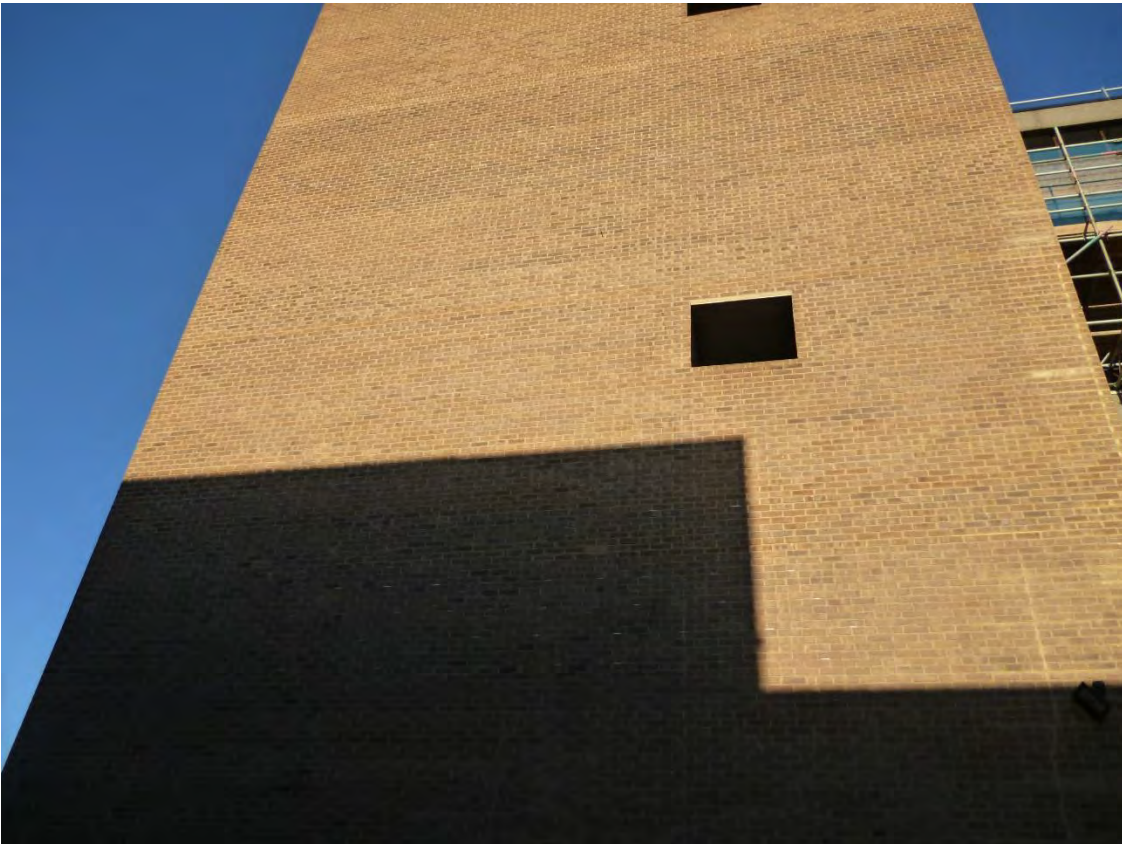
Ditto a view higher up note the short horizontal chalk marks for the tie locations.
