**MLTS Limited,**  
*Structural Engineers,*  
55 Mill Road,  
Lode,  
Cambridge.,  
CB25 9EN  
Tel.: - 01223 812644  
Email: -mlts@btopenworld.com

Date: 28<sup>th</sup> February 2020

**Preliminary Report on the Apparent Cracking within the External Façade Brickwork, Concrete Façade Panels and Year 2 Urgent Remedial Works of Princess and Hanover Courts, Cambridge, CB2 1JJ and CB21 JH**

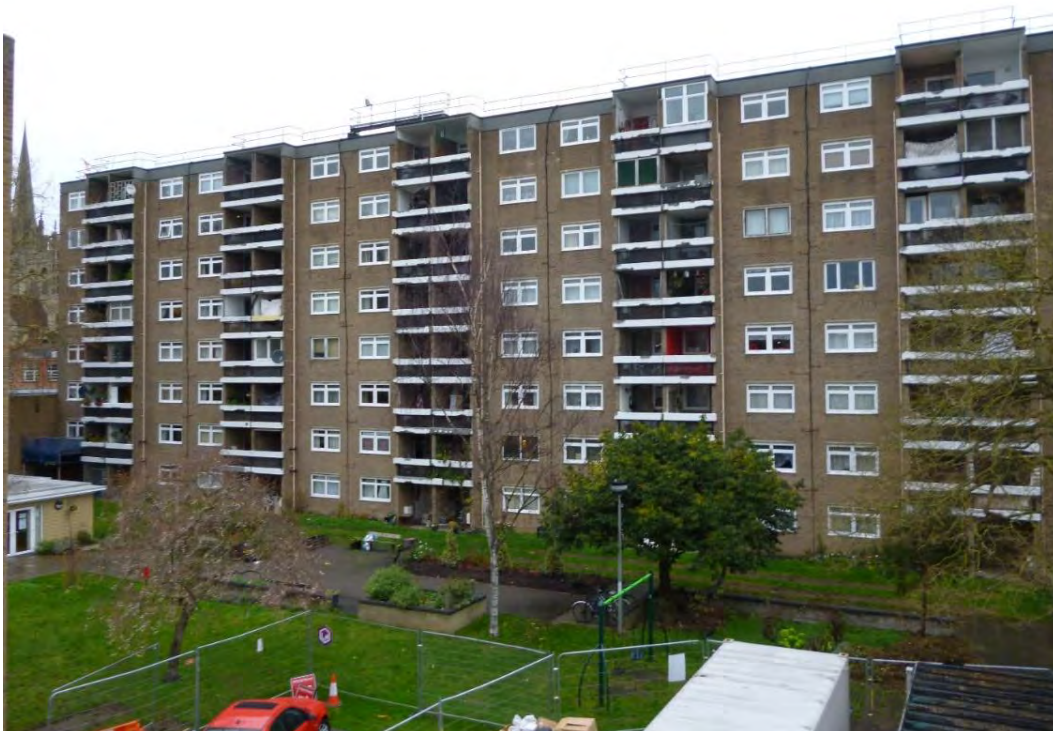
**Hanover Court Western Elevation:** - Note the grey Sika 903 and Sika 610 temporary blinded areas on the concrete balcony panels. See SJW Photographs and lists of the defects and locations and MLTS Ltd Drawings for overall view of these records.

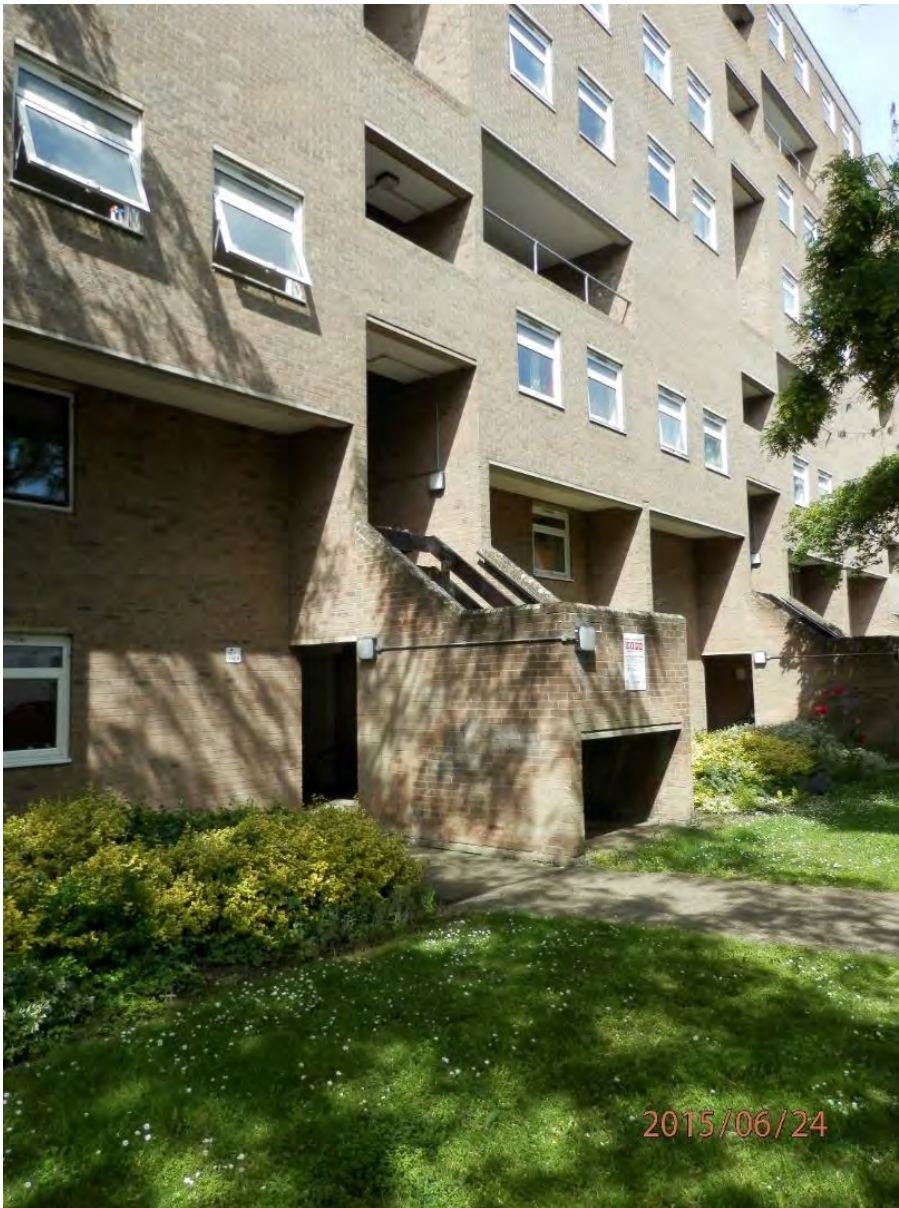
### Eastern Side of Hanover Court Typical Entrance Structure Ditto Princess Court: -

**Note** the entrance crippling the supporting pier above and the concrete lintel over resting upon the staircase structure and brickwork, repaired Year 1.

**NB:** - The main drains are understood to run along under these staircase structures and the eastern slender bin chute towers adding to the issuers and potential issues with structural movements caused by drains and trees.

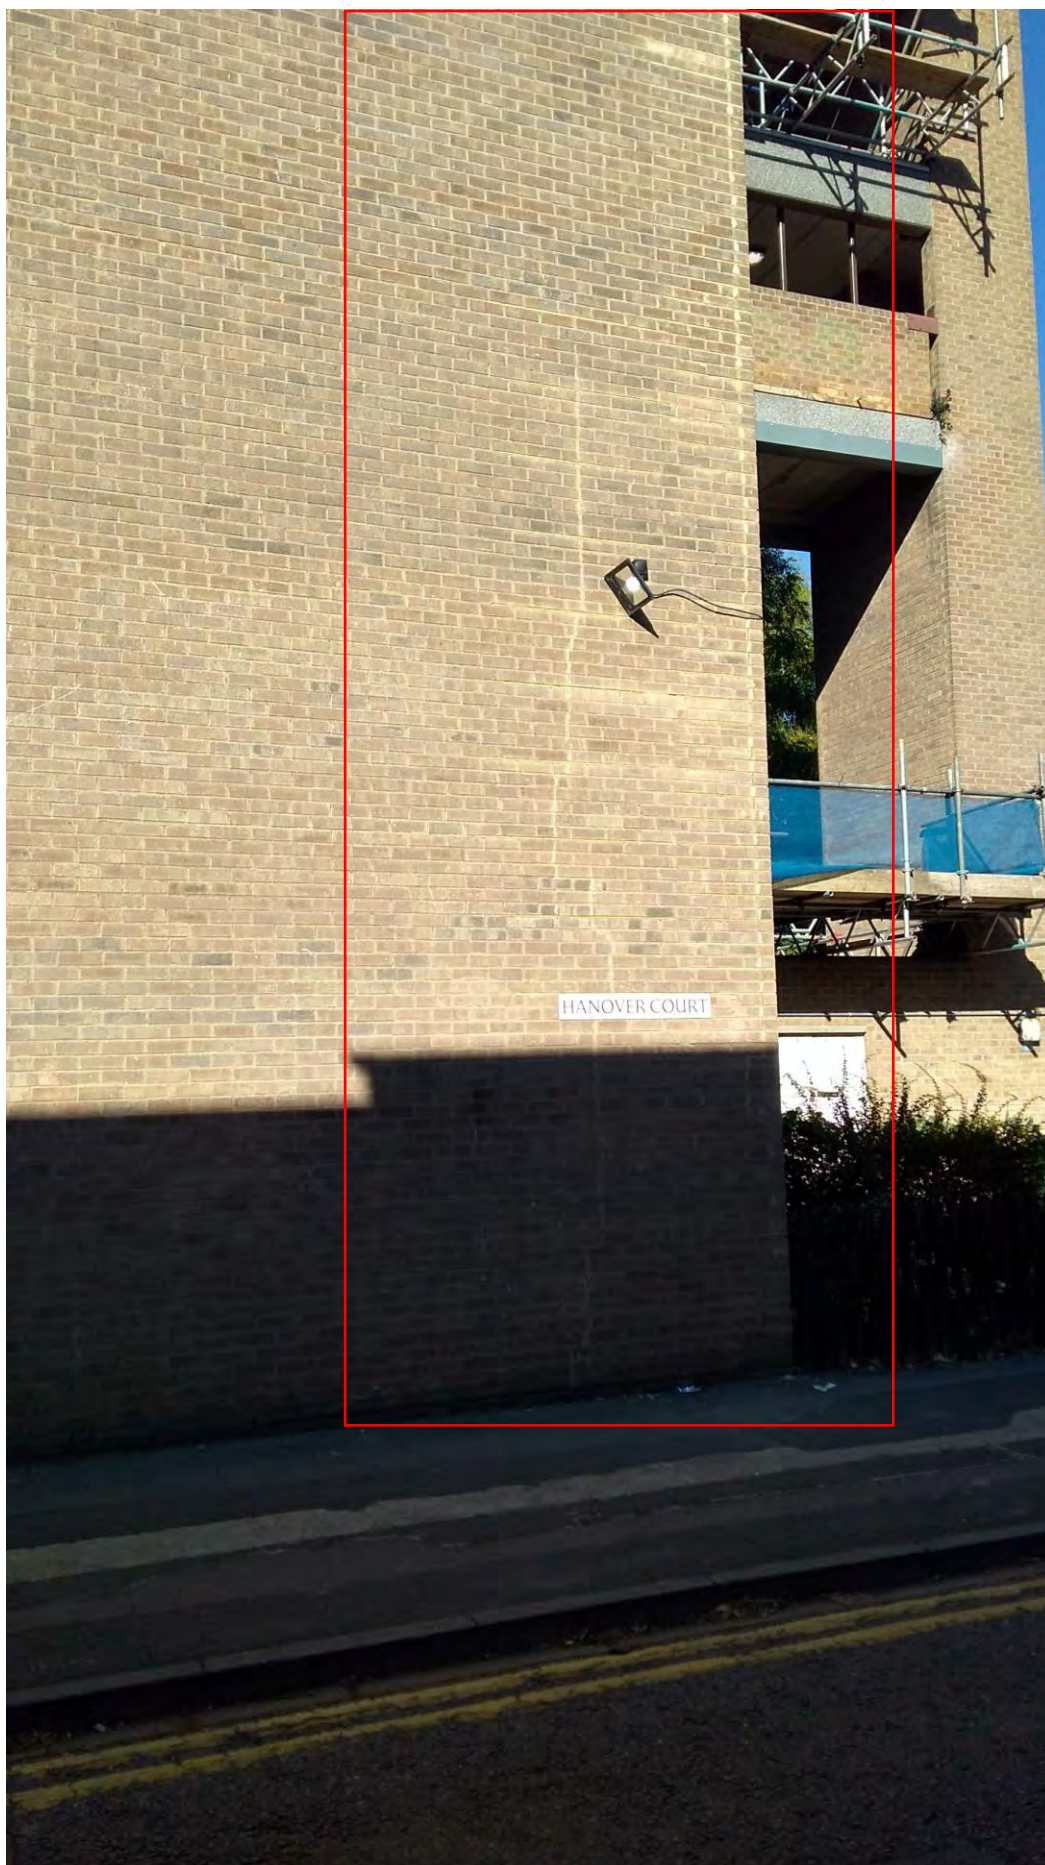
**Corner of Hanover Court after Repairs 2017 / 2019 Ditto Another View**

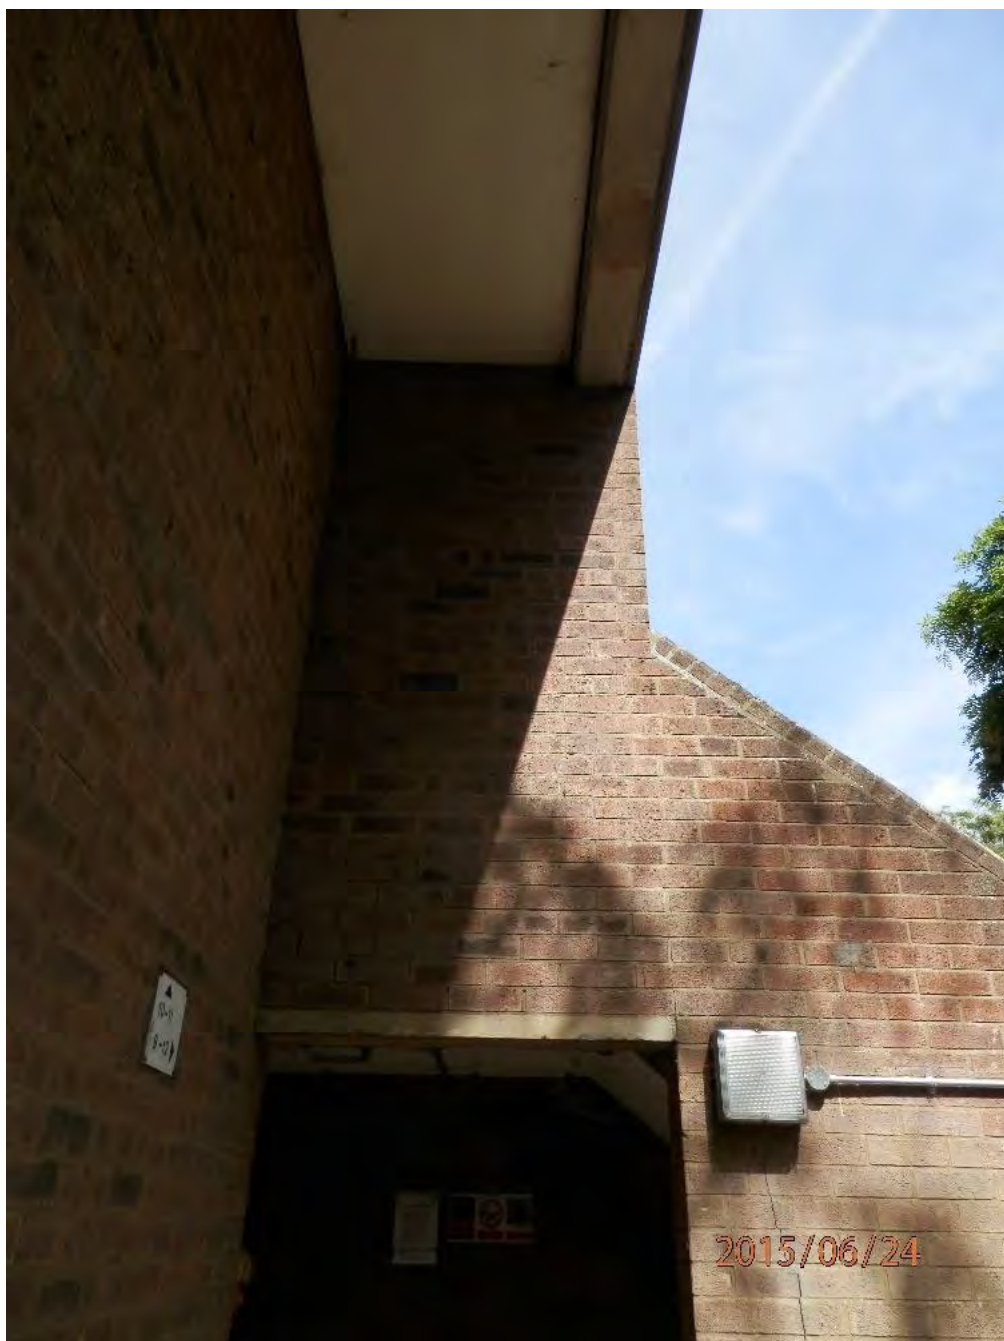
**Eastern Side of Hanover Court Typical Entrance Structure Cracking - Repaired in Year 1 Urgent Works**

**Note** the entrance crippling the supporting pier above and the concrete lintel over resting upon the staircase structure and brickwork

**NB:** - The main drains are understood to run along under these staircase structures and the eastern slender bin chute towers adding to the issues and potential issues with structural movements caused by drains and trees.

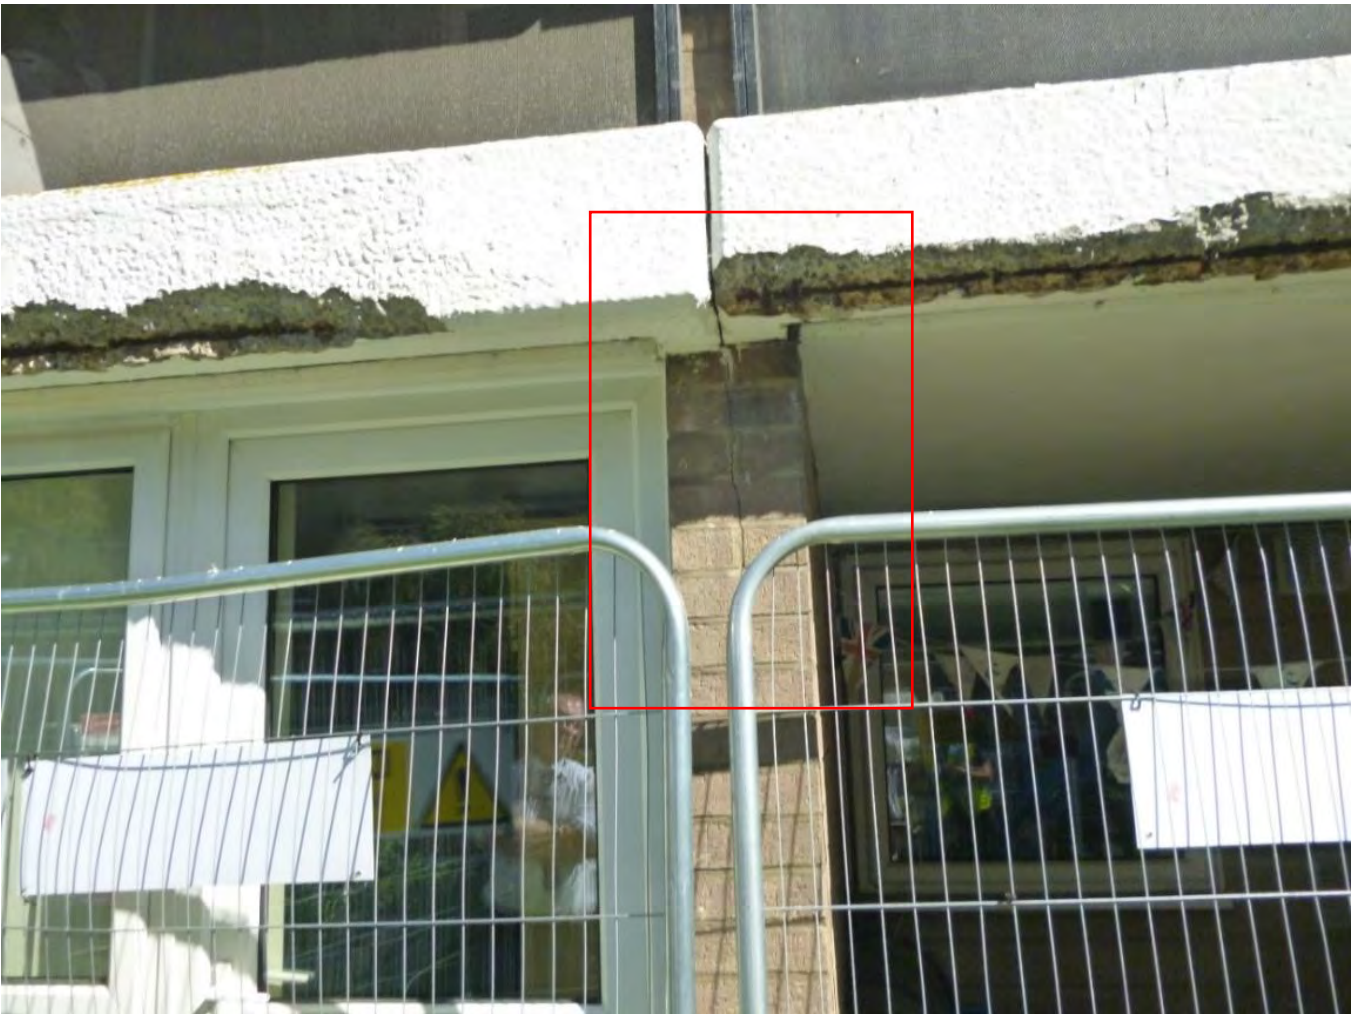
**Balcony Beam Typical Loose Concrete Removal:** - Note the rusty square twist reinforcing bars buried within the precast concrete balcony panels.

Also note the crack in the masonry party wall on the western side due to the loading including wind loading compression load due to wind acting on the eastern side of the building.

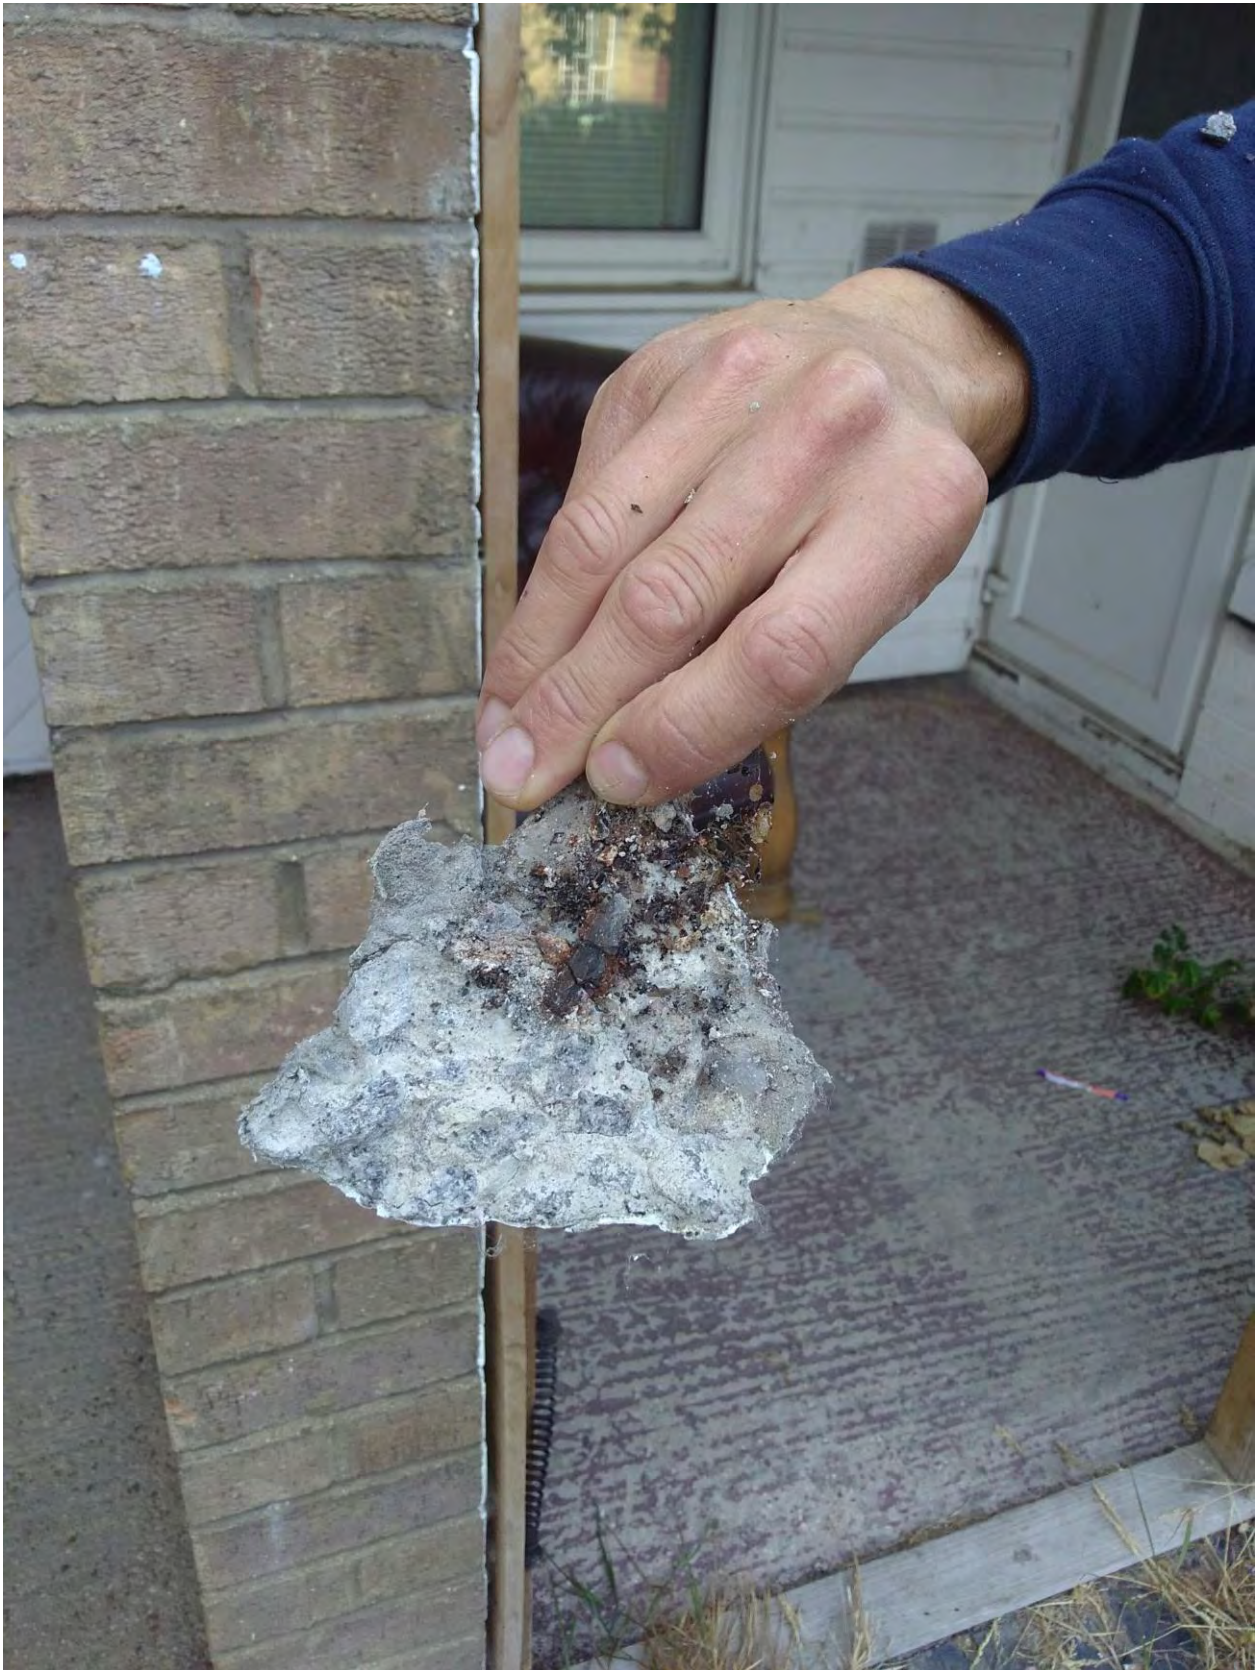
**Typical loose Balcony panel corner Removed Easily by Hand.**

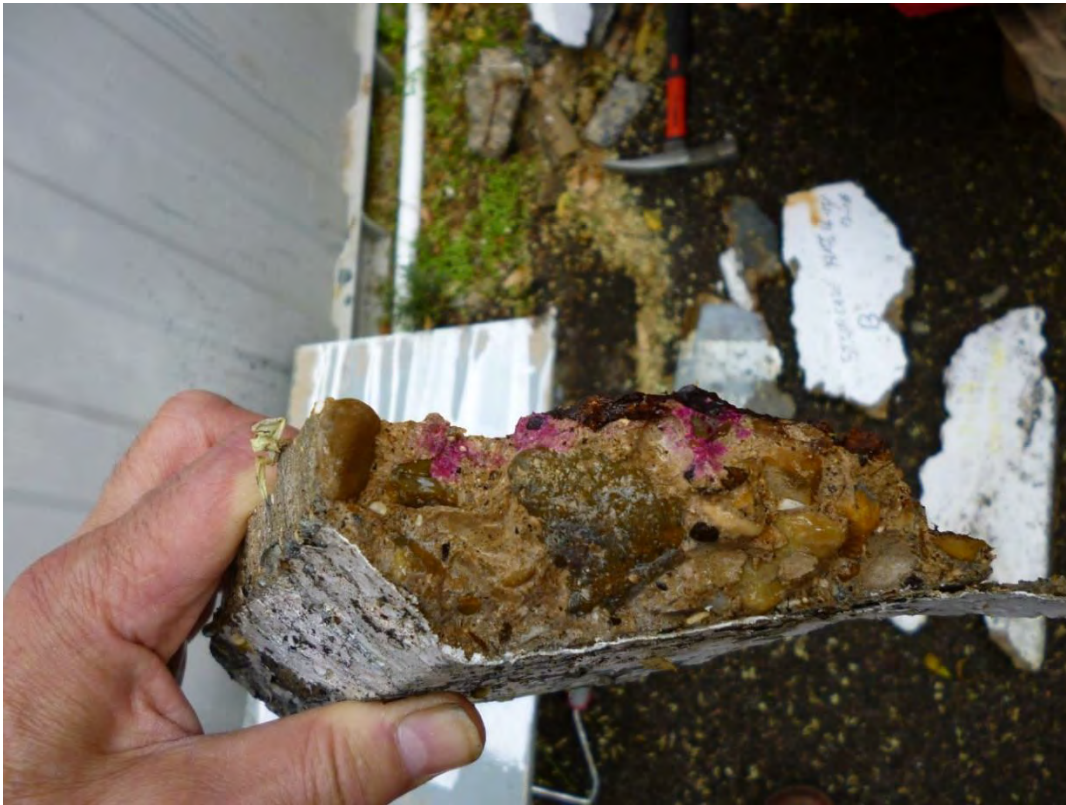
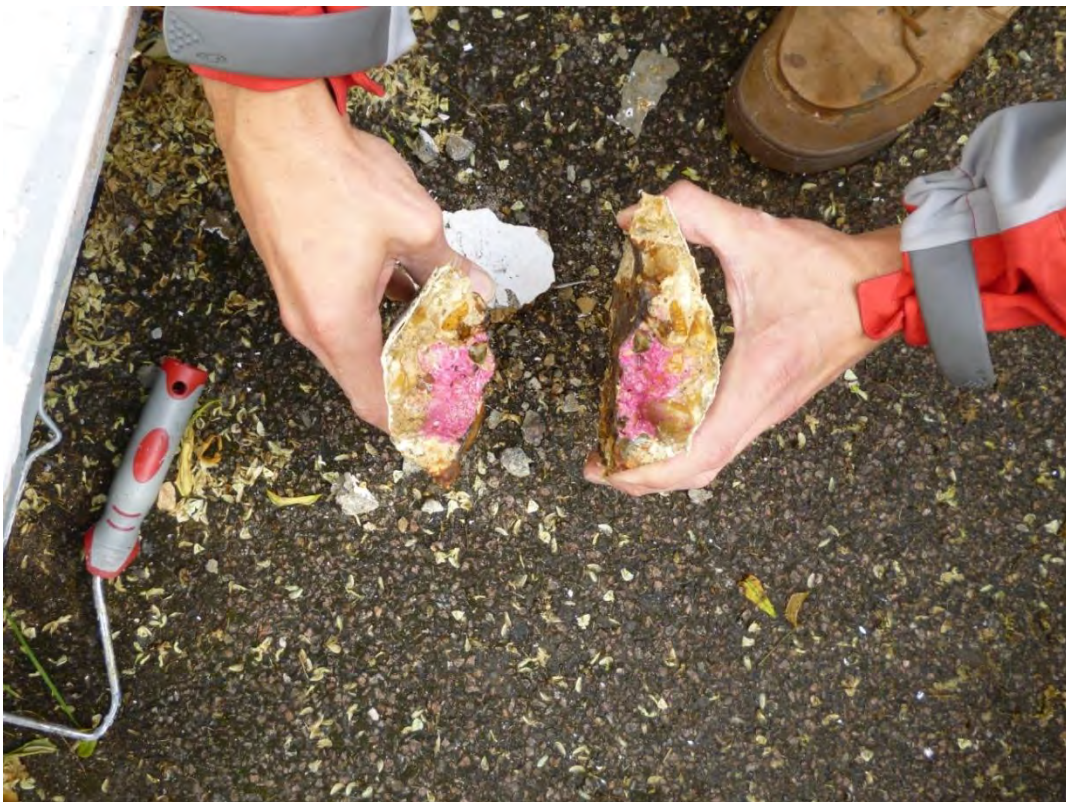
**Note** the only concrete retaining any alkalinity to help bars resist corrosion is turned pink by the carbonation test the remaining concrete is carbonated and has lost its natural alkalinity due to exposure to the environment. Note: - the almost complete carbonation of the lower drip detail on the panels containing the corroded reinforcing bars.

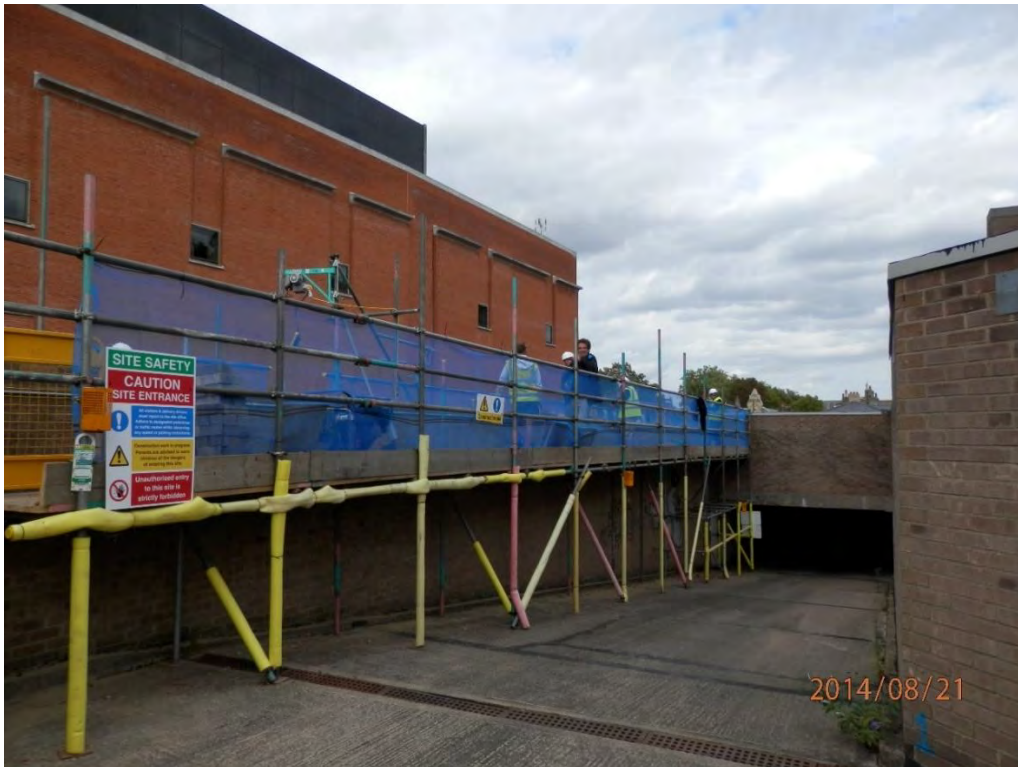
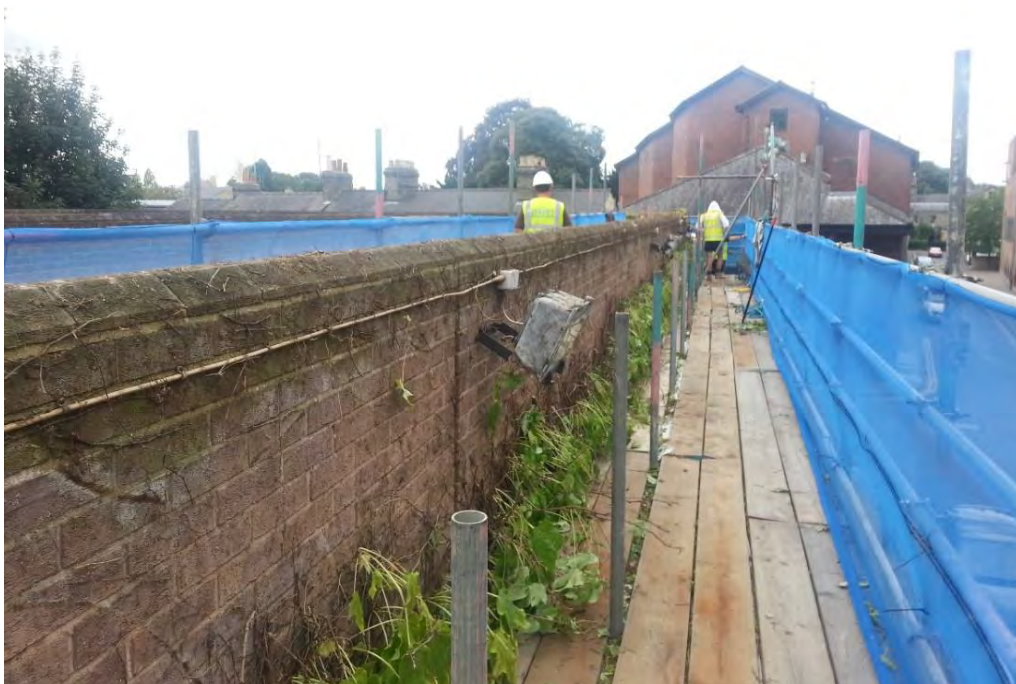
General Views of the unstable access ramp wall

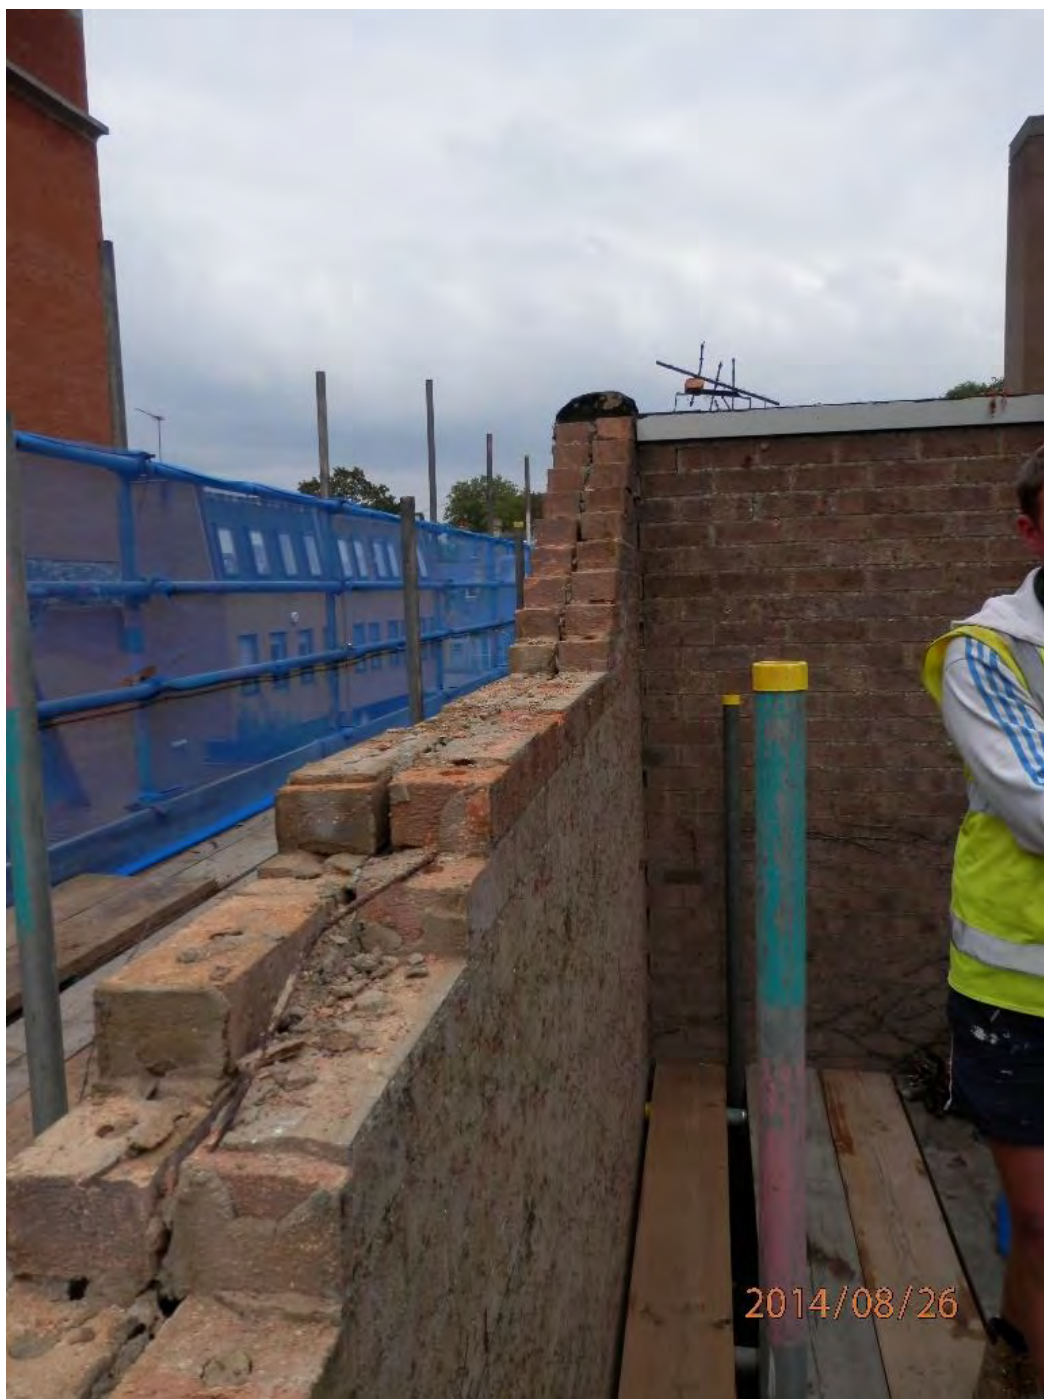
**Removal by hand of the loose and frost damaged brickwork – Note the easy separation of the bed joint mortar from the bricks and at the perpend joints. Indicating that the bond between the mortar and the bricks was not especially good possibly as result of the early use of plasticizers to keep the mortar workable for longer periods. Note the clean mortar bed separation with the removed bricks.**

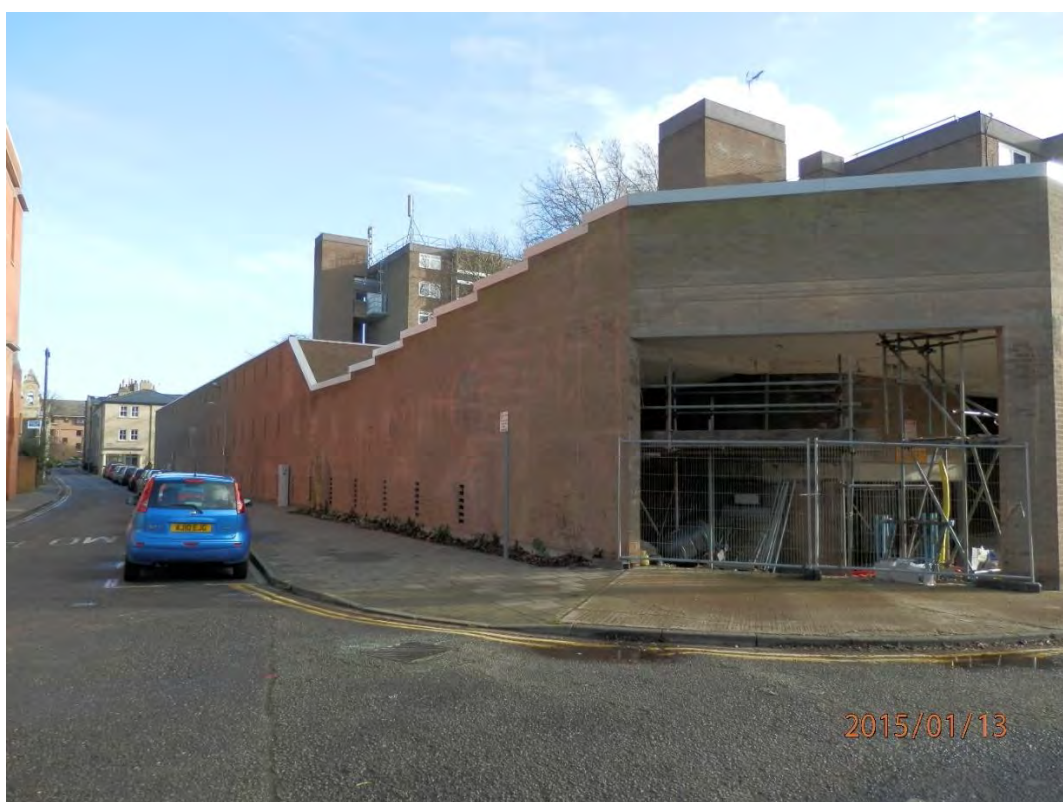
**External View - after the Year 0 Remedial works and the reduced and tied back external wall located aside the car access ramp.**

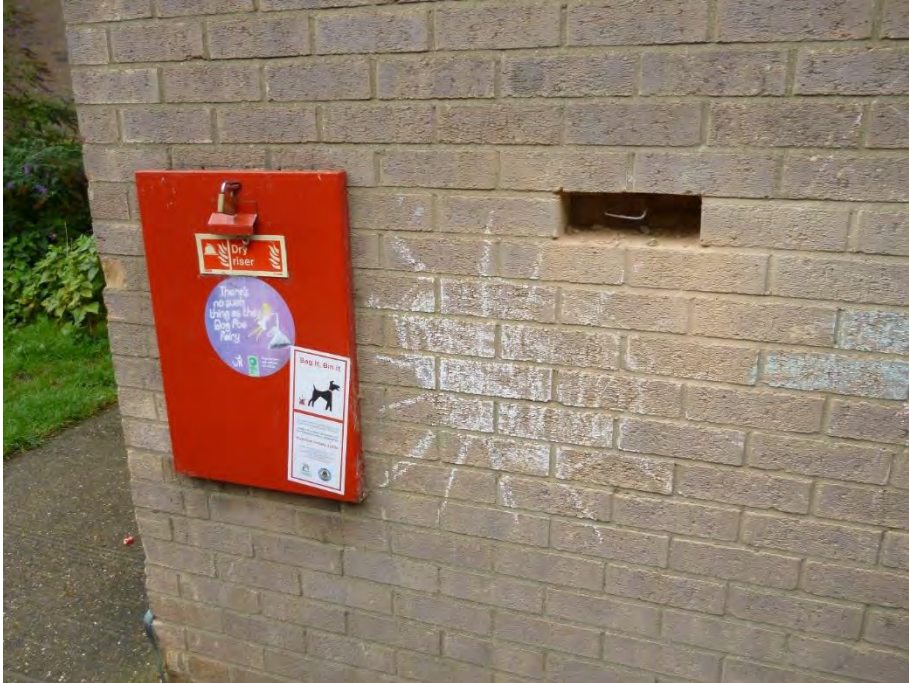
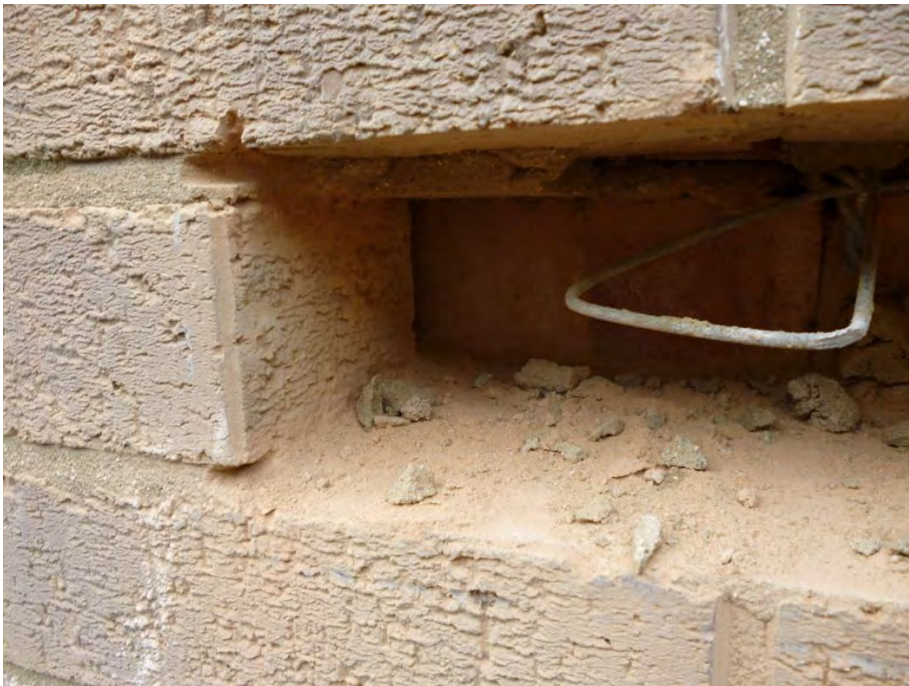
**Brickwork:** - Only appears to be an overall with both layers of brickwork to be in the order of 225mm thick.

**Note** the butterfly ties are not sufficient to transfer shear between the layers of brickwork for composite action to occur they merely tie the brickwork together thus reducing the effective lateral stiffness of Brickwork to two layers acting alone rather than cross bonding the brickwork together to form one solid and much stiffer wall forming the bin chute tower structures.

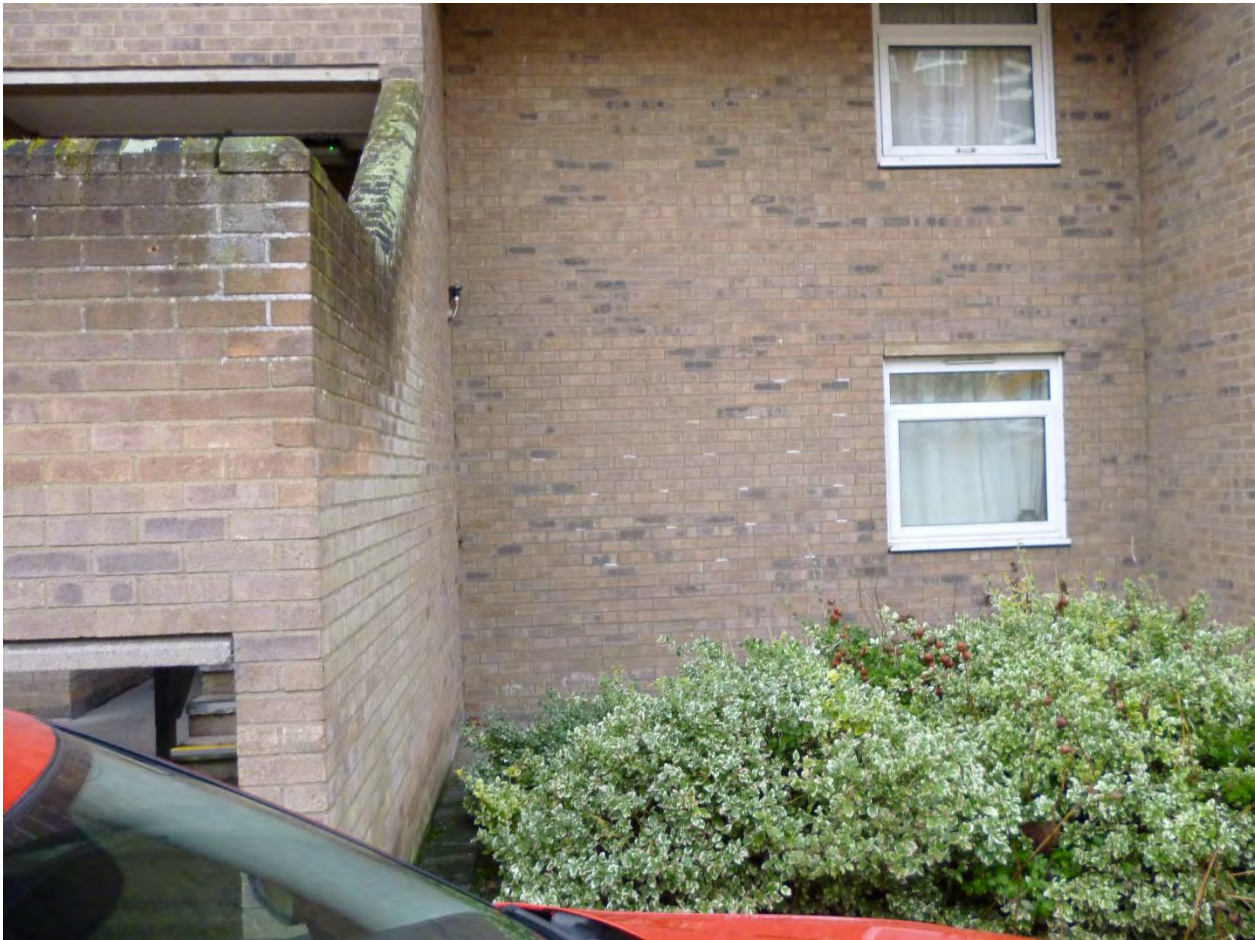
**Princess Court Sample Panel – Tracing Brickwork Ties with metal detectors**

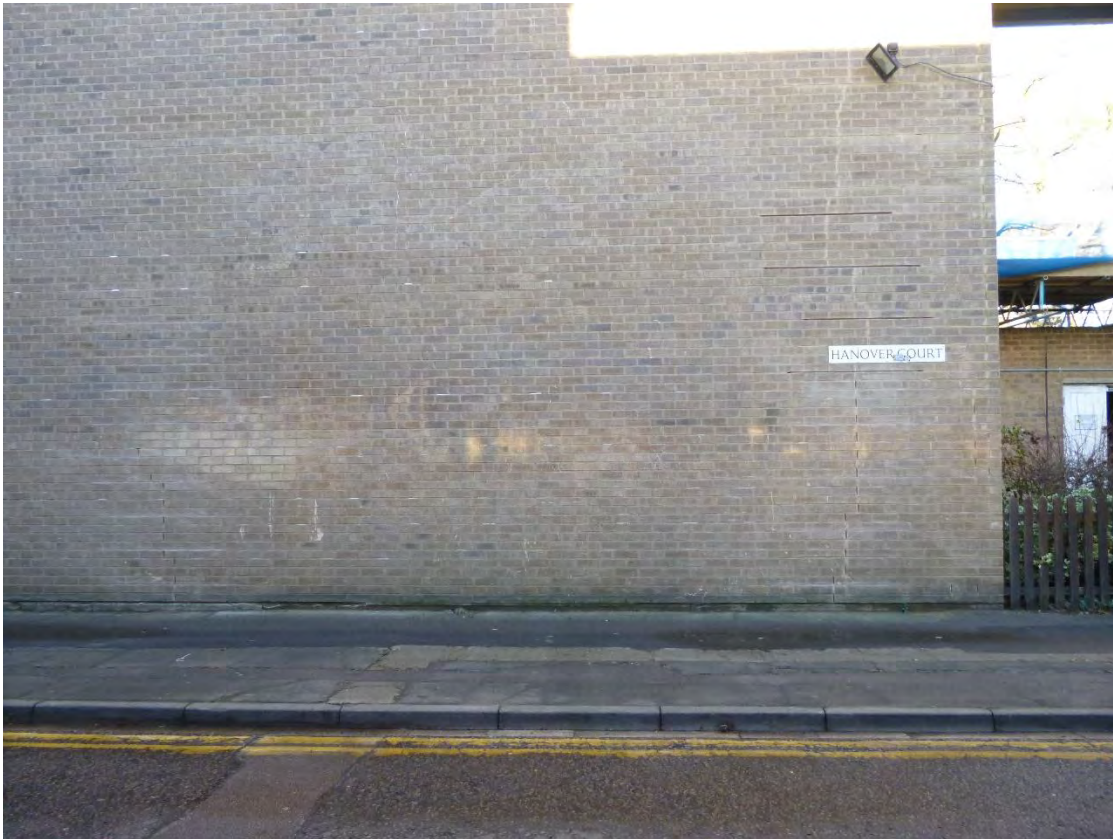
**Hanover Court Sample Gable End Panel Tracing Brickwork Ties – Note the unusual pattern**

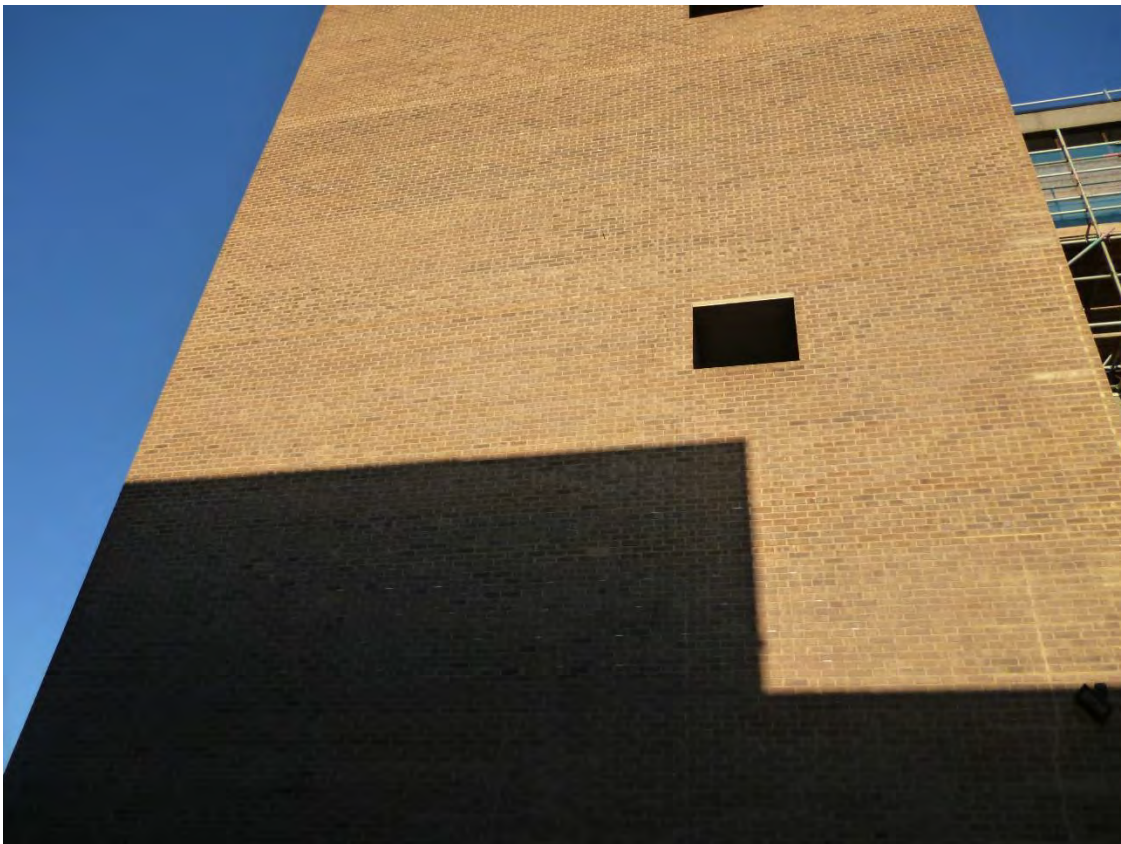
**Ditto a view higher up note the short horizontal chalk marks for the tie locations.**

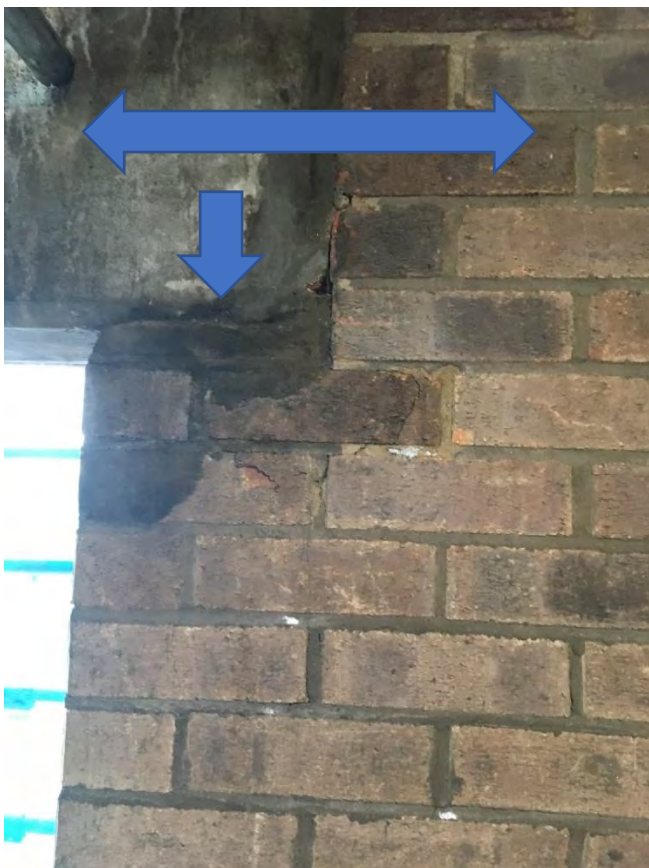
**Ditto another view**

**Note: - The typical crumbling and cracking brickwork due to the combined vertical and horizontal loadings**
