# REGULATORY REFORM (FIRE SAFETY) ORDER 2005

## Fire Risk Assessment

**Assessed Area:** Princess Court, Coronation Street, Cambridge

**Date of Inspection:** Jul 17, 2020

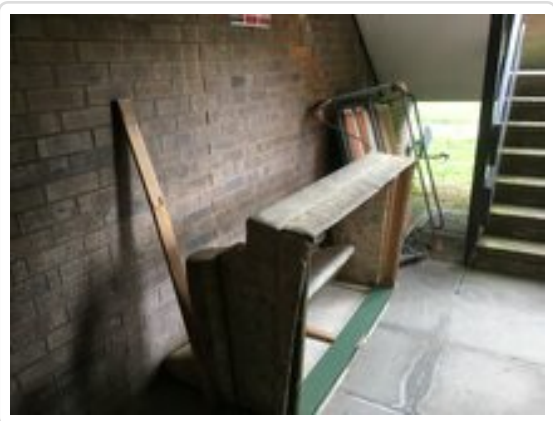
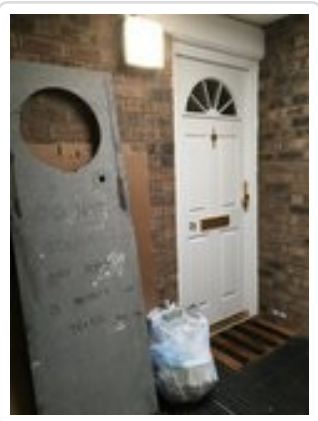
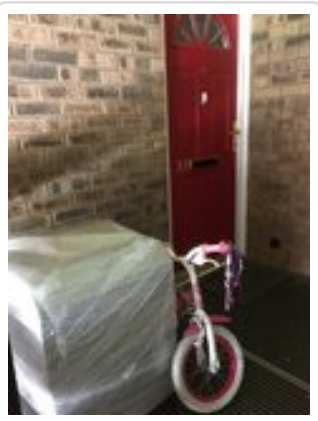
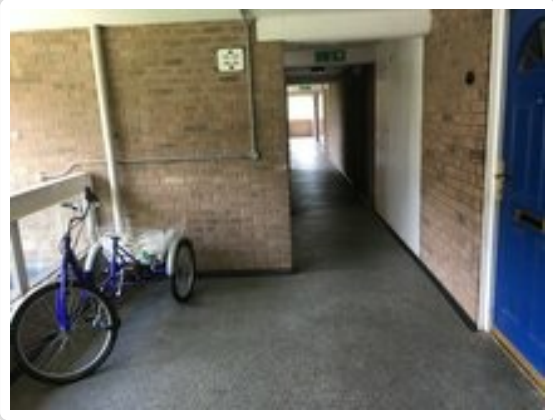
Housekeeping to the premises was poor in the following areas due to storage of bicycles and/or items outside flats causing an obstruction and trip hazard.

As can be seen from the attached images there are either bikes or items of storage outside some flat entrance doors. Application of the Council's zero tolerance policy as per other flats is recommended although acknowledged as difficult to implement in some instances.

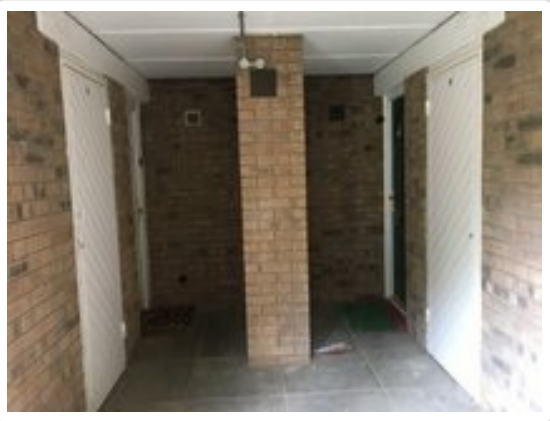
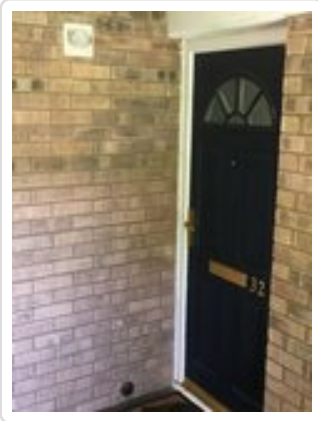
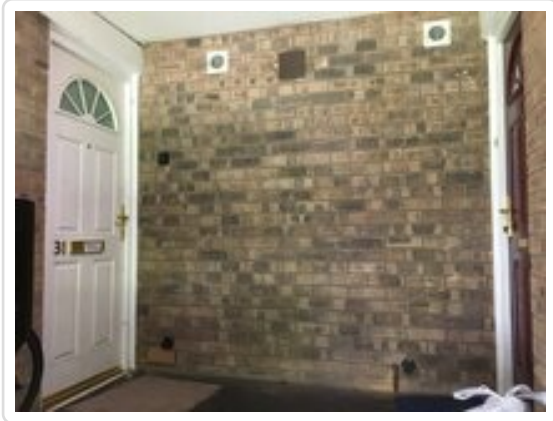
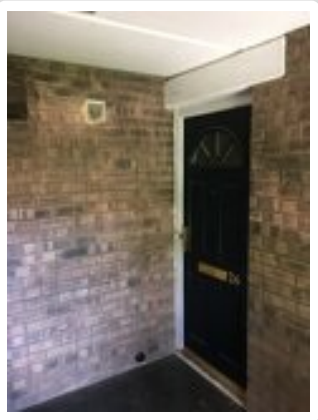
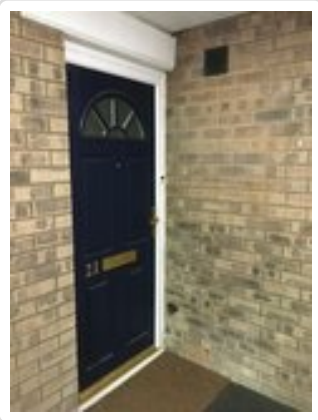
There is ventilator in the external wall outside flats: 8,9,21,26,30,31,32 & 49. Depending on its position inside the flat it may allow smoke to enter the stair in the event of a fire. It is noted that there is some ventilation to open air but this is not at the head of the stair and smoke logging may occur.

It is recommended that this is investigated and if necessary the ventilation re routed or an appropriate fire rated block fitted.
