REGULATORY REFORM (FIRE SAFETY) ORDER 2005

Fire Risk Assessment

Assessed Area: Princess Court > All Areas

Date of Inspection: 08 May 2023

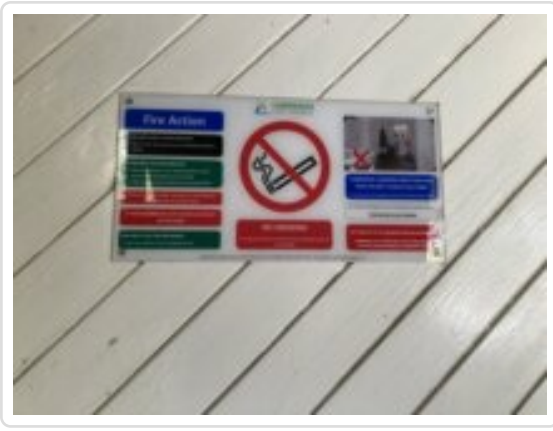
IMG_2378

A no smoking policy is applied to the communal areas in accordance with The Health Act 2006 and signage displayed accordingly.
— SC @ 22 Jun 2023 13:51:08

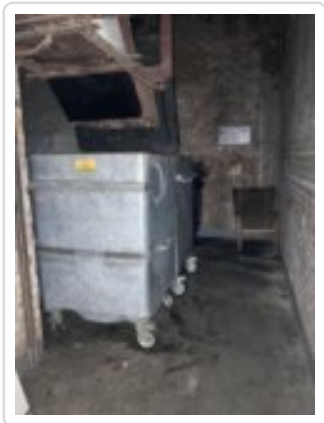
IMG_2398

Bin storerooms were in reasonable condition.

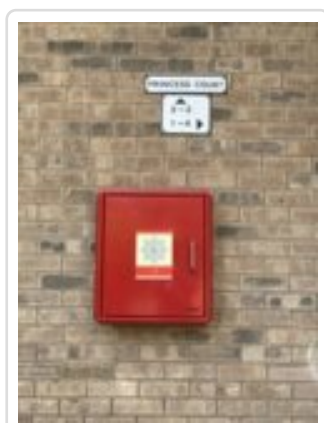
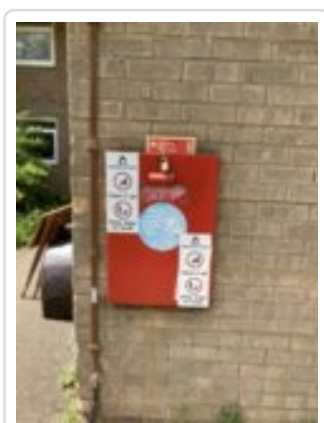
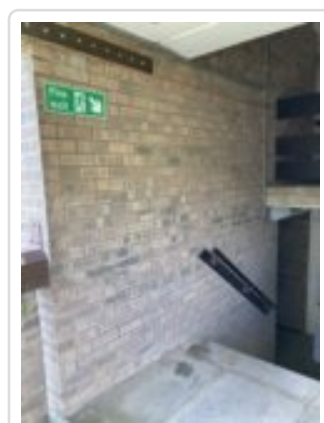
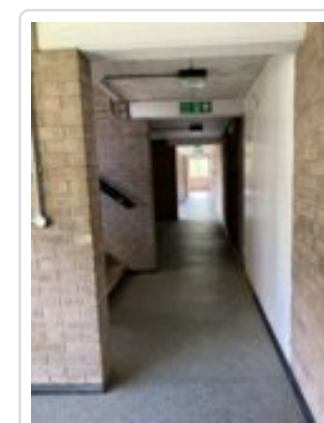
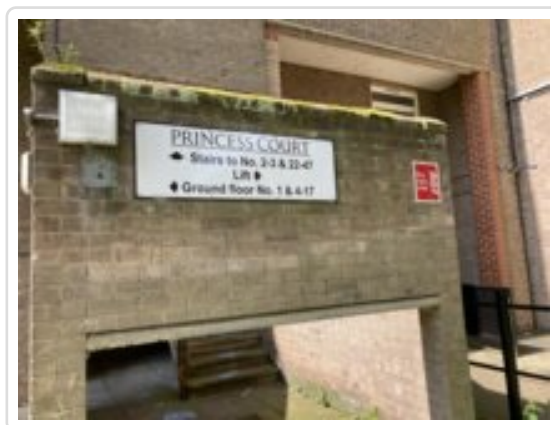
One of the DR inlet boxes has been defaced with stickers - the box is still identifiable to the FRS but it is recommended these are removed.

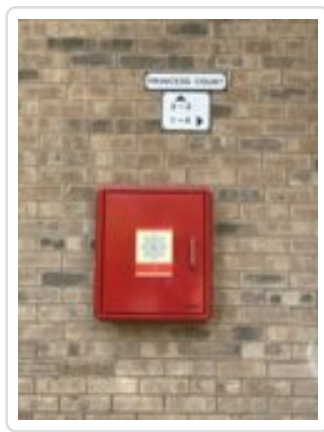
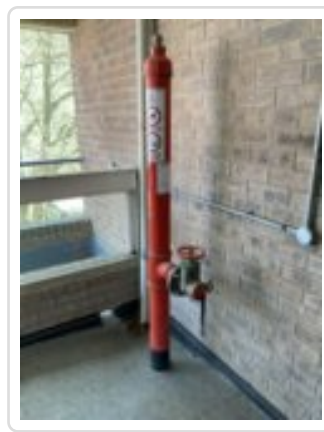
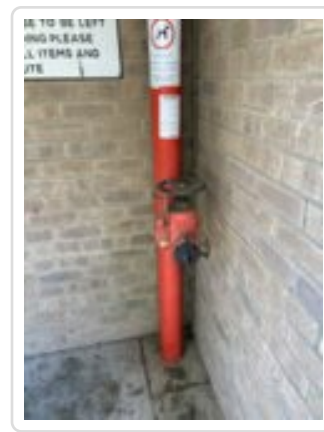
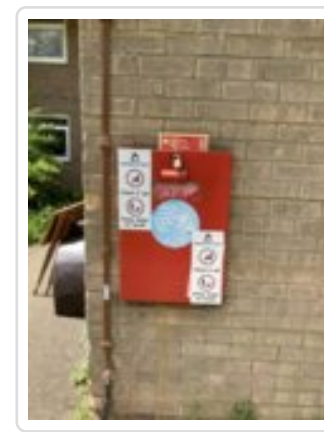
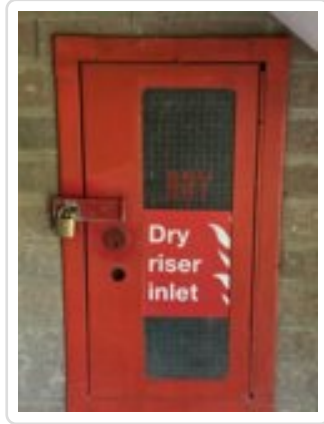
The DR outlets are not enclosed in a box for protection but were secured with a strap and lock.

It is recommended that the fire service are invited to use the DR's as part of a training/familiarisation exercise.

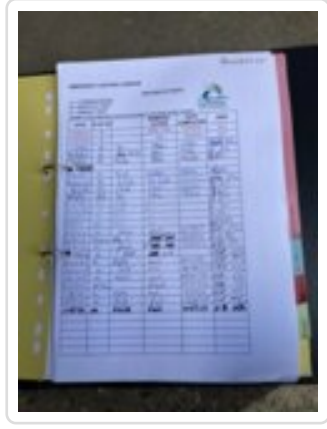
IMG_2366

Testing carried out by ATL - more failures as per 2022 FRA - fed back to TSG.

A defective outlet valve (seized) was observed on one of the risers. This was approved for remedial action by CCC on 13.06.2023 (e mail from John Conroy 13.06.2023). This should be undertaken ASAP to ensure the DR system is available for FRS use in the event of a fire on the upper levels - the lack of availability of this facility may delay the fire service in search and rescue/fire fighting operations.
