REGULATORY REFORM (FIRE SAFETY) ORDER 2005

Fire Risk Assessment

Assessed Area: Hanover Court > All Areas

Date of Inspection: 07 May 2023

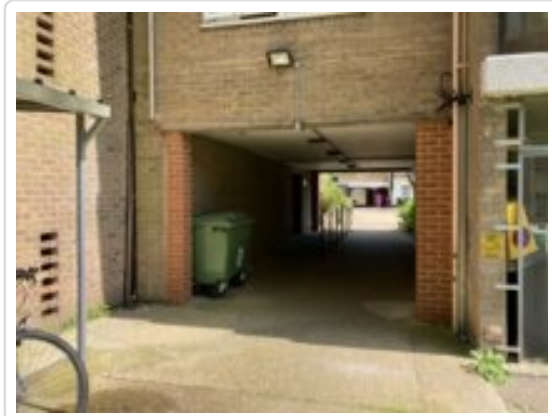
There was a large wheeled bin located under the archway that could be prone to an arson attack and should ideally be located away from the building, however, it was noted as being locked shut.

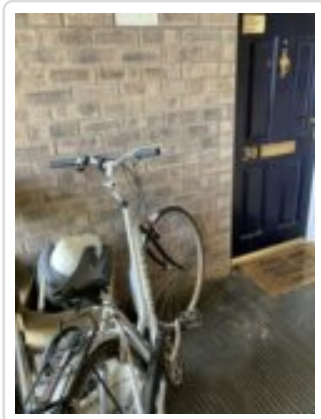
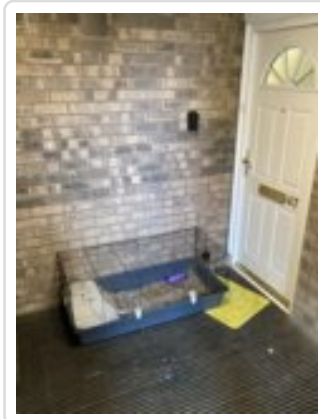
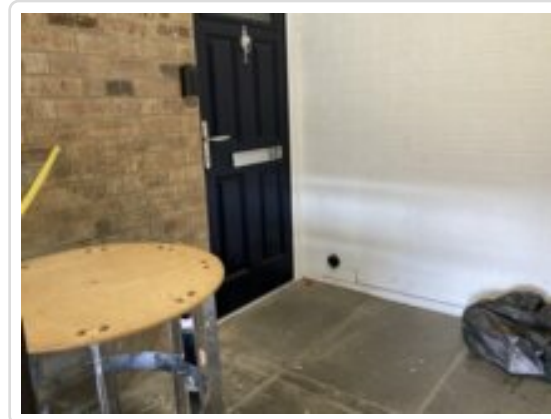
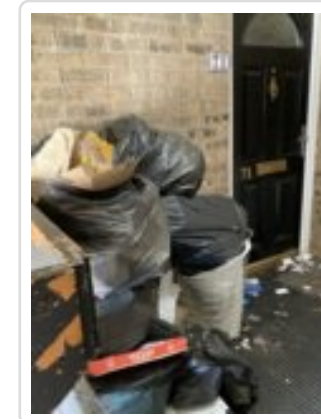
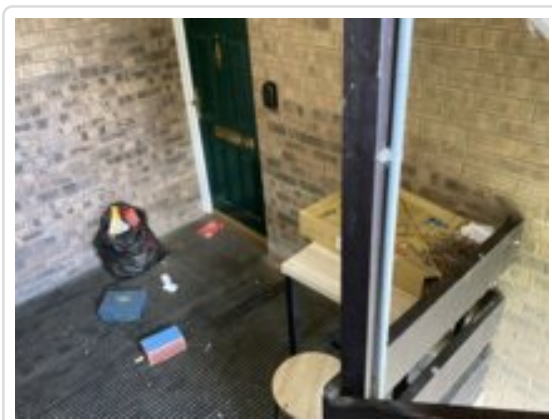
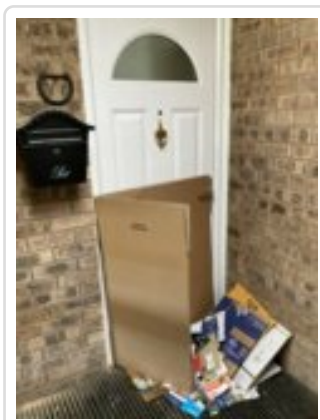
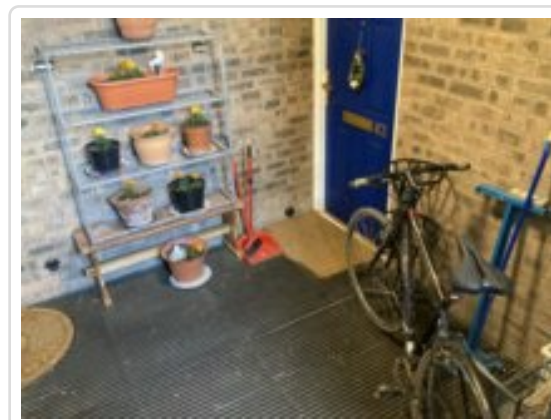
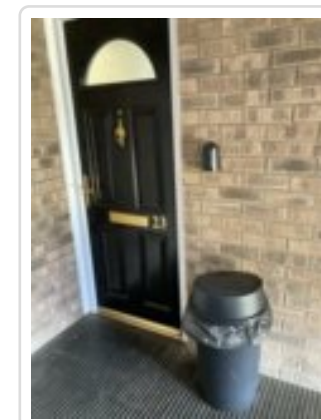
Items located in escape routes. These can be an obstruction to the means of escape, a trip hazard for fighters and add to fire loading in an area that should be managed as a sterile space.

A range of items were observed in the communal areas outside flat entrances. See photographs. Outside flats: 23/30/47/59/62/65/68/71/77.

As can be seen from the attached images there are either bikes or items of storage outside some flat entrance doors. Application of the Council's zero tolerance policy as per other flats is recommended although acknowledged as difficult to implement in some instances.

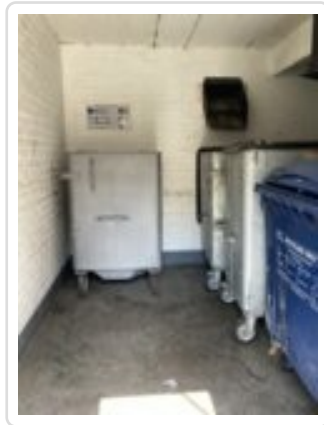
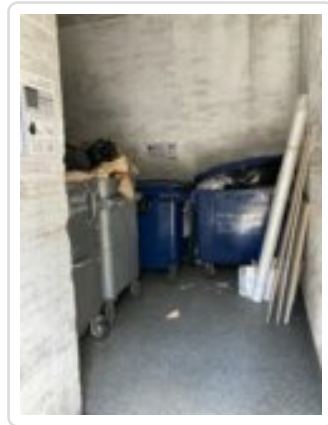
See action above. Bin stores were in good housekeeping condition.

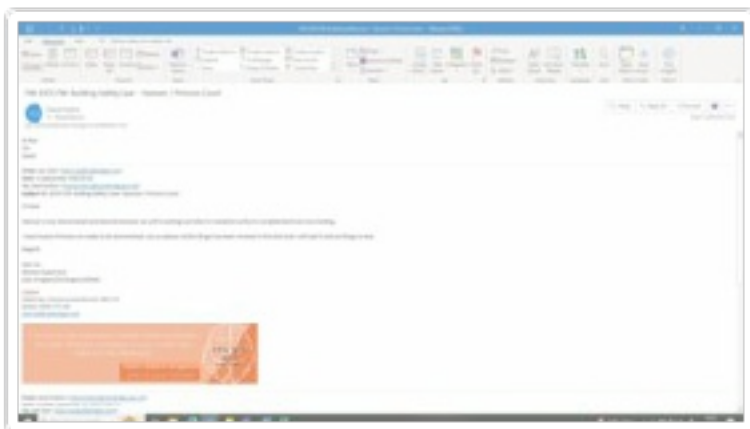
Hanover Princess Gas Removal

A report has been submitted to CCC regarding the ability the structures at Hanover and Princess Courts to cope with a gas installation explosion. The report recommends removal of gas installations at Hanover and Princess Courts to completely negate the risk of a progressive building collapse. The Council has accepted and will implement this recommendation.

Depending on the time taken to undertake removal and fitting alternative appliances, it is recommended that the Fire and Rescue Service are made aware of this hazard and resulting risk so that they can plan accordingly. Discussion with them regarding information in the PIB might be appropriate, as well as means to evacuate the block if required.

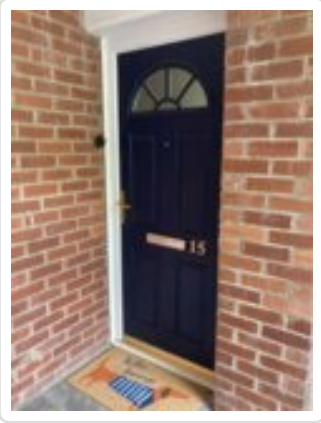
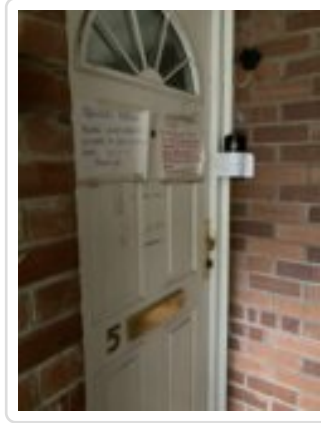
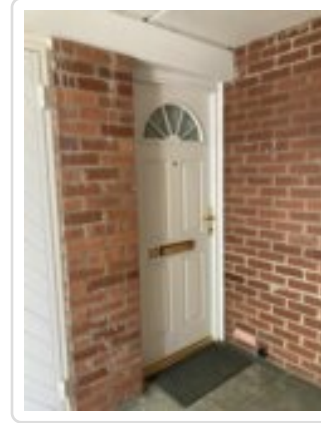
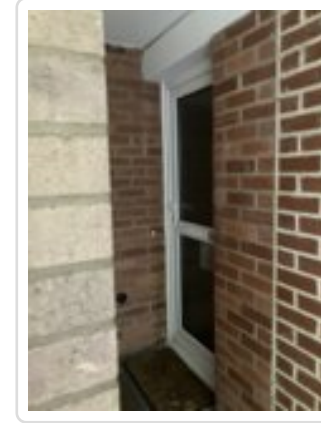
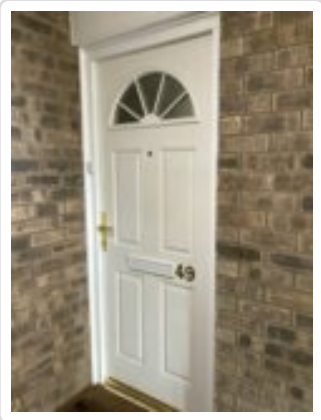
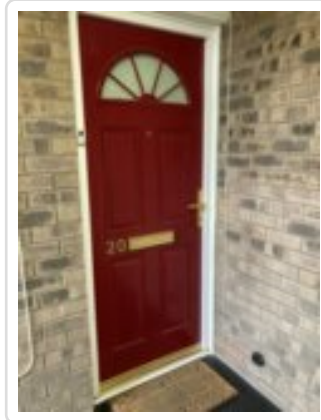
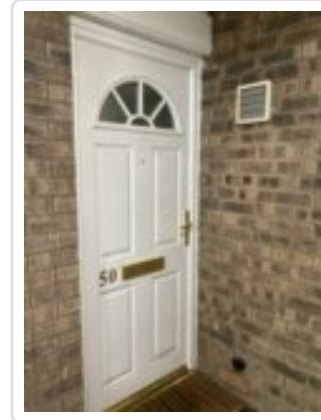
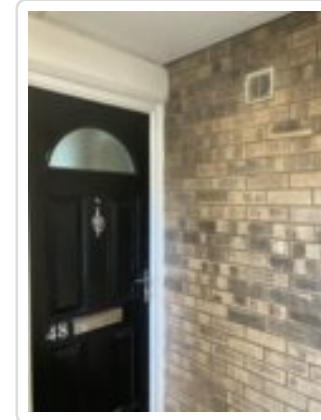
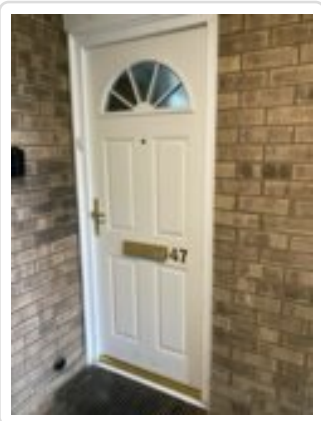
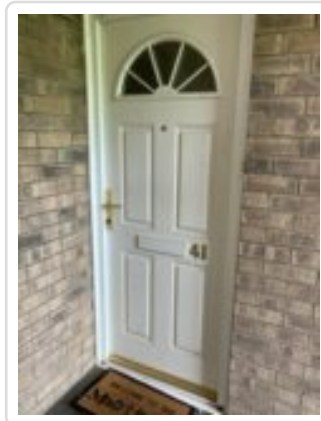
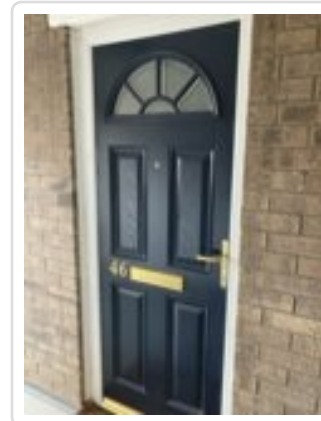
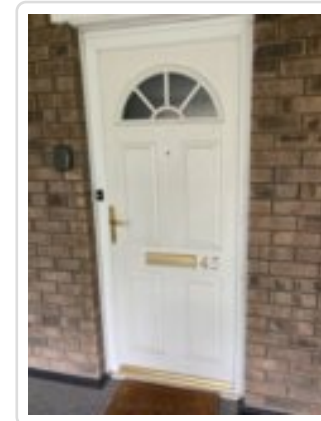
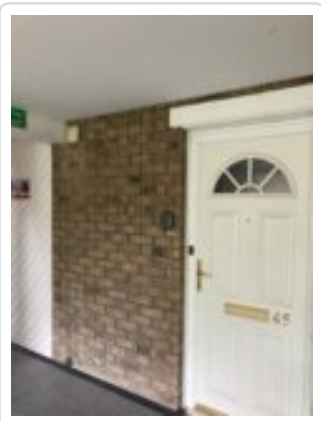
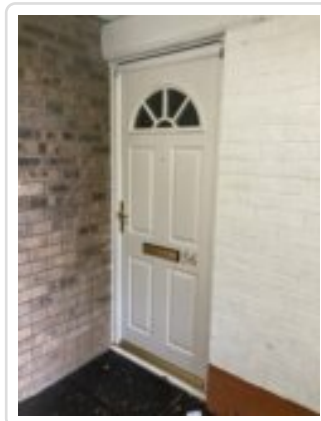
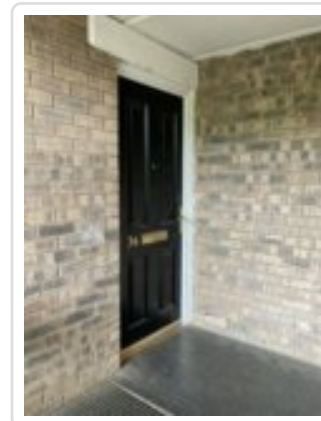
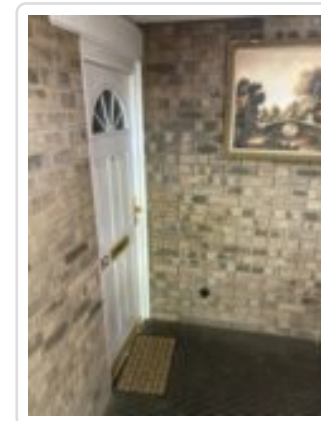
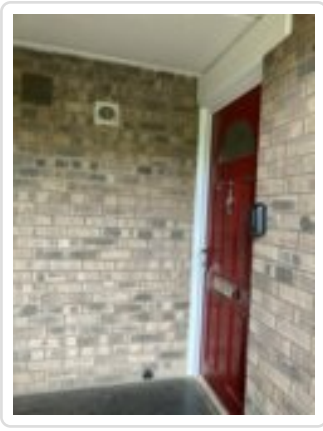
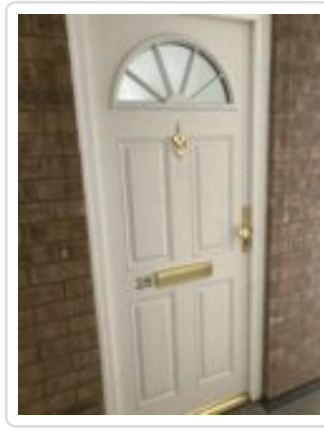
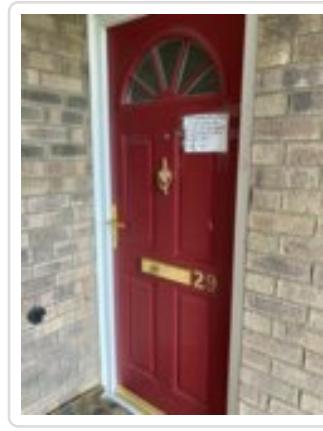
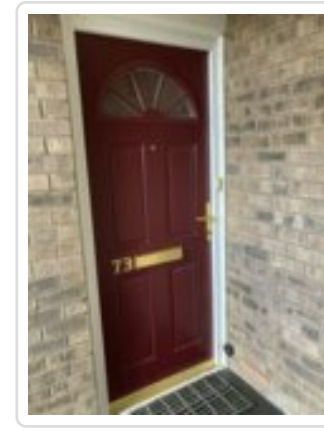
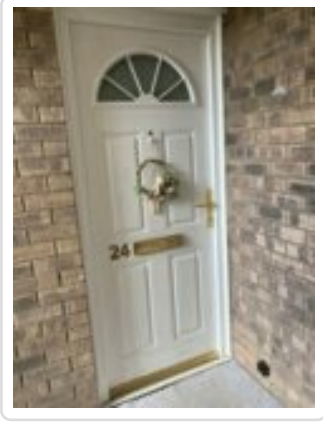
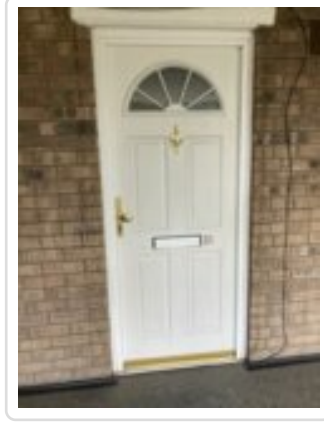
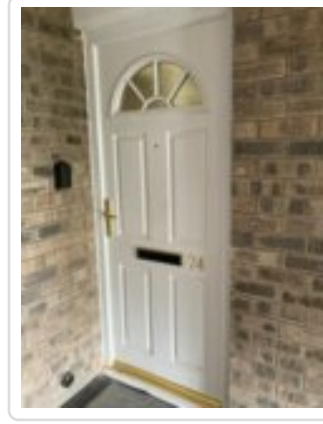
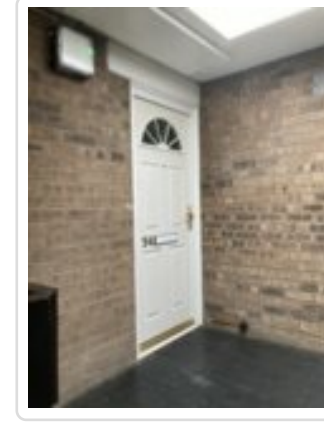
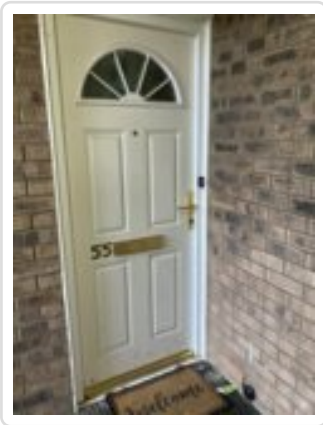
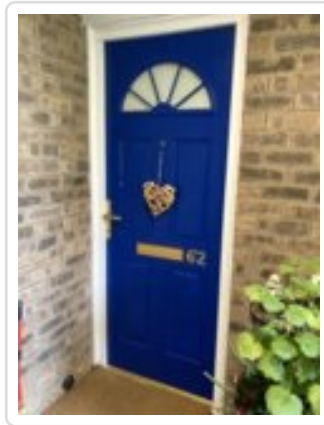
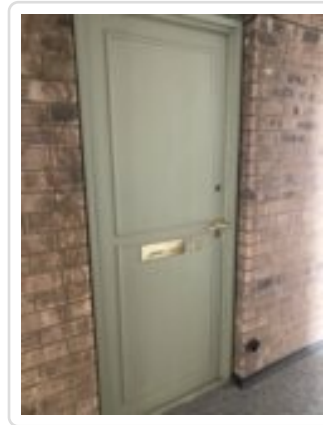
A survey of flat entrance doors and the door furniture in 2019 revealed that the doors on escape routes were non fire rated doors. The majority of tenant doors (50/51) in the blocks were replaced in 2020/21. However, leasehold doors are still mostly non-compliant.

Likelihood: Moderate **Consequence: High Harm** **3 x 2 = 6 | Substantial Risk**

All leasehold doors in a recent survey (end of 2019) were identified as HIGH priority as they are non fire rated flat entry doors and need to be replaced with an FD30S standard door. Leaseholders were written to in 2020 and offered a replacement door as part of the Councils program of work. However, many of the doors across the block remain non-compliant. The Council should continue to pursue flat entry door replacement where there is non-compliance. The Leasehold Team are currently in the process of writing to leaseholders again to request evidence of compliance.

The Council should continue to pursue flat entry door replacement where there is still non-compliance.

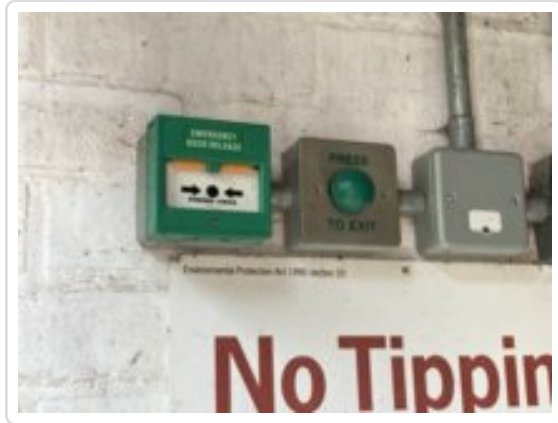
IMG_2371

Manual over ride devices activated.

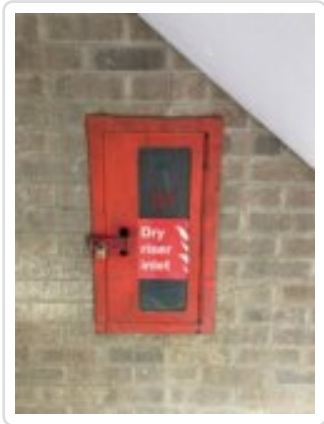
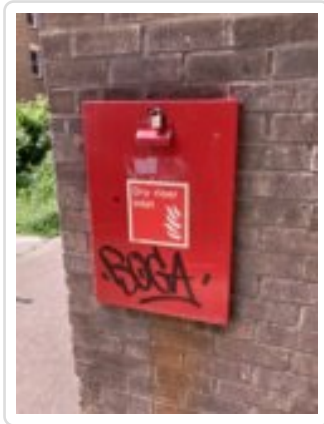
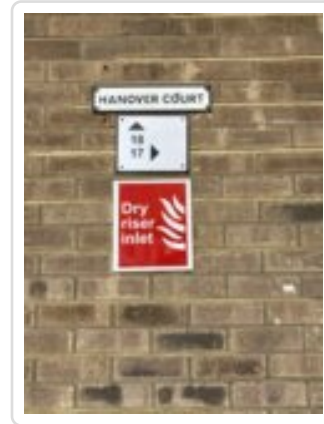
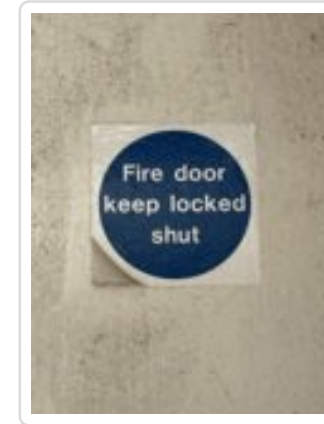
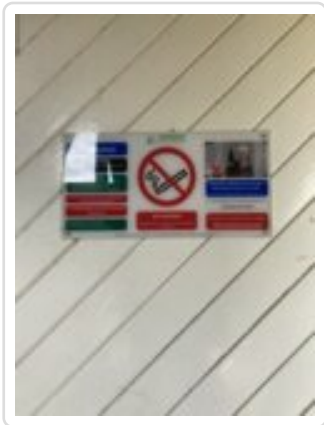
Where appropriate fire safety signage and notices are provided including fire action notices, fire exit directional signage, some store/electrical cupboards and dry riser inlets.

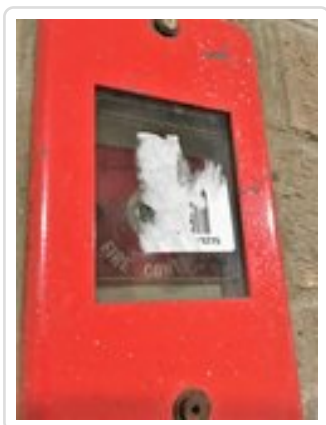
IMG_6484

Fire fighters lift - assess

The lift has a fire fighters control switch outside the lift doors at ground level. It is not clear if this is still operative - see recommendation above and section below.

An assessment by lift engineers is recommended. Given the height of the building this facility would be of use to the fire service.

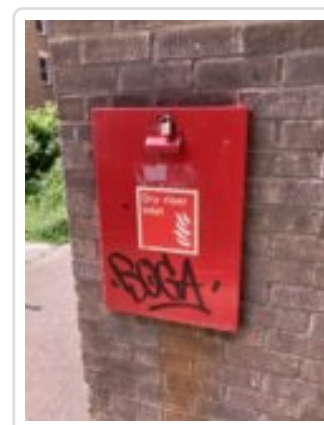
The DR outlets are not enclosed in a box for protection but were secured with a strap and lock.

It is recommended that the fire service are invited to use the DR's as part of a training/familiarisation exercise.
