# REGULATORY REFORM (FIRE SAFETY) ORDER 2005

## Fire Risk Assessment

**Assessed Area:** Hanover Court, Coronation Street, Cambridge

**Date of Inspection:** Jul 17, 2020

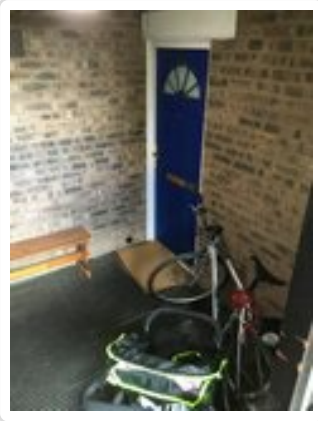
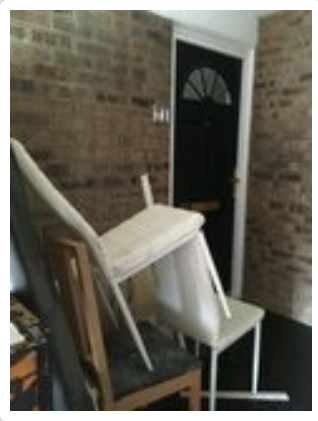
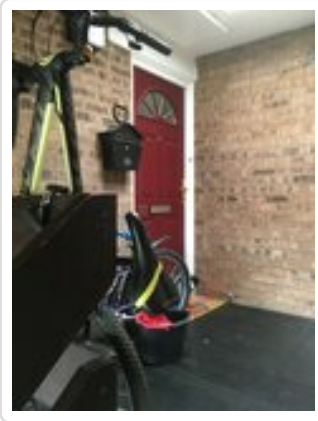
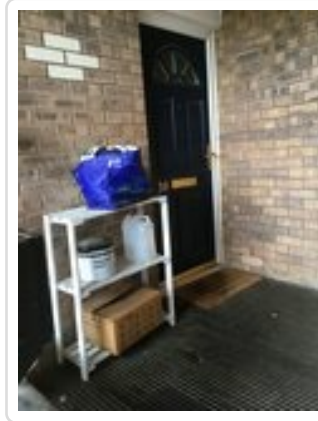
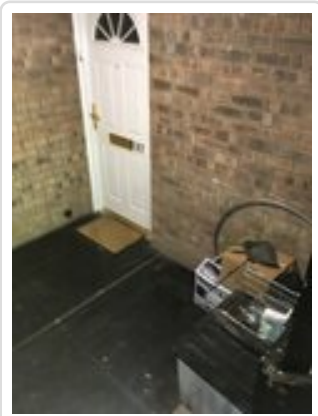
Images 9

Housekeeping to the premises was poor in the following areas due to storage of bicycles/items outside flats causing an obstruction and trip hazard.

The picture outside flat 31 is not a particular fire hazard but should be discouraged so as not to set precedent for other residents.

As can be seen from the attached images there are either bikes or items of storage outside some flat entrance doors. Application of the Council's zero tolerance policy as per other flats is recommended although acknowledged as difficult to implement in some instances.

| Housekeeping | Tolerable Risk | <p>Is the standard of housekeeping to the assessed area generally adequate?: No</p> <p>📍 Complete building (Complete Building)</p> <p>Significant Finding</p> <p>Housekeeping to the premises was poor in the following areas due to storage of bicycles/items outside flats causing an obstruction and trip hazard.</p> <p>Actions Required</p> <p>⊗ Housekeeping-improve</p> <p>Housekeeping to the premises should be improved by removal of items/bicycles that may obstruct escape routes. These are outside flats 5,7,30,31,37,67,71,77,78 and on the walkway. The picture outside flat 31 is not a particular fire hazard but should be discouraged so as not to set precedent for other residents.</p> <p>— complete within 3 months to reduce the risk by 100%</p> | Y | |

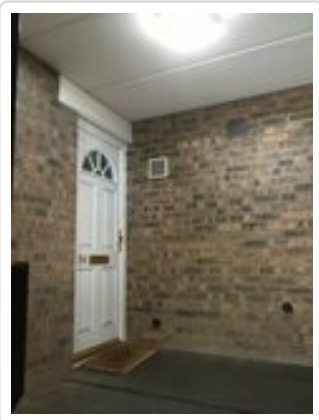
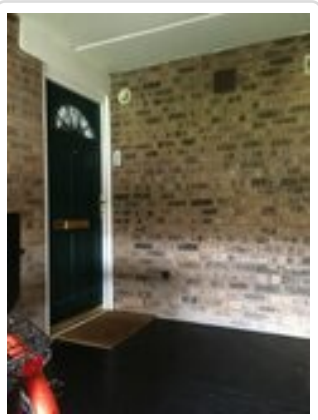
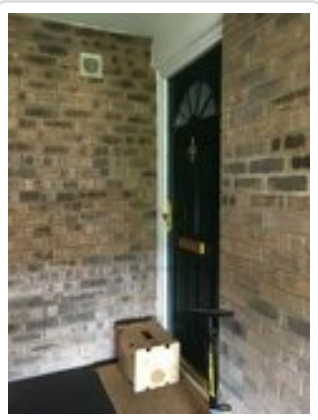
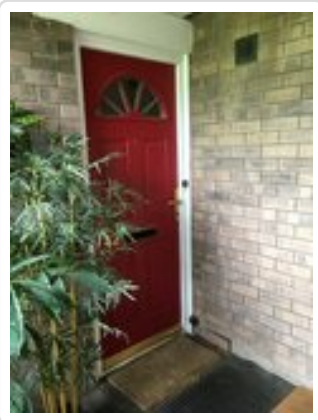
Images 7

There is ventilator in the external wall outside flats: 17,35,42,48,50,65 & 66. Depending on its position inside the flat it may allow smoke to enter the stair in the event of a fire. It is noted that there is some ventilation to open air but this is not at the head of the stair and smoke logging may occur.

It is recommended that this is investigated and if necessary the ventilation re routed or an appropriate fire rated block fitted.

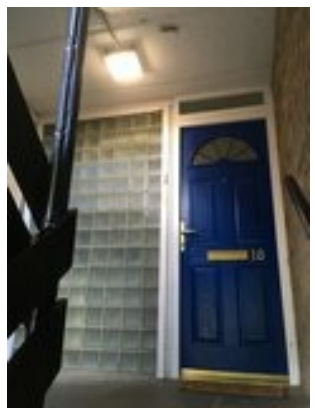
IMG\_4521  
— Jul 26, 2020, 12:30:54 PM

The escape for most of the flats above ground floor is via generally semi-open routes which provides venting for smoke, however, also see comment above re 'escape routes' regarding impact of a fire on these routes. This includes the staircases from ground to first floor flats and those serving 2nd/4th and 5th/7th floor flats off the walkways at 3rd and 6th floors. The main staircases at each end running the full height of the building are open at all levels except the head of the stair. The walkways are also ventilated at each end of the block.

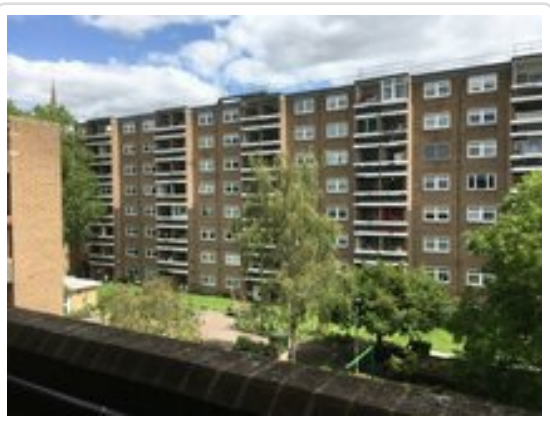
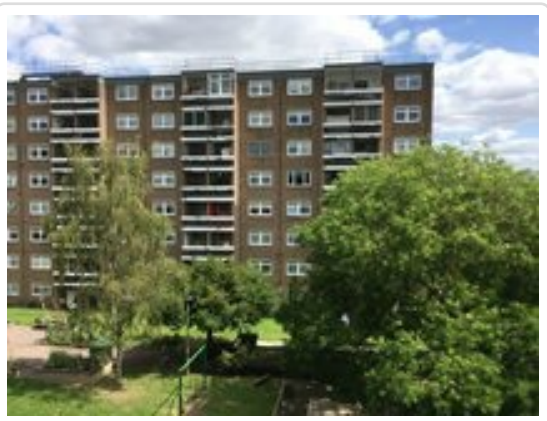
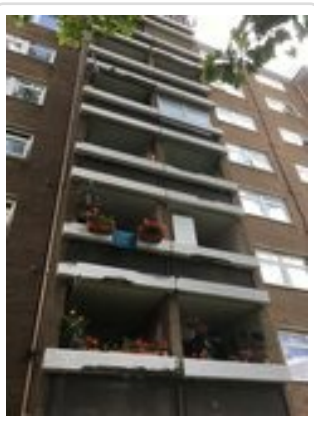
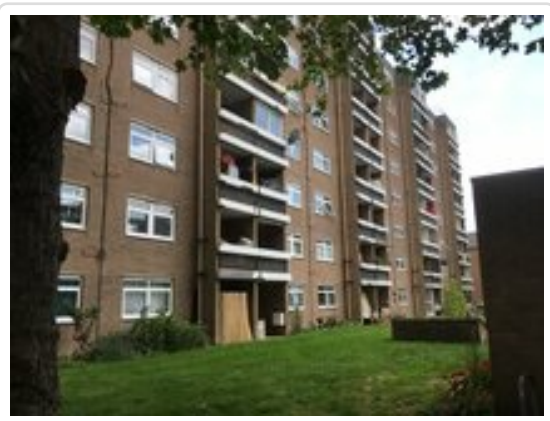
🖼 Images4

It was not possible for the assessor to externally check by observation the use of all the resident balcony spaces given the height of the building. In discussing this with the caretaker there are some balconies of concern (flats 15 and 20) that may present additional fire hazards. With the support of the housing management team these should be investigated and information provided to residents more generally about the usage of balconies.

Resident balconies are not constructed of combustible materials although some are enclosed - see recommendation above.
