# REGULATORY REFORM (FIRE SAFETY) ORDER 2005

## Fire Risk Assessment

**Assessed Area:** Hanover Court, Coronation Street, Cambridge

**Date of Inspection:** Jul 17, 2020

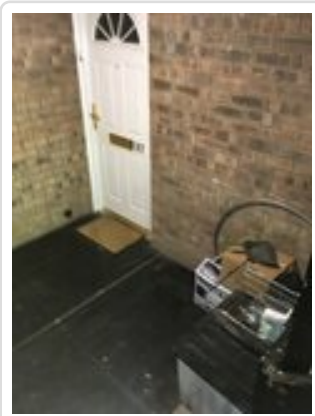
As can be seen from the attached images there are either bikes or items of storage outside some flat entrance doors. Application of the Council's zero tolerance policy as per other flats is recommended although acknowledged as difficult to implement in some instances.
