# Greater Cambridge Chalk Streams Project Report

Prepared for Guy Belcher, Cambridge City Council, and Jennifer Thomas, Cambridge Water  
Version 1.1

Prepared by:	Ruth Hawksley, Wildlife Trust BCN	01/12/2020
	Rob Mungovan, Wild Trout Trust	01/12/2020
Reviewed by:	Martin Baker, Wildlife Trust BCN	16/12/2020
	Shaun Leonard, Wild Trout Trust

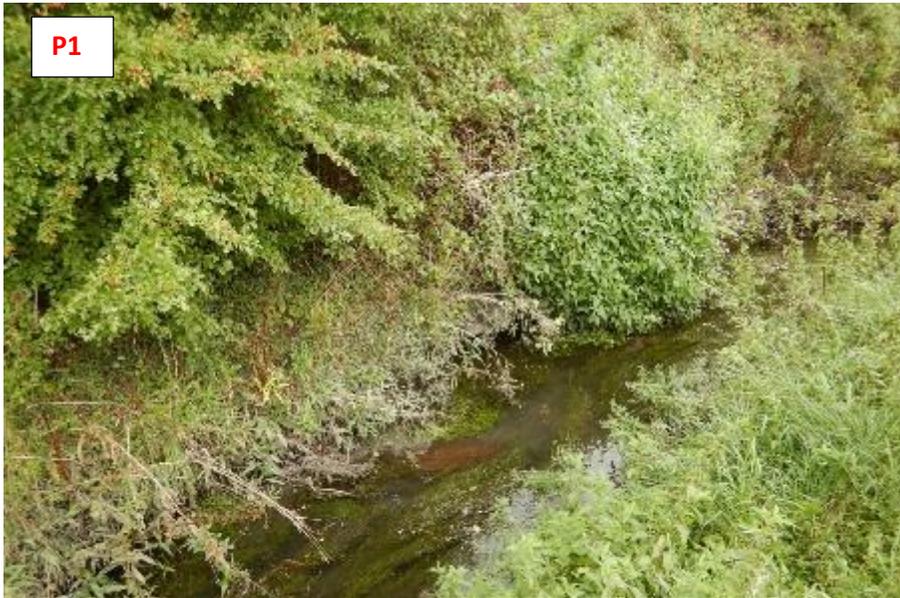
P1

At Coldham's Common, Aug 2020 – note the flood line on trailing vegetation.

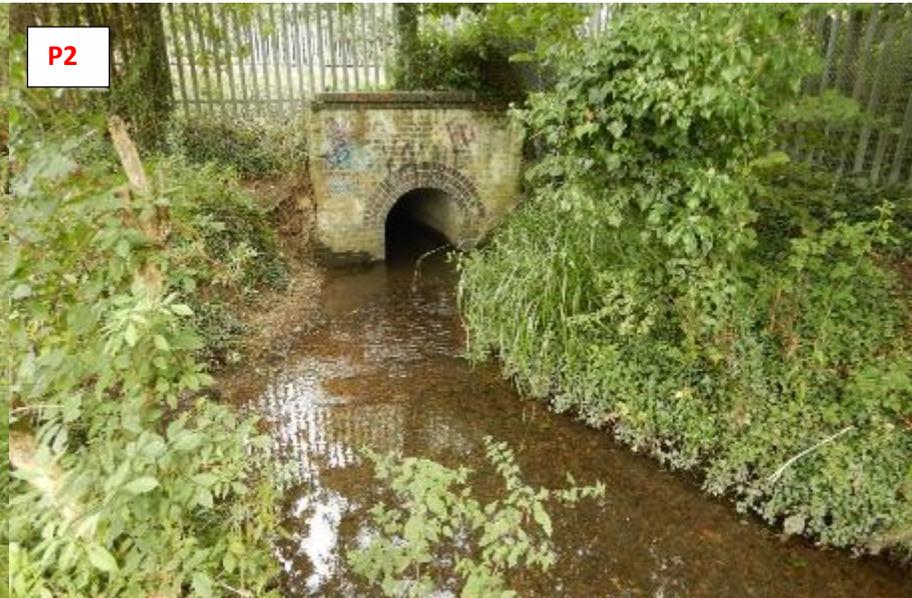
P2

The culvert beneath the railway, Aug 2020 – note the narrow culvert and gravel bed.

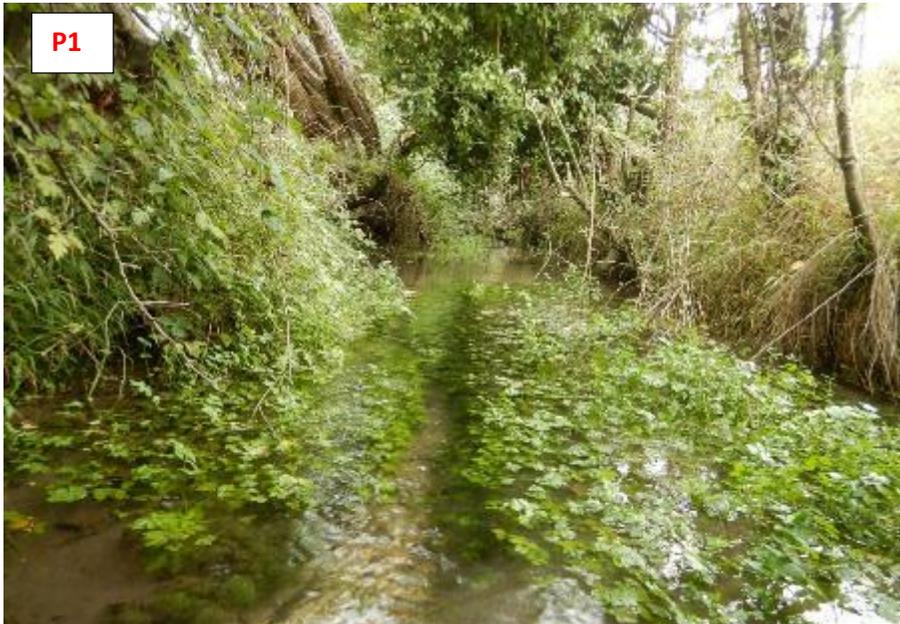
P1

The headwaters of the brook, Oct 2020 – trout used to spawn here.

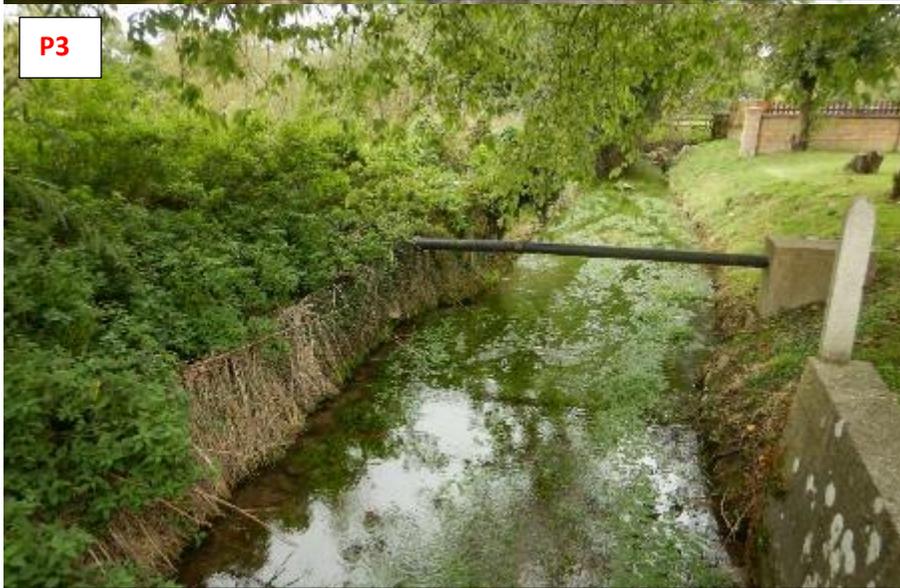
P3

A shallow reach downstream of a bridge, Oct 2020 – brook lamprey, minnow and occasional trout spawn here.

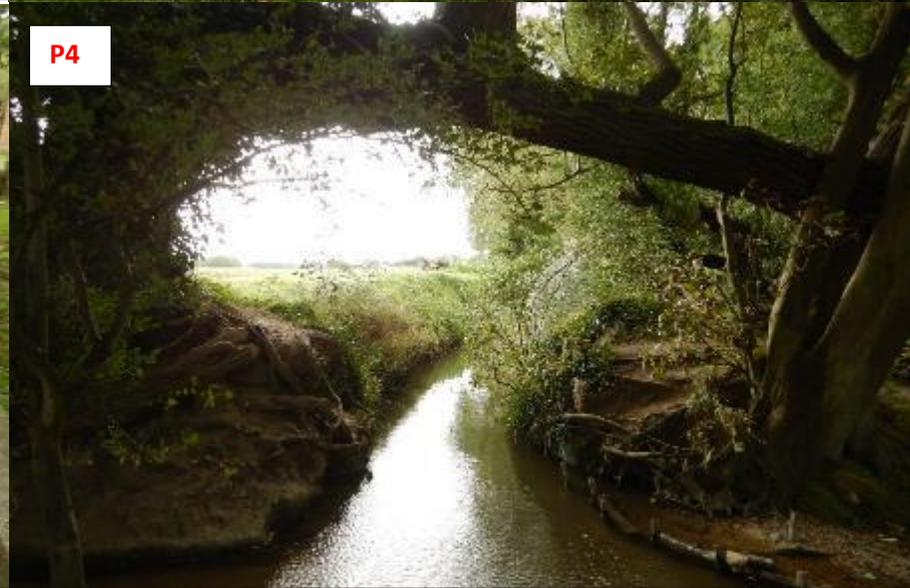
P4

The confluence of the brook with the Shep, Sept 2020

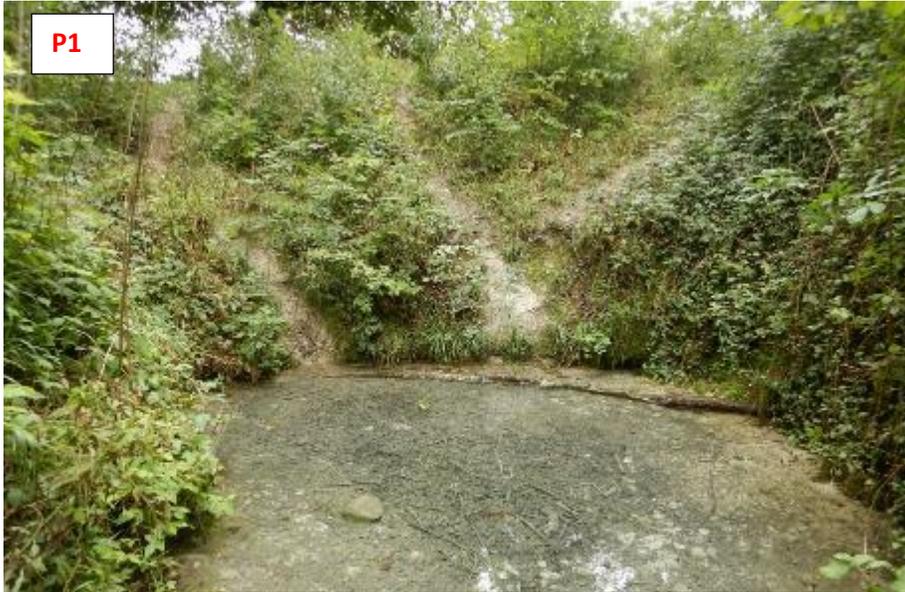
P1

One of the spring areas at Nine Wells Sept 2020

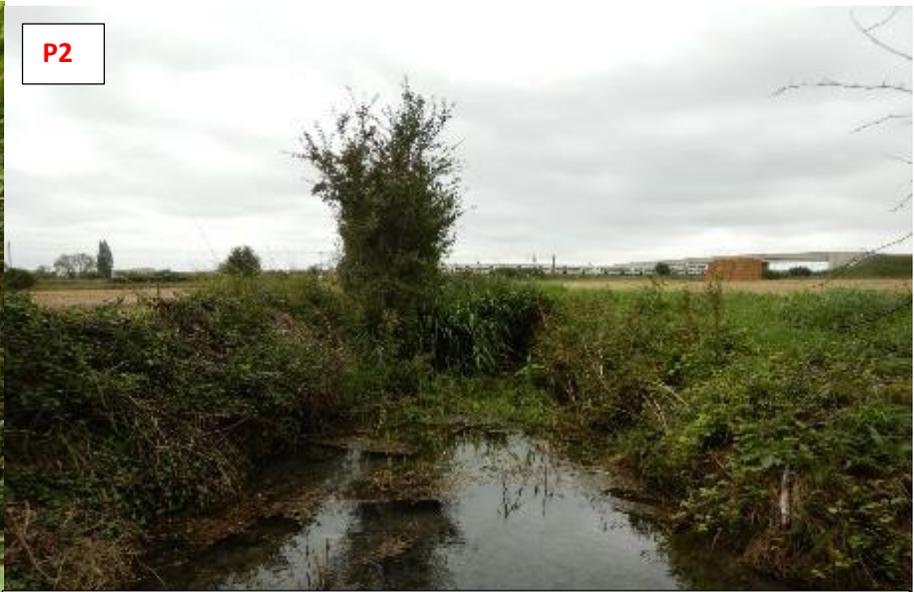
P2

The brook as it leaves Nine Wells Sept 2020 – the brook becomes a drain through farmland.

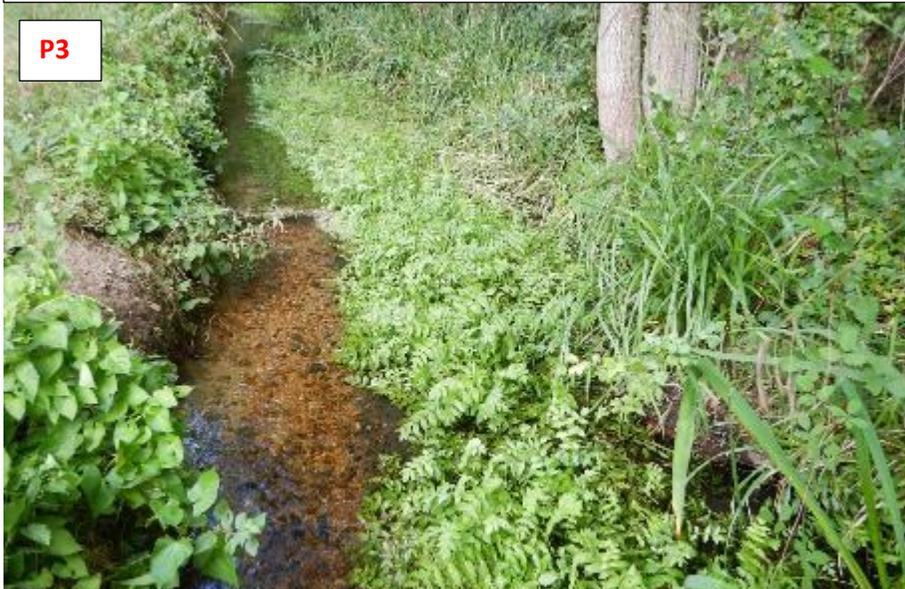
P3

The brook Sept 2020 - showing chalkstream characteristics once plants have narrowed the channel. Note the extensive gravel bed.

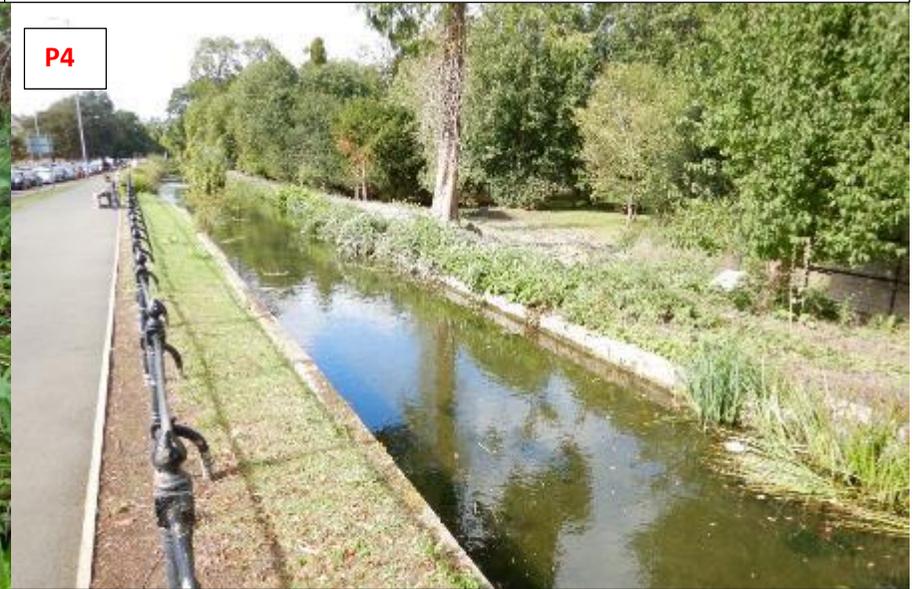
P4

The brook has become the conduit as it leads to Cambridge, Sept 2020. The channel is prone to siltation, algae and poor habitat.

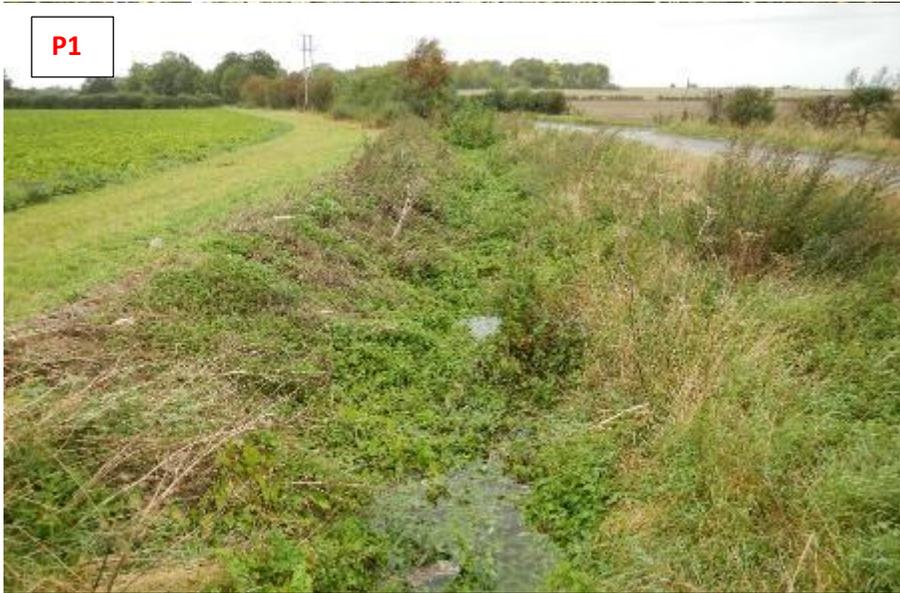
P1

The brook upstream of Newton Sept 2020 – water was flowing but it sunk into the ground a short distance downstream.

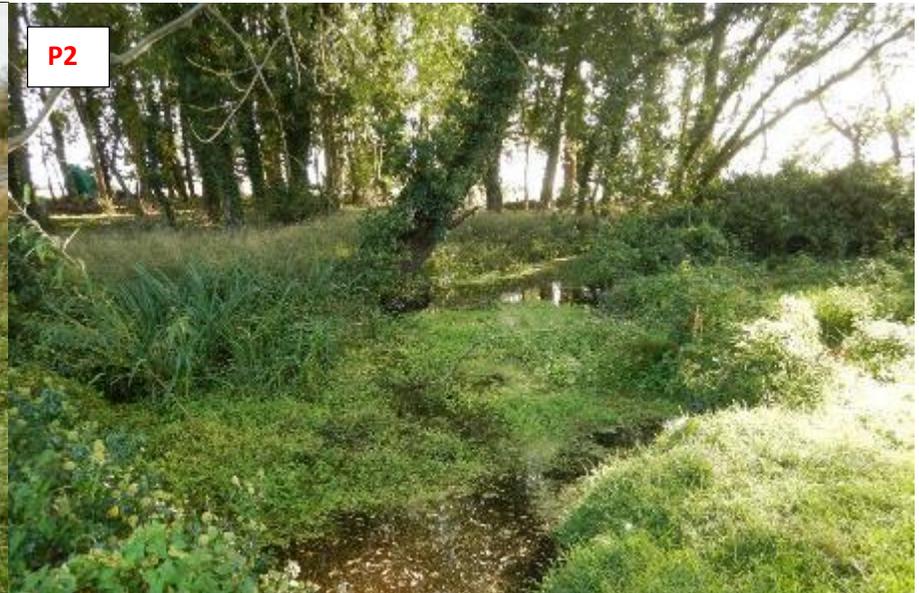
P2

The brook immediately above Chardles' Springs Sep 2020.

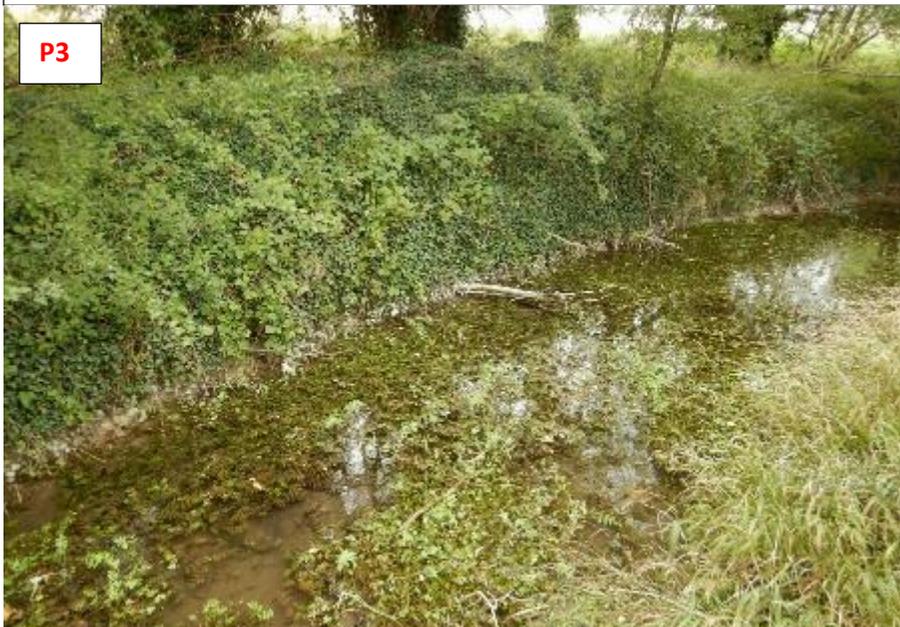
P3

The brook downstream of the railway suffering from low flow Sept 2020

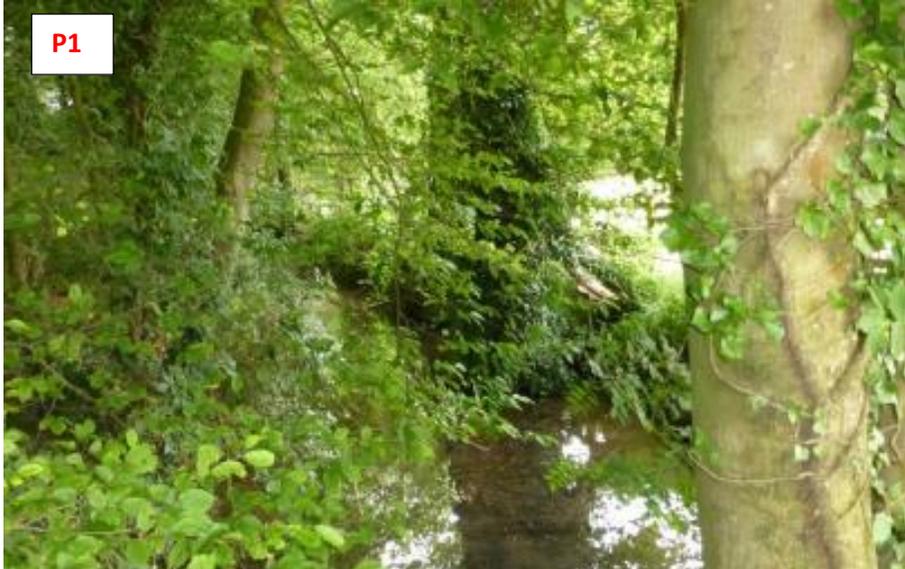
P1

Nr to Temple Springs, April '15 – a stream more typical of a chalk river.

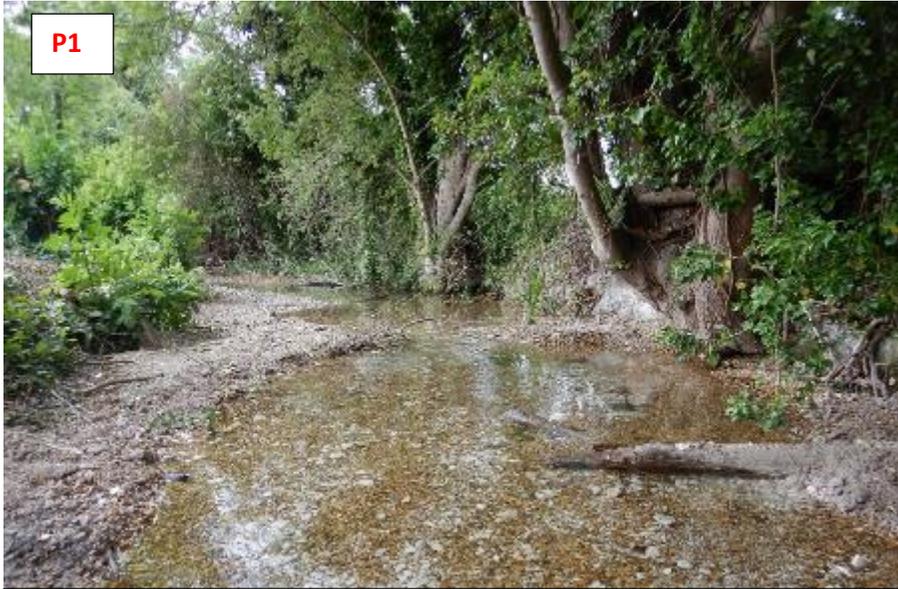
**P1**

Melbourn playing fields, June 2020 – the bed has been restored with chalk and gravel to increase fish spawning habitat.

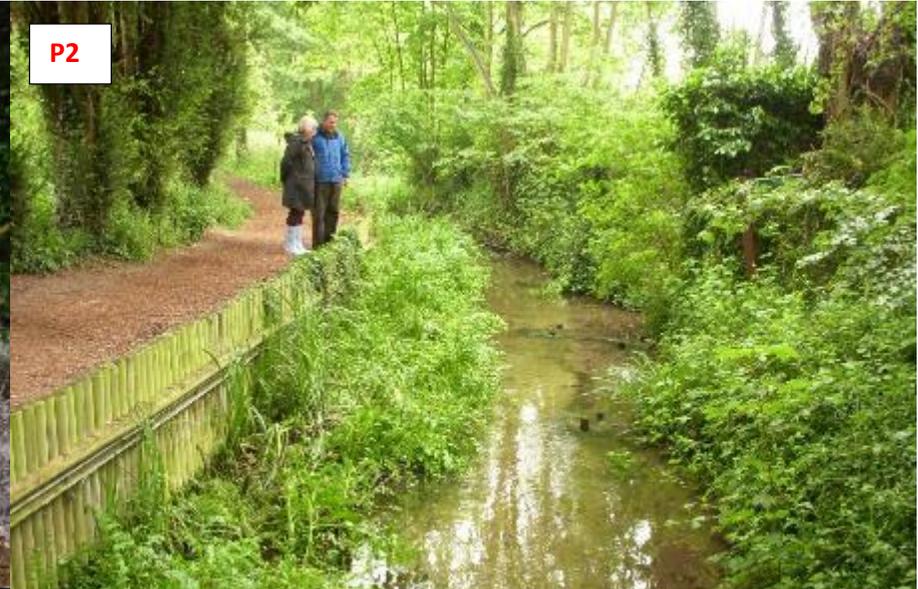
**P2**

Meldreth May 2012 – the margins have been enhanced through planted brushwood ledges.

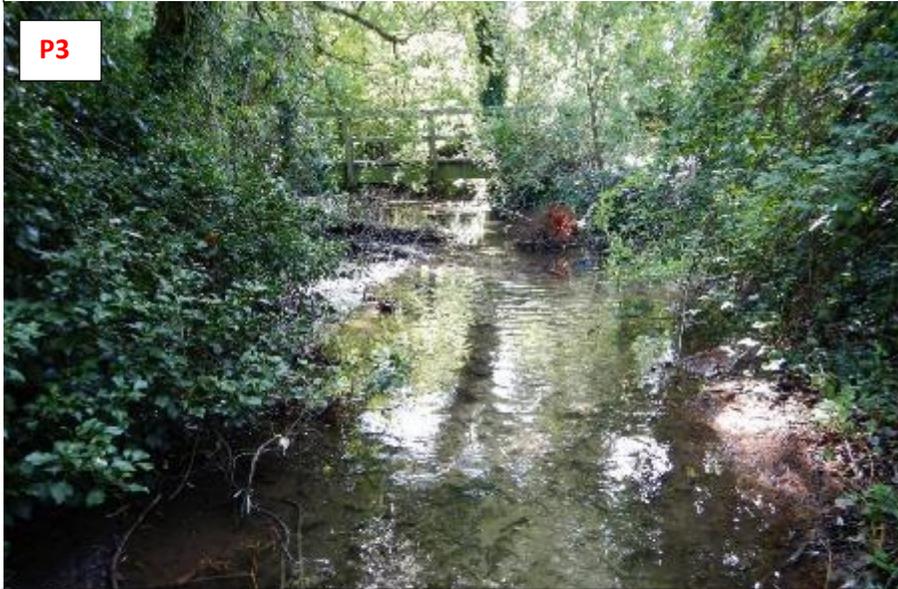
**P3**

Downstream of Meldreth church, Sept 2020 – the reach is over-shaded. It is to be the focus of habitat enhancement work in 2021.

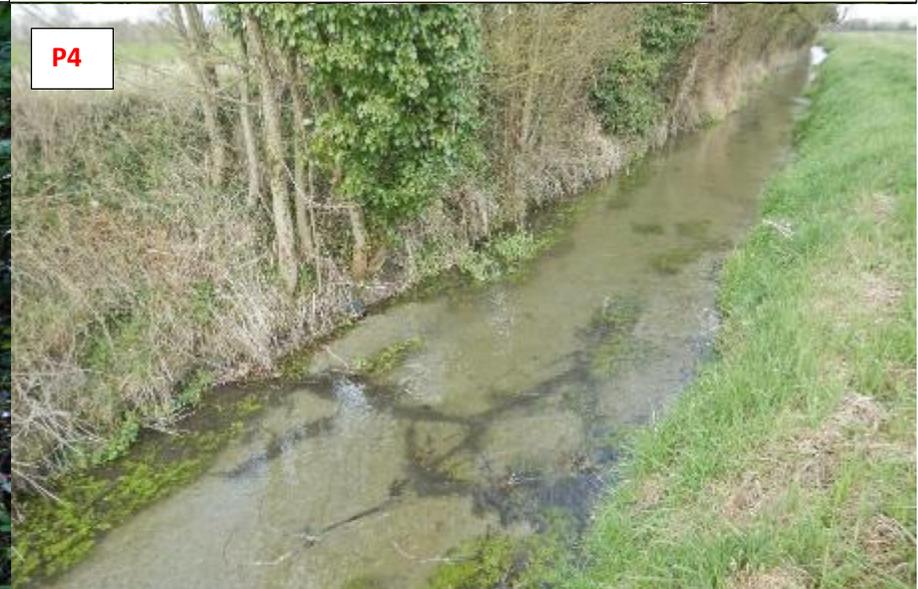
**P4**

Near to the Rhee confluence, March 2018 – the river flows in a straight channel with little habitat diversity.

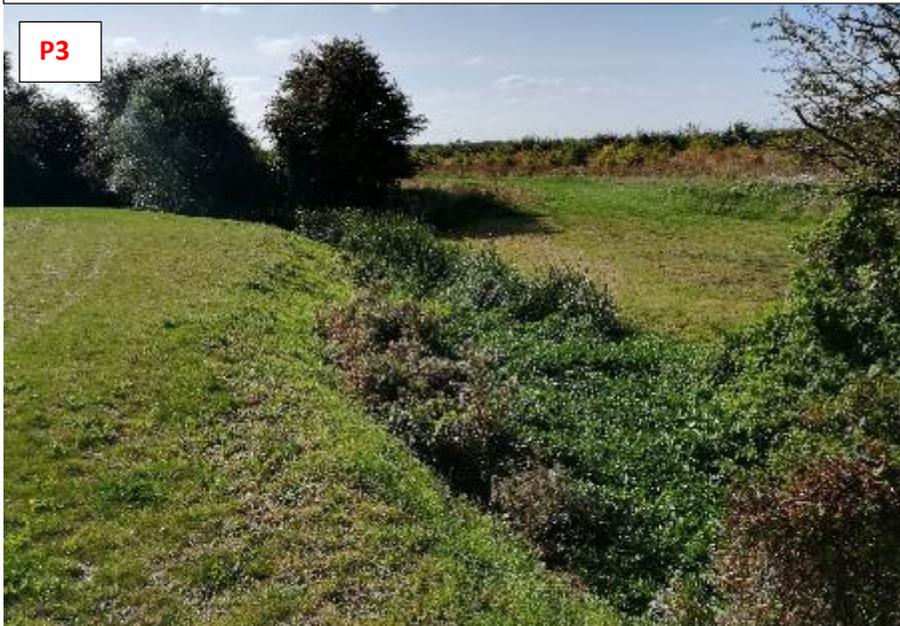
Mill River Reserve, Sept 2020 – a reprofiled section with lush growth.

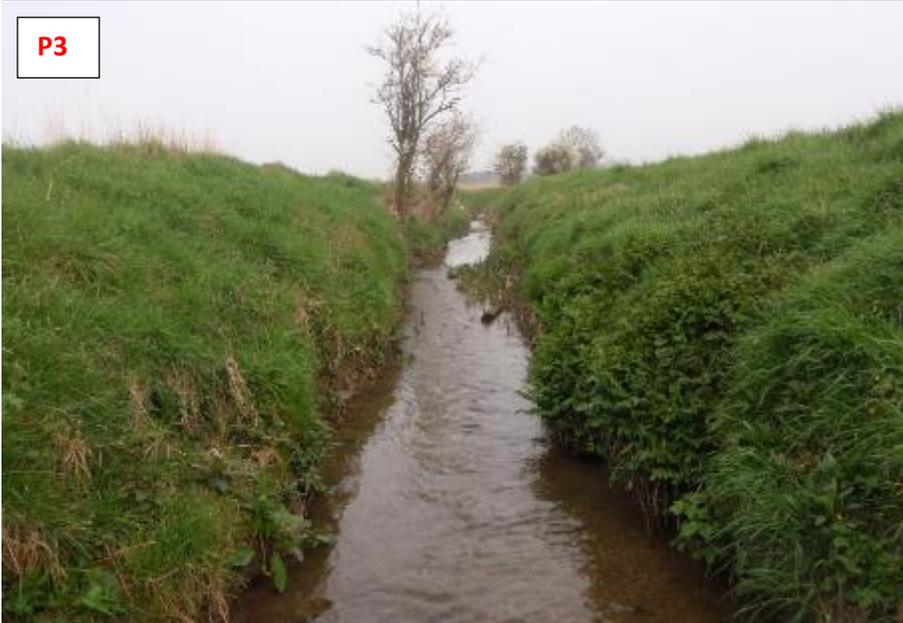
P3

Downstream of Orwell, April 2014.

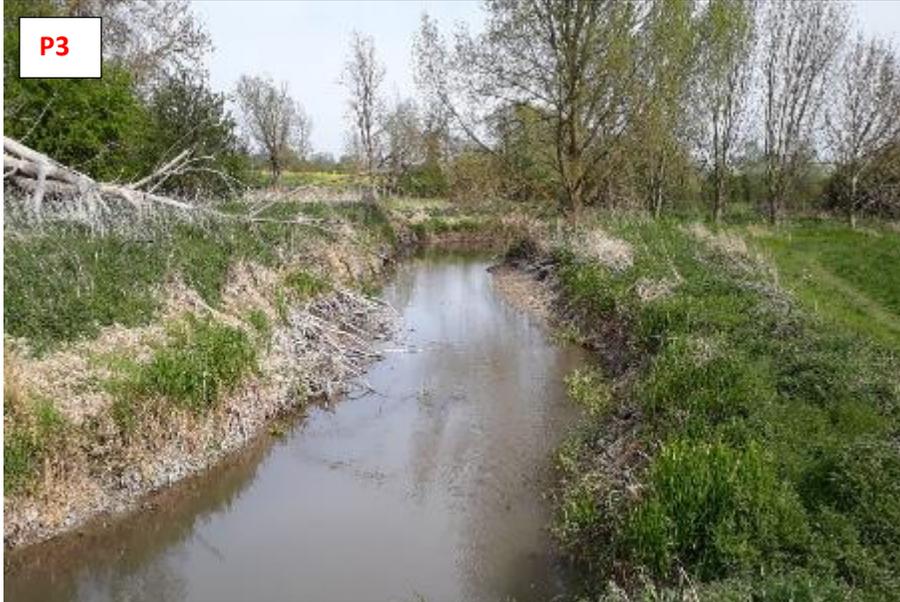
P3

The river between Harston and Barrington following the weir removal at Harston Mill, April 2019.

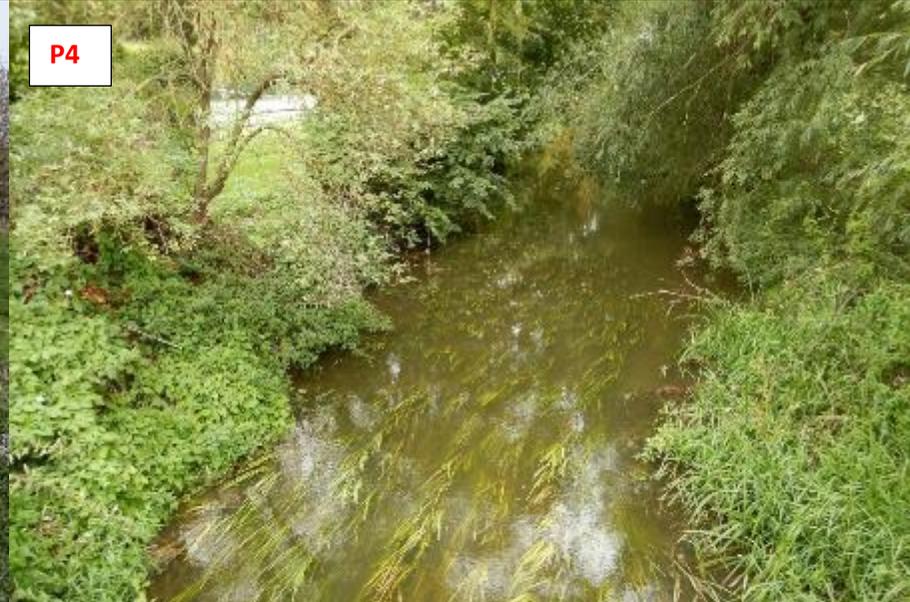
P4

The view upstream from Harston bridge Oct 2020.

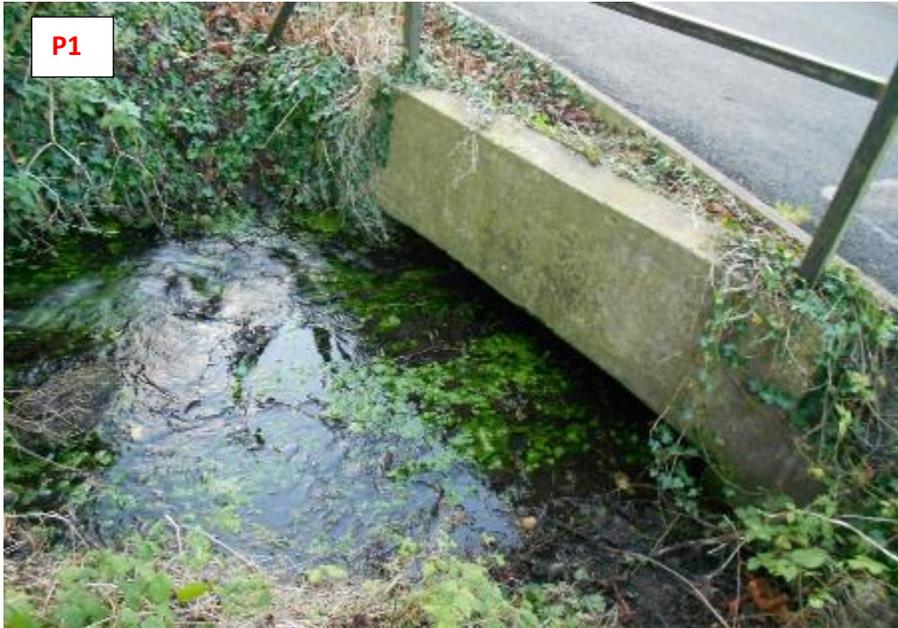
**P1**

At Hauxton Primary School Oct 2020 – a narrow ditch-like habitat.

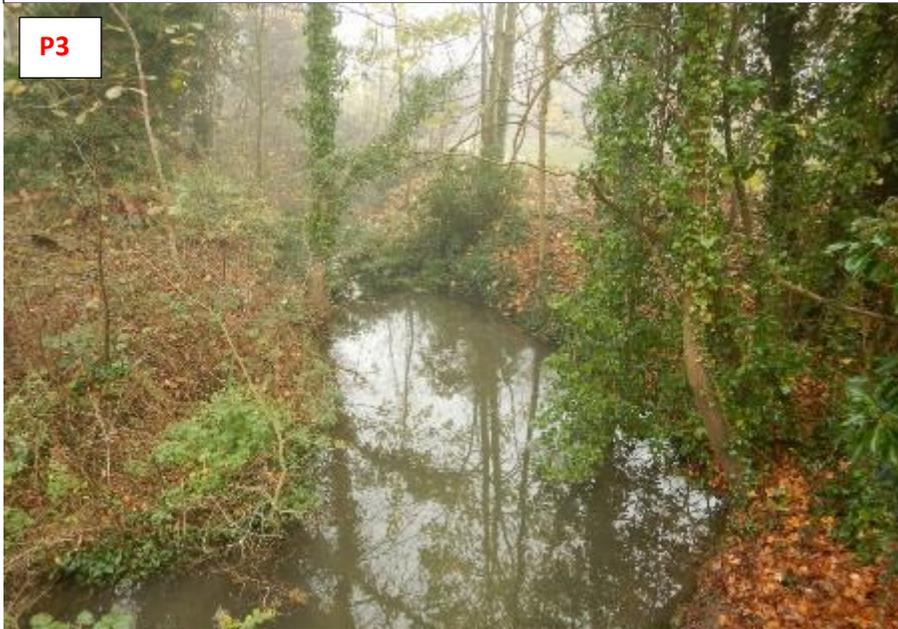
**P3**

Below Hauxton church Nov 2020 – over deep and wide.

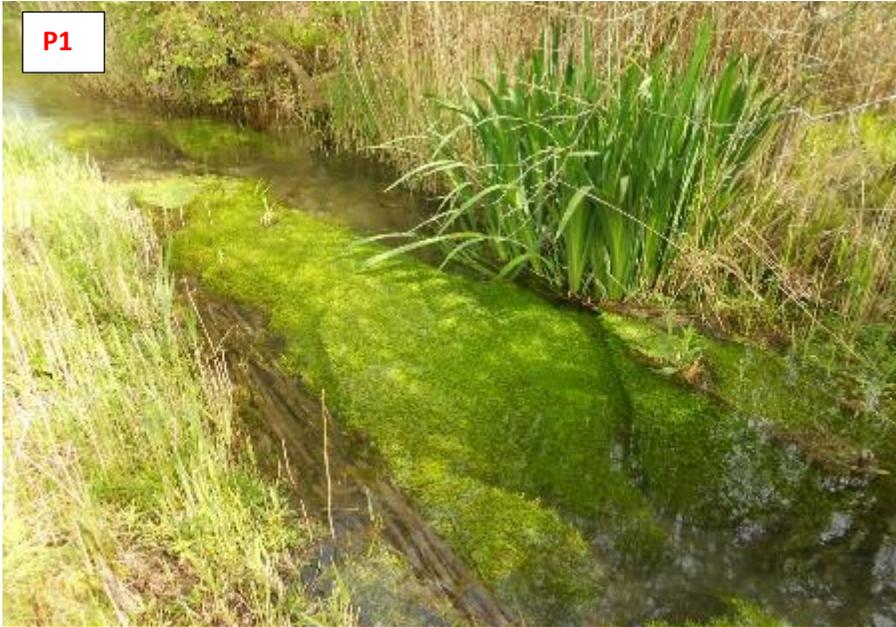
P1

At RSPB Fowlmere May 2014 – a restored reach following bed raising.

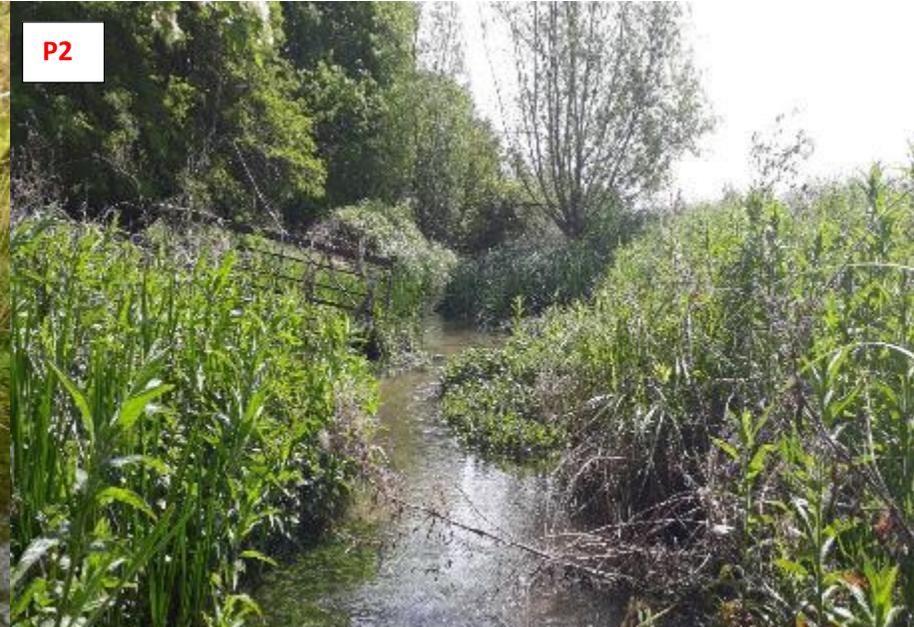
P2

Manor Farm, Shepreth April 2020 – lush emergent plants provide cover.

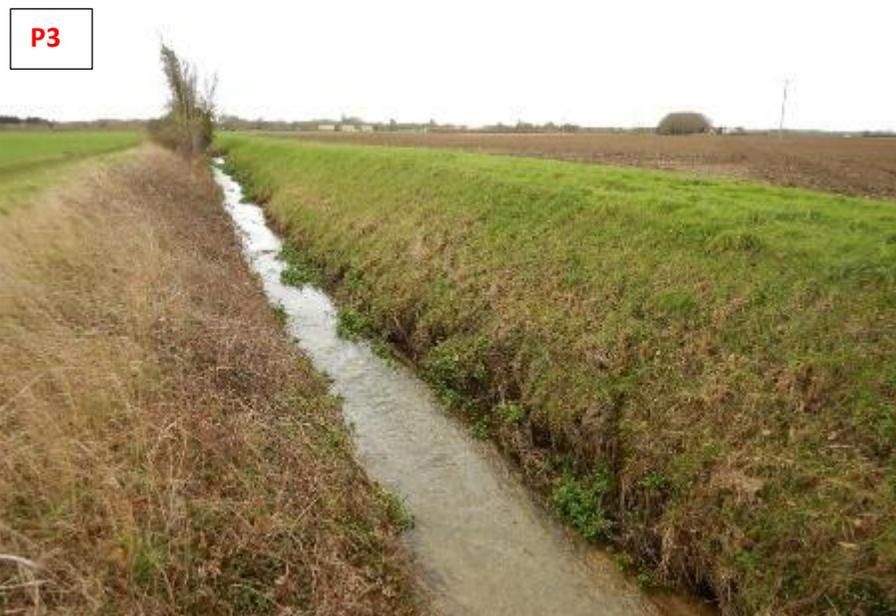
P3

Downstream of Shepreth, Jan 2020 – the long cut is a stark contrast.

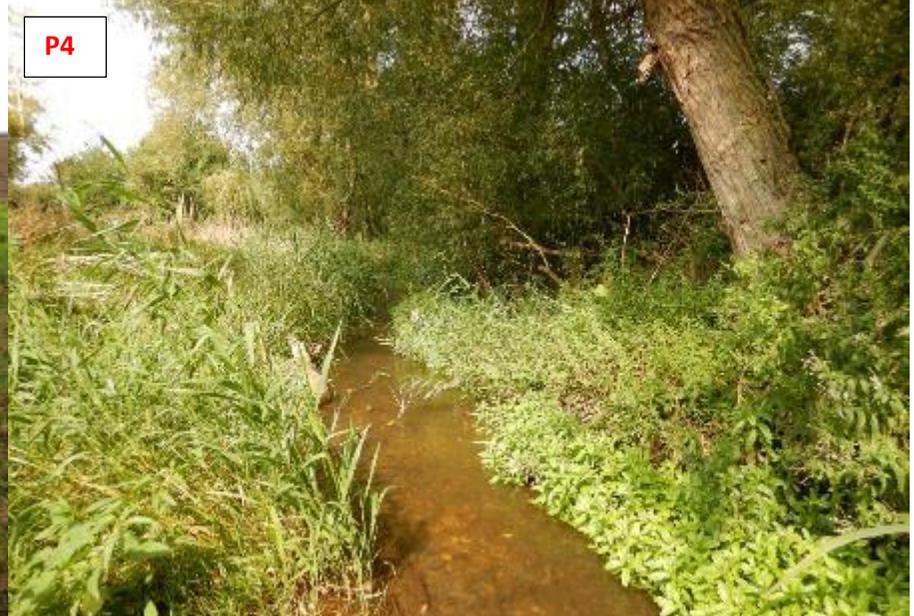
P4

Near Boot Lane, Barrington, Sept 2020 – a restored section.

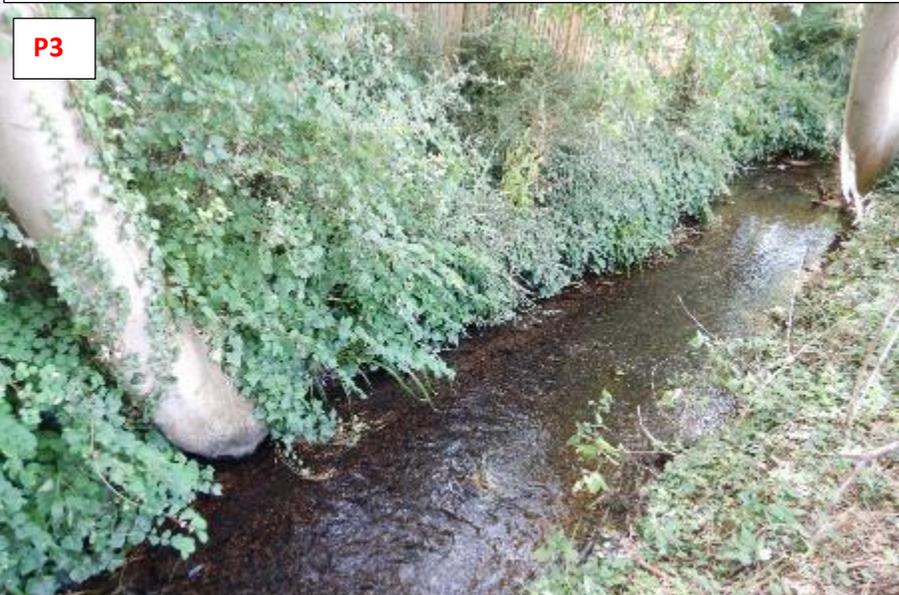
P3

The brook at New Bit Common, Sept 2020 – note the shallow depth and lack of cover.

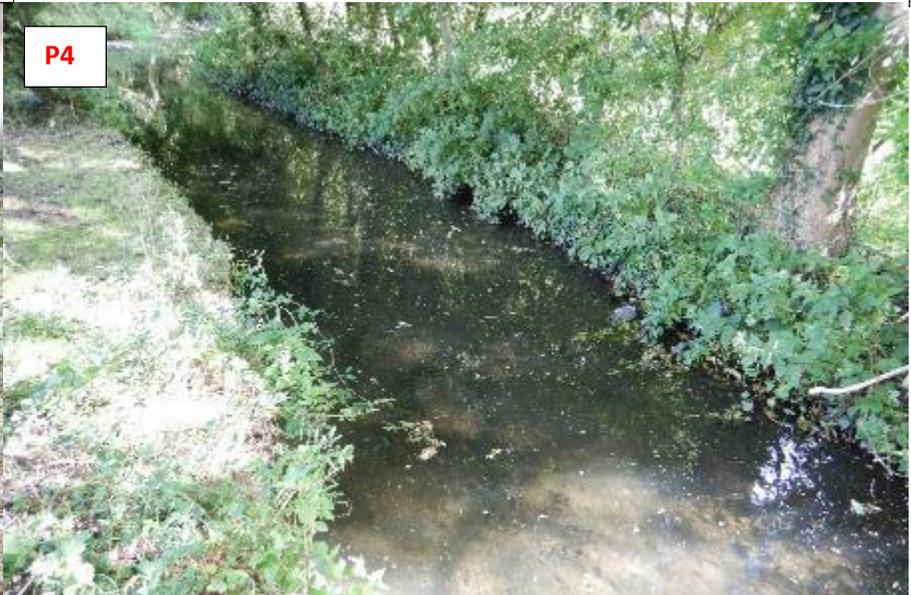
P4

The brook at the Cam confluence, Sept 2020 – note the deep silt creating a sub-optimal habitat for fish wanting to migrate upstream.

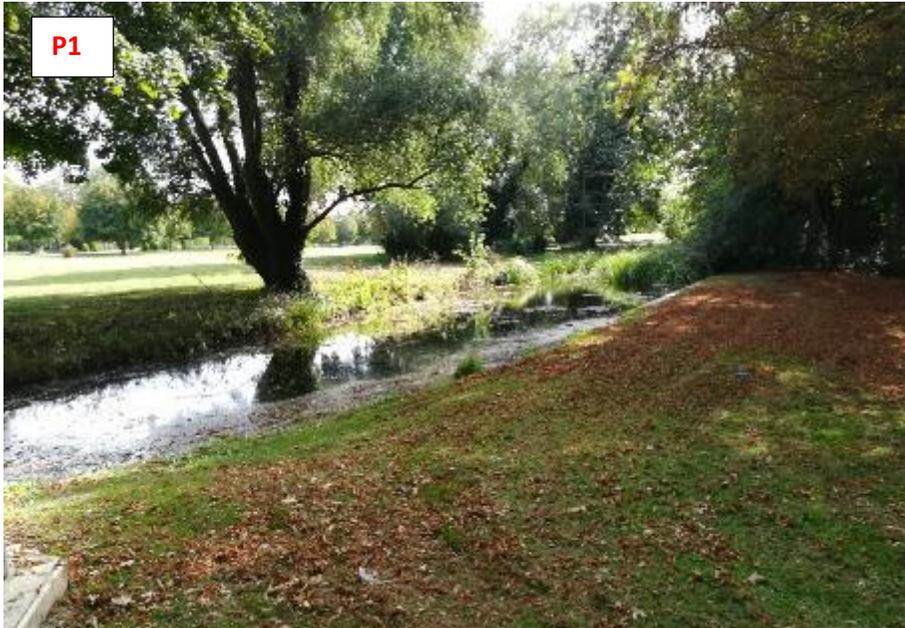
P1

Kneesworth House Sept 2020– water impounded.

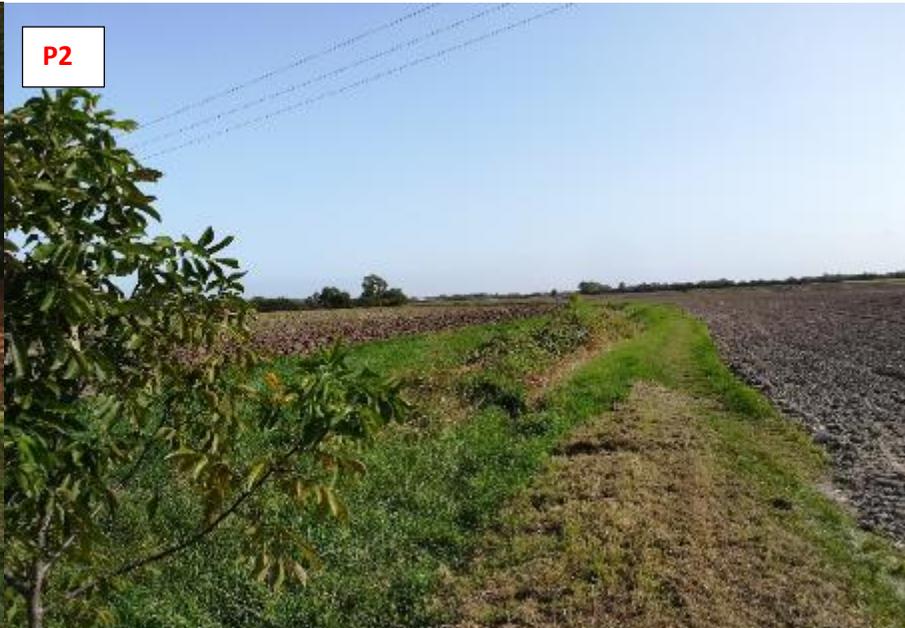
P2

Near Fountain Farm Sept 2020 – an almost-empty farm ditch.

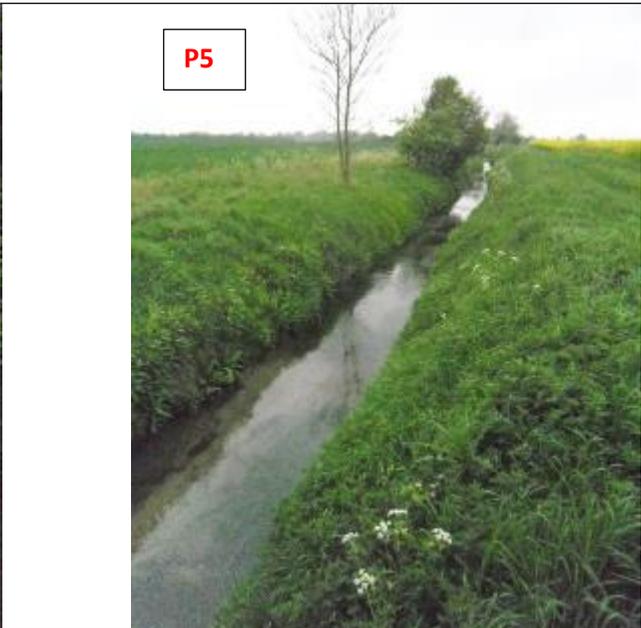
P5

Lower section of brook 2014 – steep-sided and very shaded in some areas, but some potential for 2-stage channel.

- Reprofile sections of bank at the lower end of the brook to create a wider pool or 2-stage channel. There is a potential small area where a strip of land is not cropped, near the confluence with another tributary stream (£10k).
- Feasibility study for restoration / wetland creation in the grounds of Kneesworth House. If wetland creation is possible, it could improve water quality for the rest of the brook (£5k).
- Feasibility study for NFM measures near Fountain Farm to hold back some water within the existing deep channel (£5k).
